# Update on Cryostat & Cryogenic Infrastructure

B. Schwingenheuer  
(K.T.Knöpfle)  
MPI-K Heidelberg  
11 March 2009, Padova

# Corrosion of the cryostat

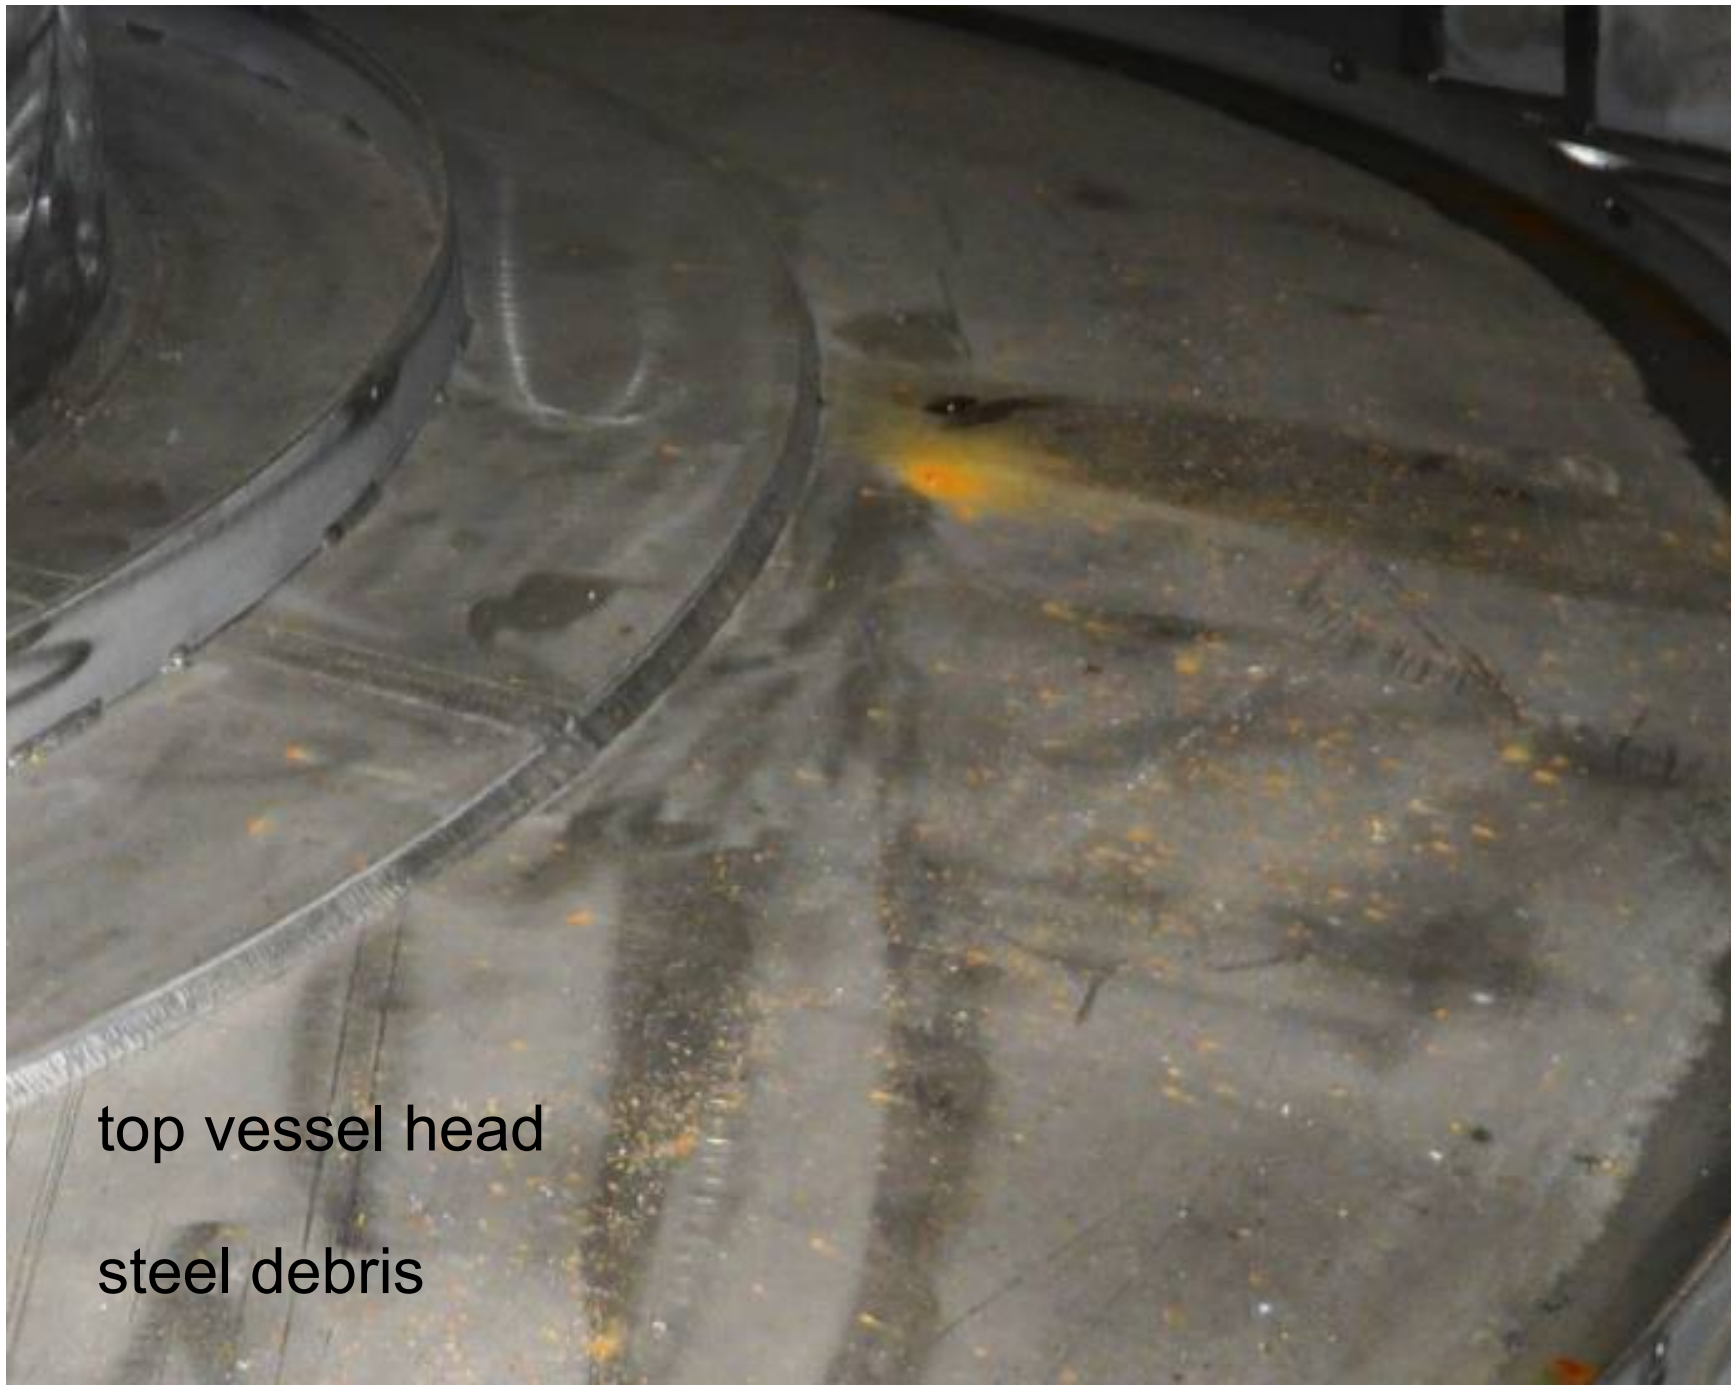
top vessel head

steel debris

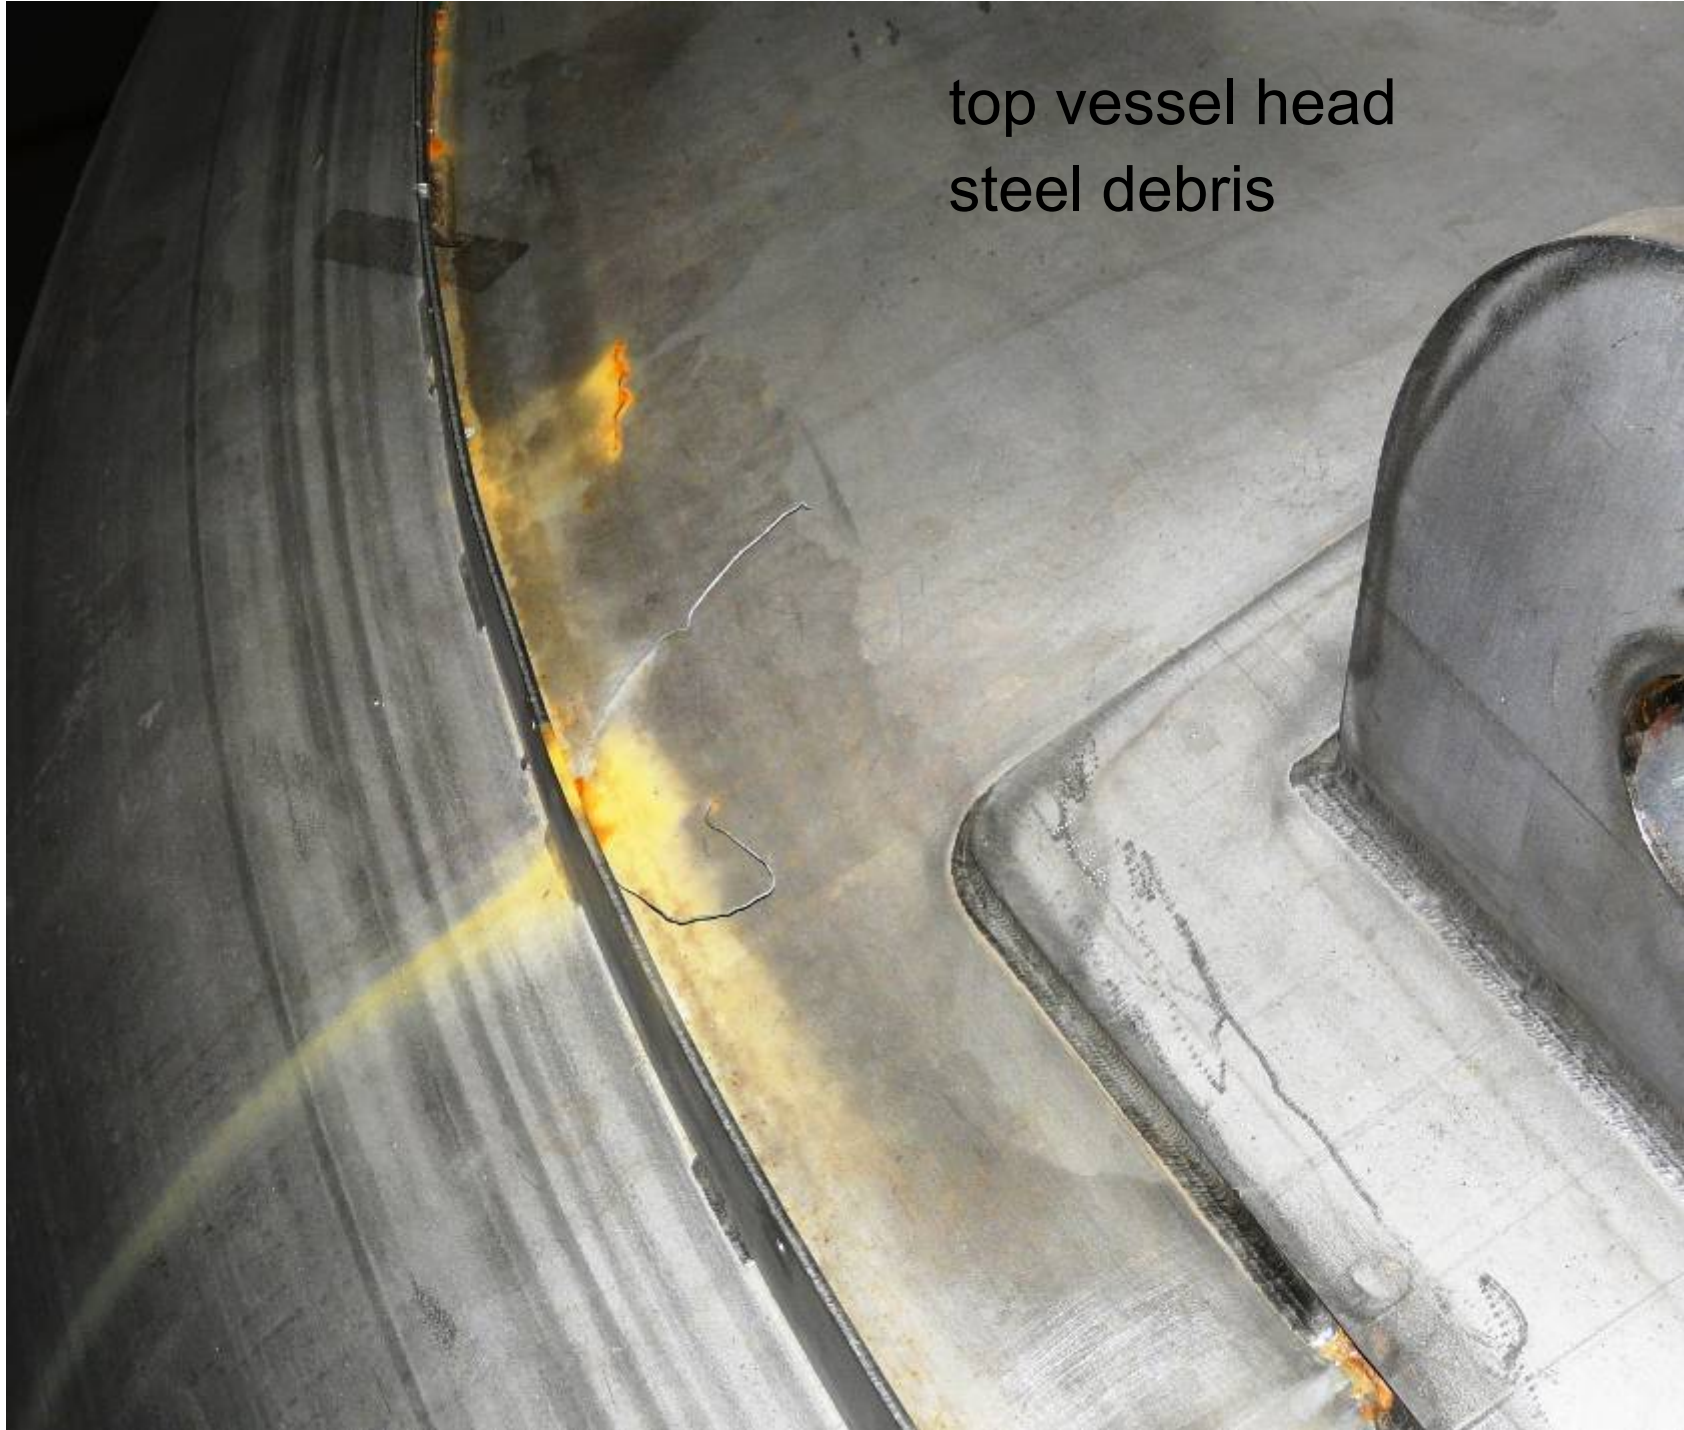
top vessel head  
steel debris

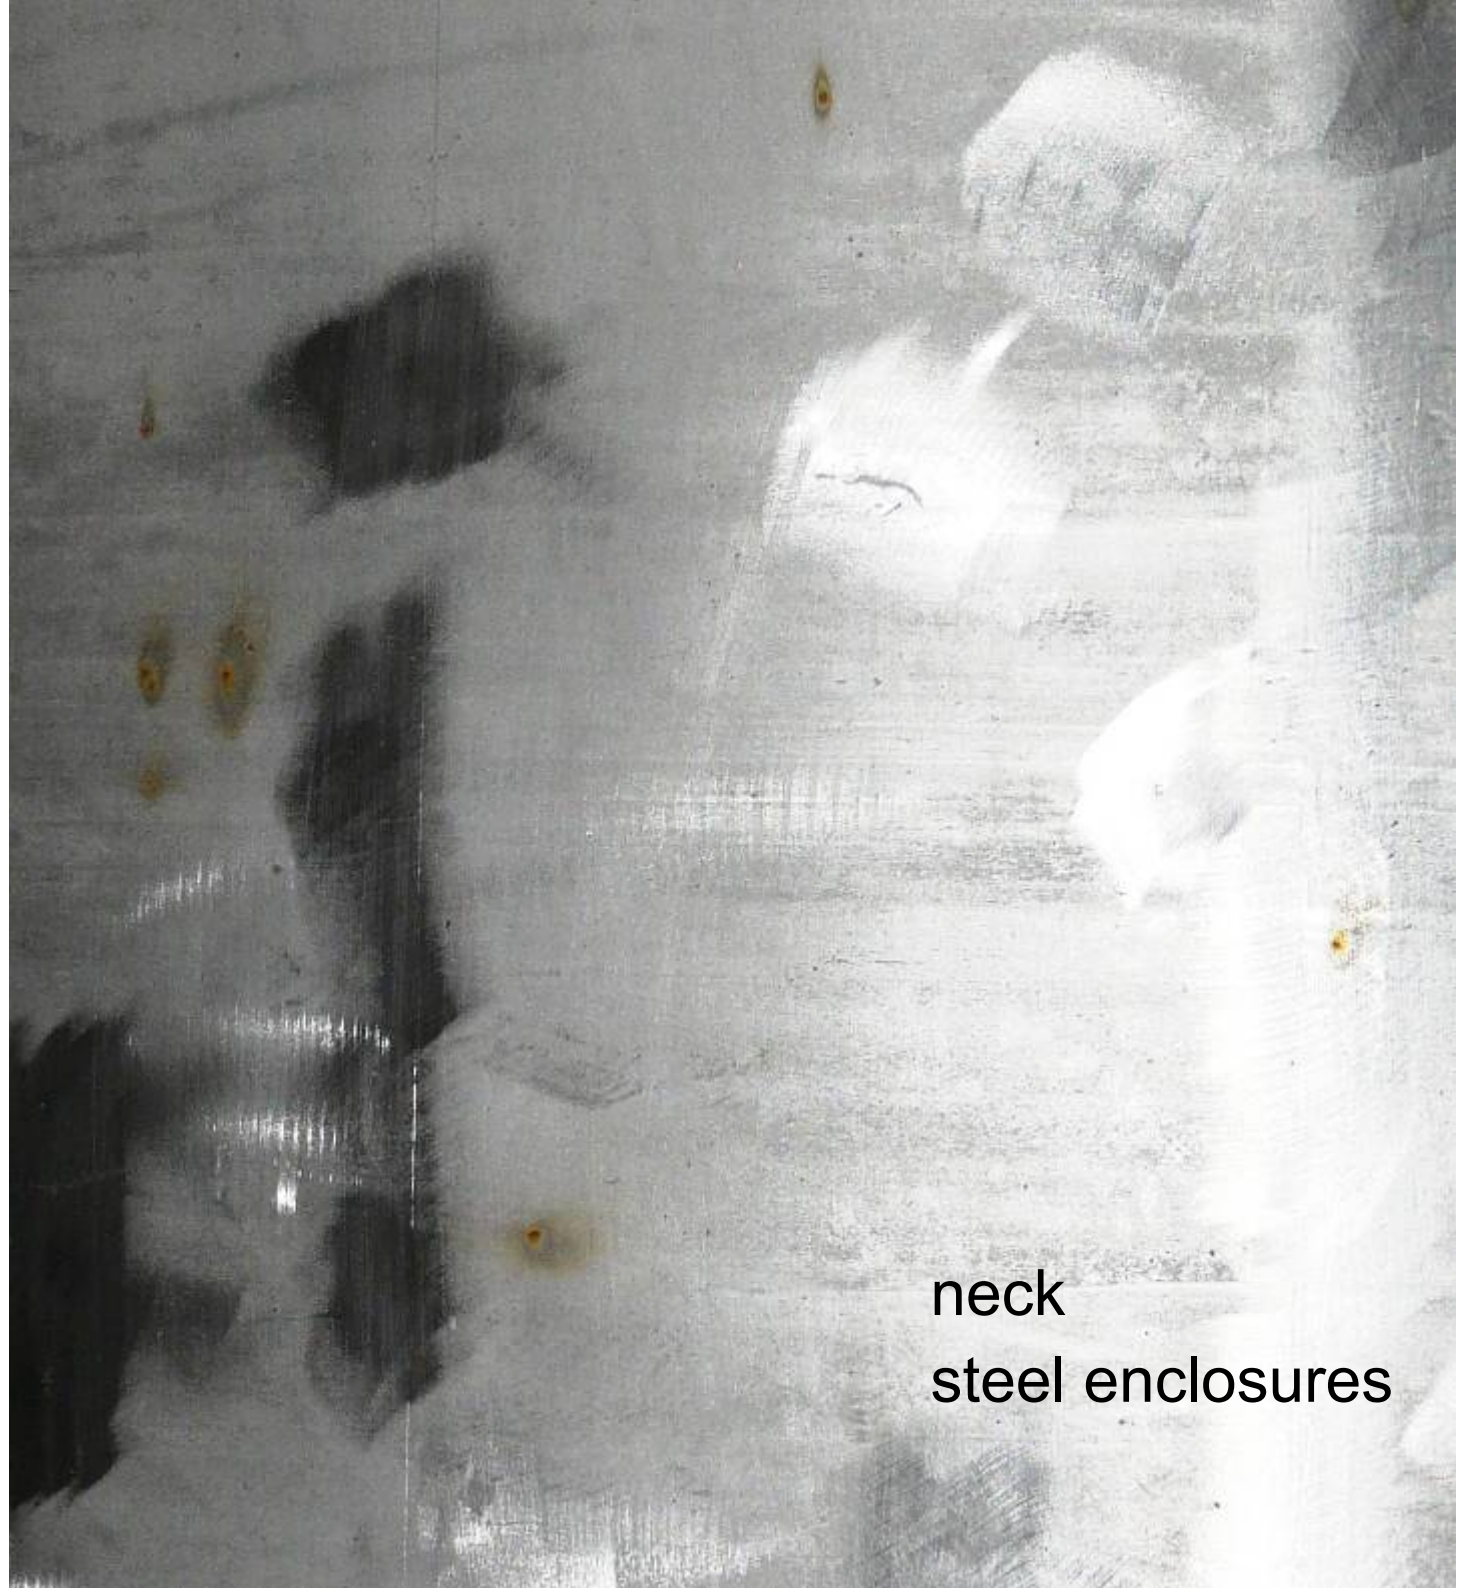
neck  
steel enclosures

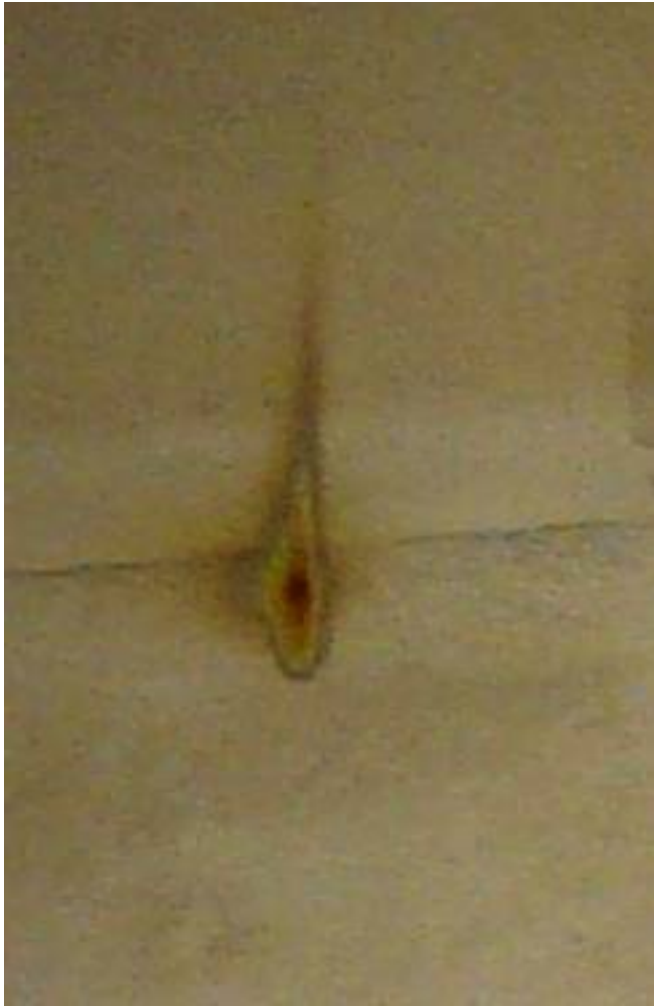
cylindrical shell  
steel enclosures

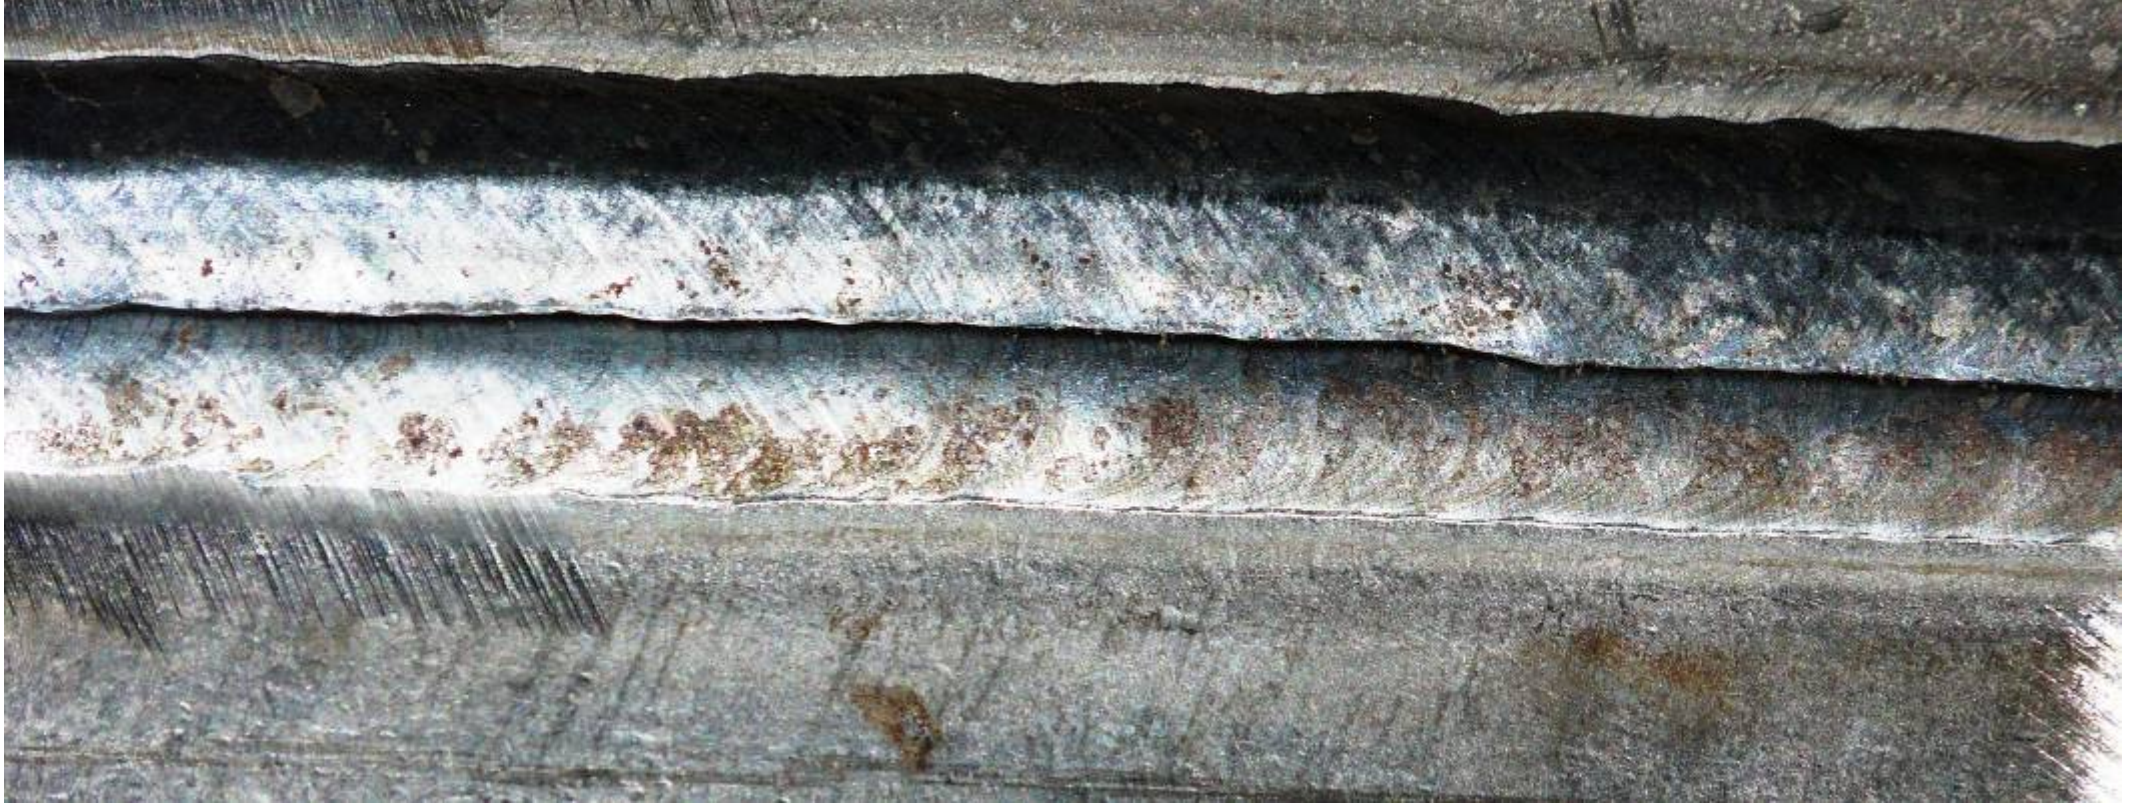
weld  
poor pickling/passivation

- surprisingly large corrosion on cryostat:  
reasons: (1) debris from works on platform  
(2) carbon steel enclosures  
(3) insufficient pickling & passivation  
(4) scratches  
(5) debris in water or moved by water from bottom of WT to cryostat  
treatment = grinding + pickling + passivation
  - cryogenic pipes + valves box will be installed in week 12 by DeMaCo
  - storage tanks installed - exhaust gas heater waiting for installation
  - PLC ready for commissioning at LNGS
  - other piping ready for installation middle/end of April
  - mechanical shroud design for Rn shielding still to be tested (end of March)
- final installation after clean room is available, time estimate = 4 weeks,  
start filling of cryostat end of June?
- installation further improved w.r.t. safety
  - draft available on 'GERDA Alarm Levels and Corresponding Actions'

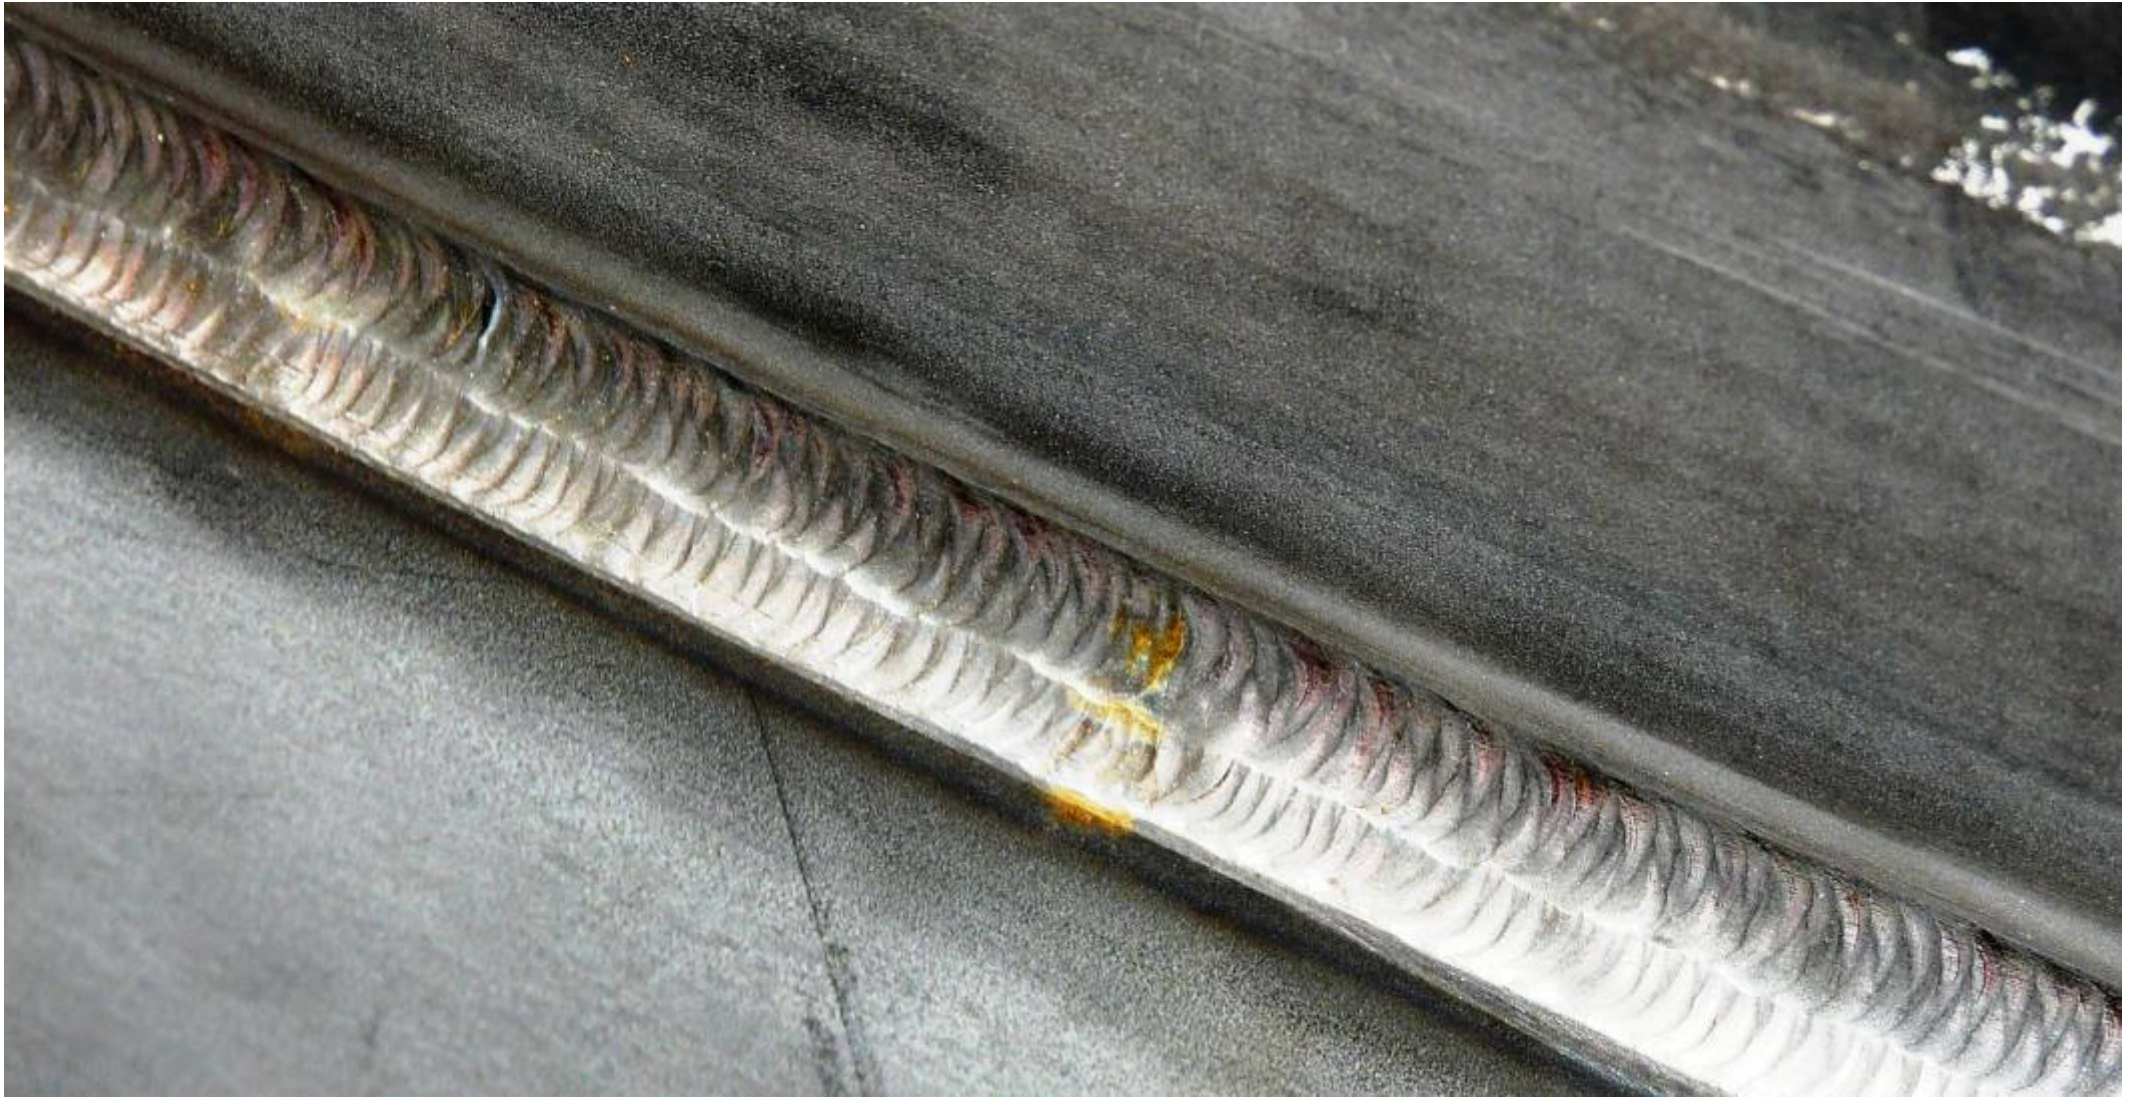
weld

poor pickling/passivation

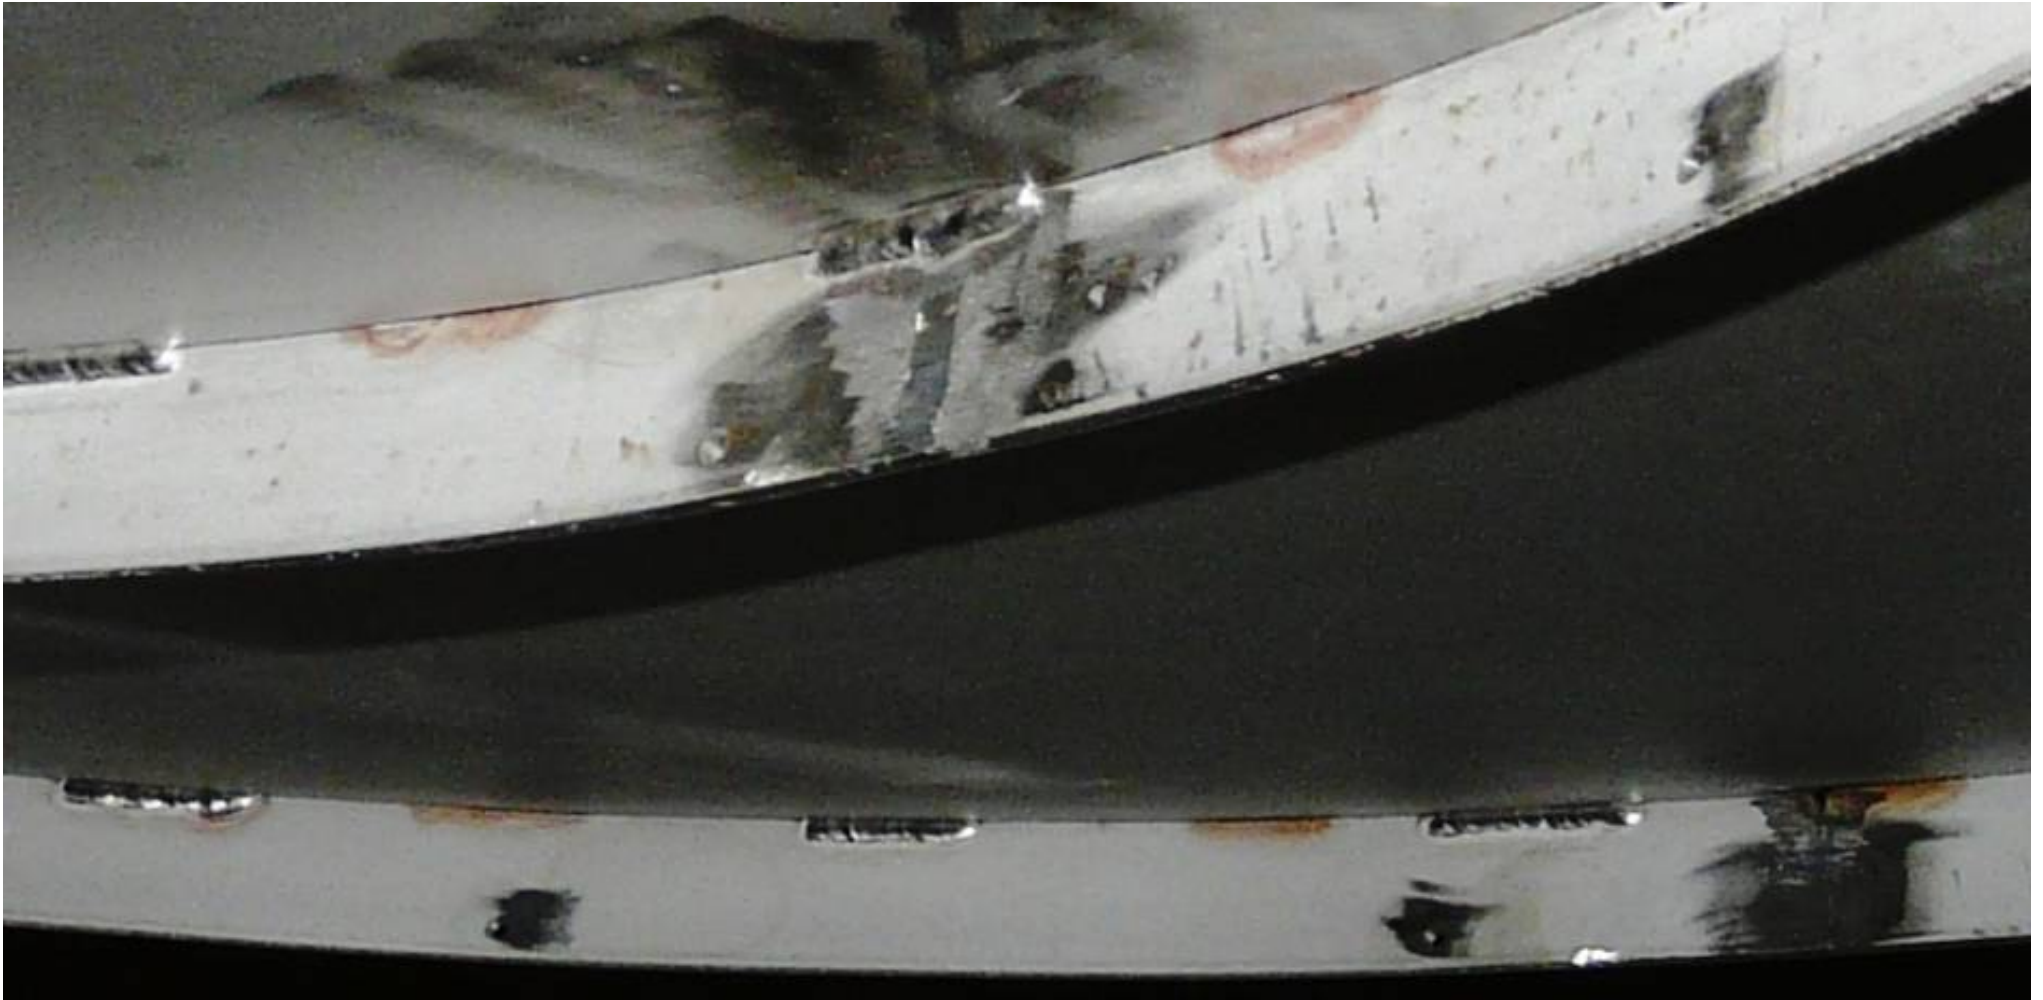
bottom vessel head  
poor pickling/passivation
