Status of IGEX detectors

O.Chkvorets
On behalf of TG-1 of GERDA
collaboration
Heidelberg, Feb 20, 2006

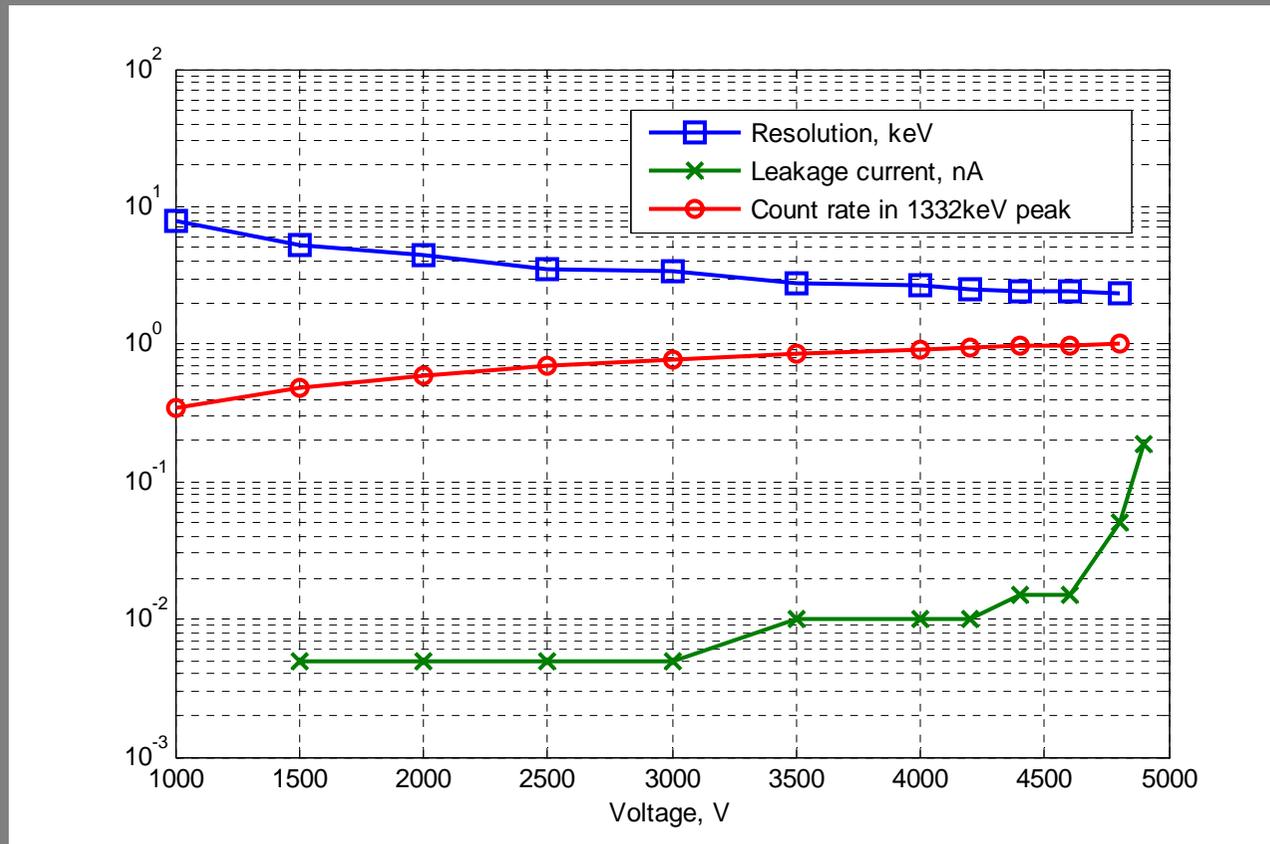
Rico Grande - I

Leakage current, resolution and count rate vs. HV

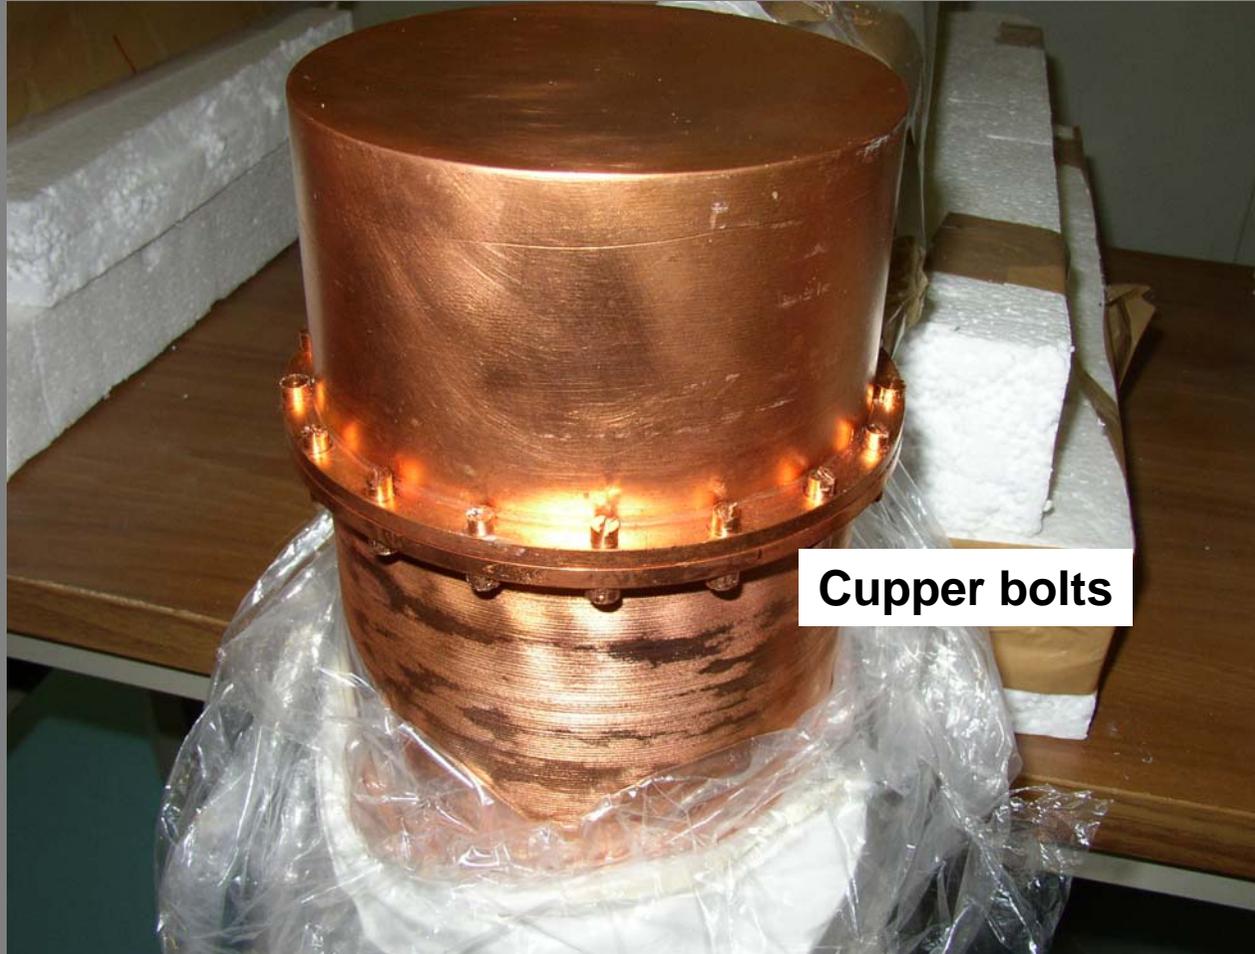
**Rico Grande-II has high leak
It was not tighten
Vacuum improved after bolts were tighten**

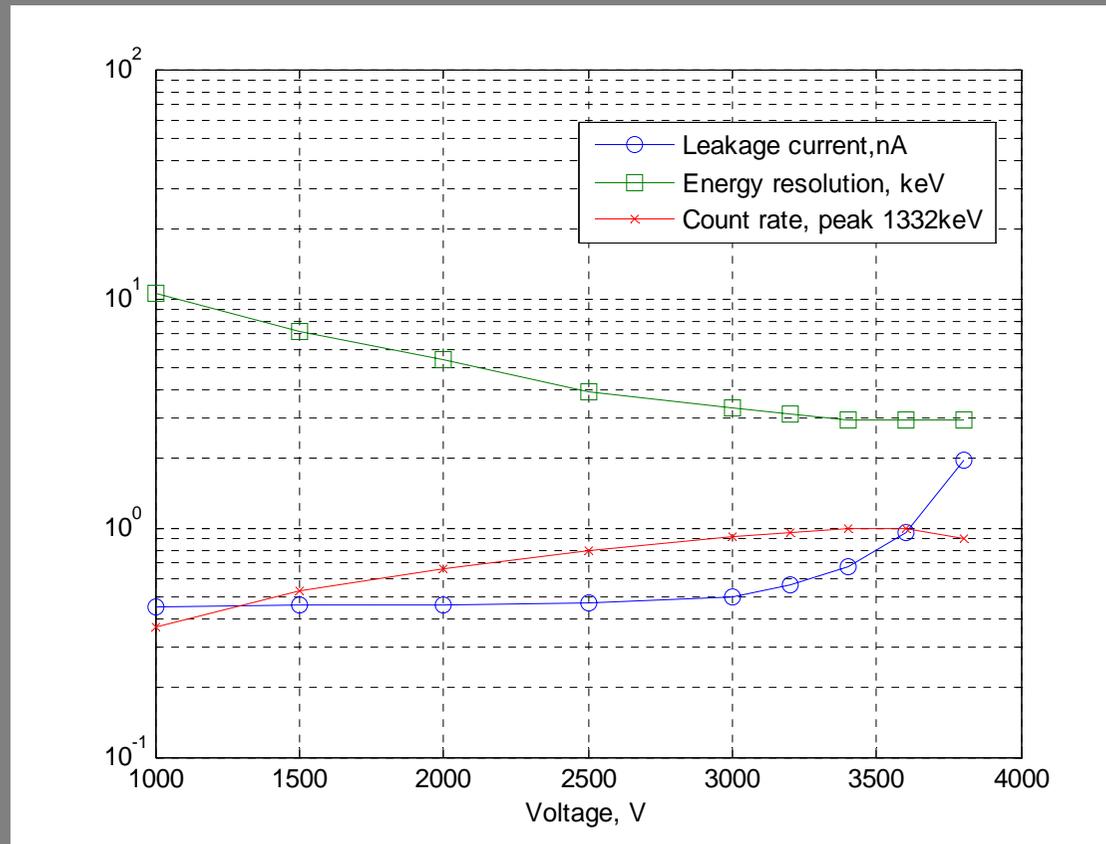
Rico Grande – II

Leakage current, resolution and count rate vs. HV

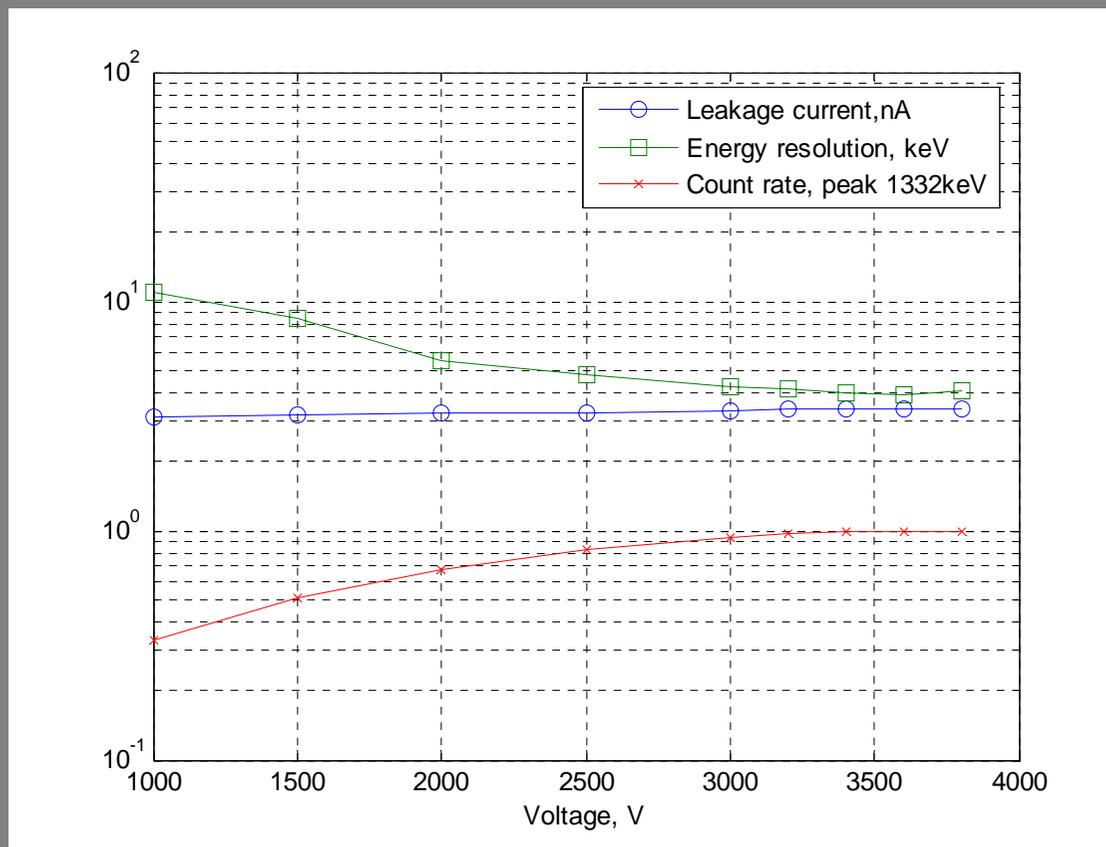
Rico Grande – III

Leakage current, resolution and count rate vs. HV
