Clean Room and Lock System

Status report and

GERDA

Commissioning Lock

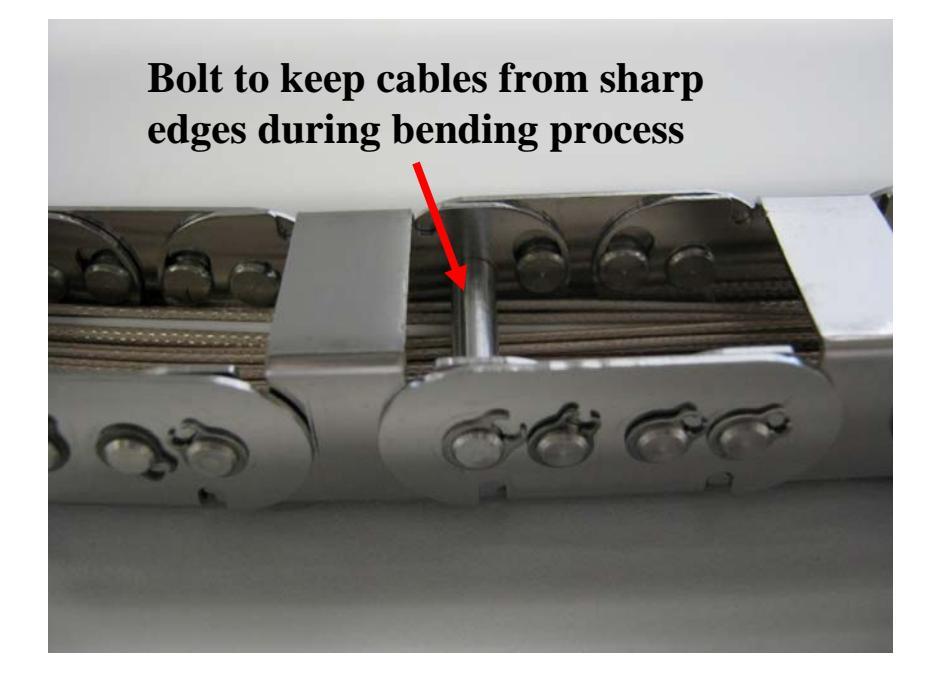
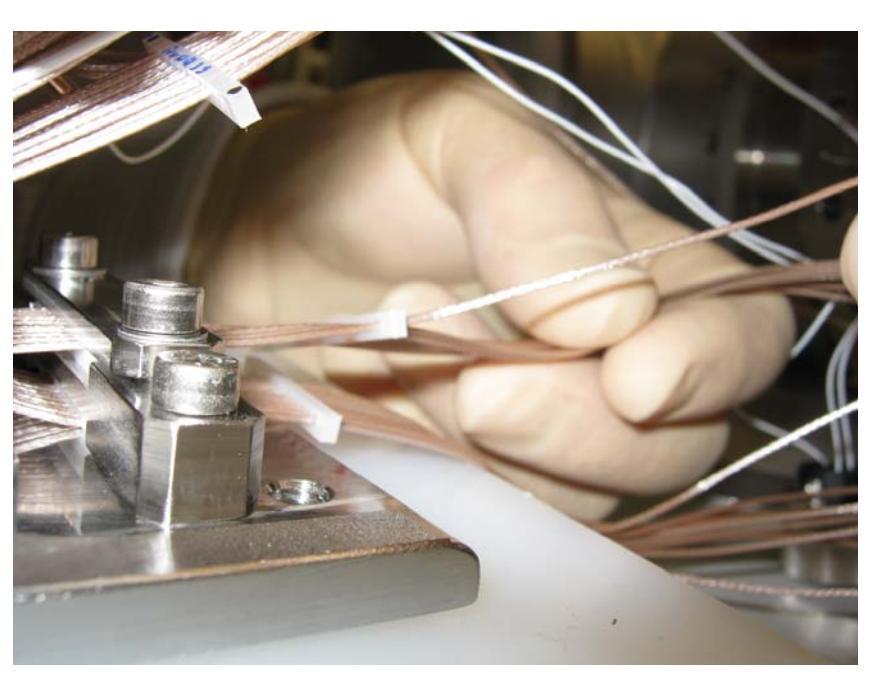
After few cycles cables started moving out from cable chain. At mounting cables had not been tightened much
 → Cable rearranged during movement and were damaged, partly at sharp edges of cable chain

Did complete remount (including laser welding to matrix). Introduced bolts to keep cables from sharp edges. Tightened cables properly.
→Commissioning lock back on hoist on 12th of February

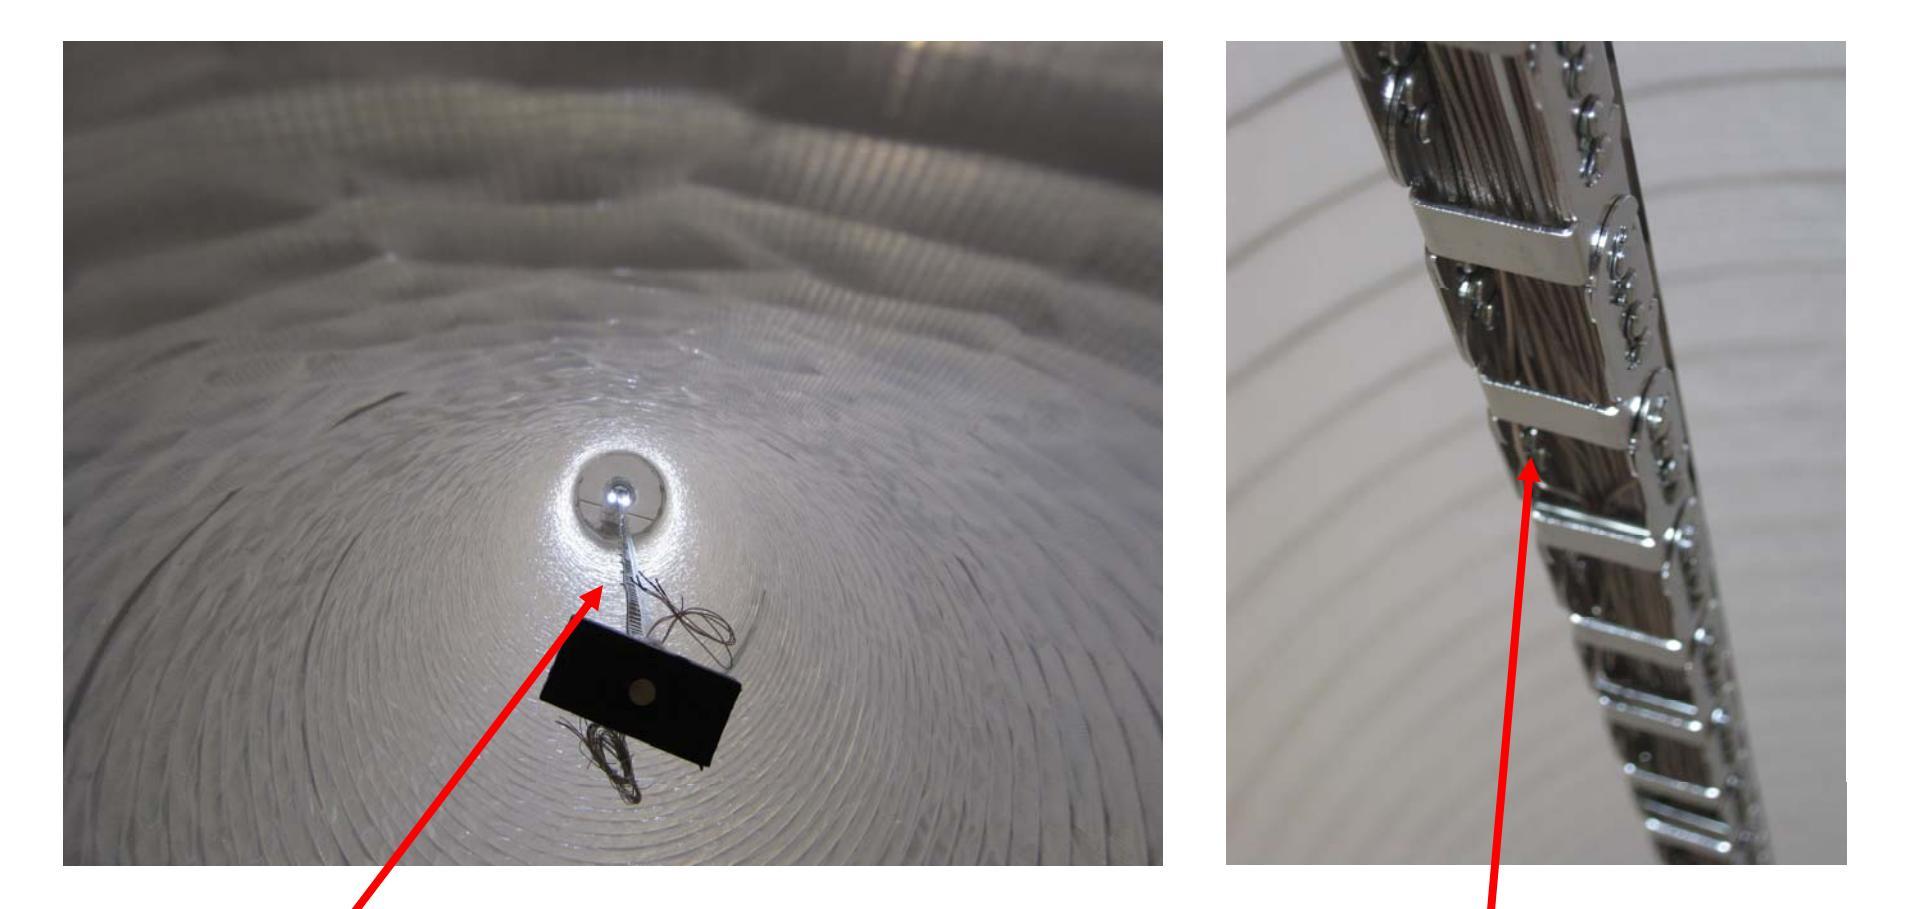
Let done cable chain on 15th of February. Cable chain not straight. Cables started moving out of chain anyway

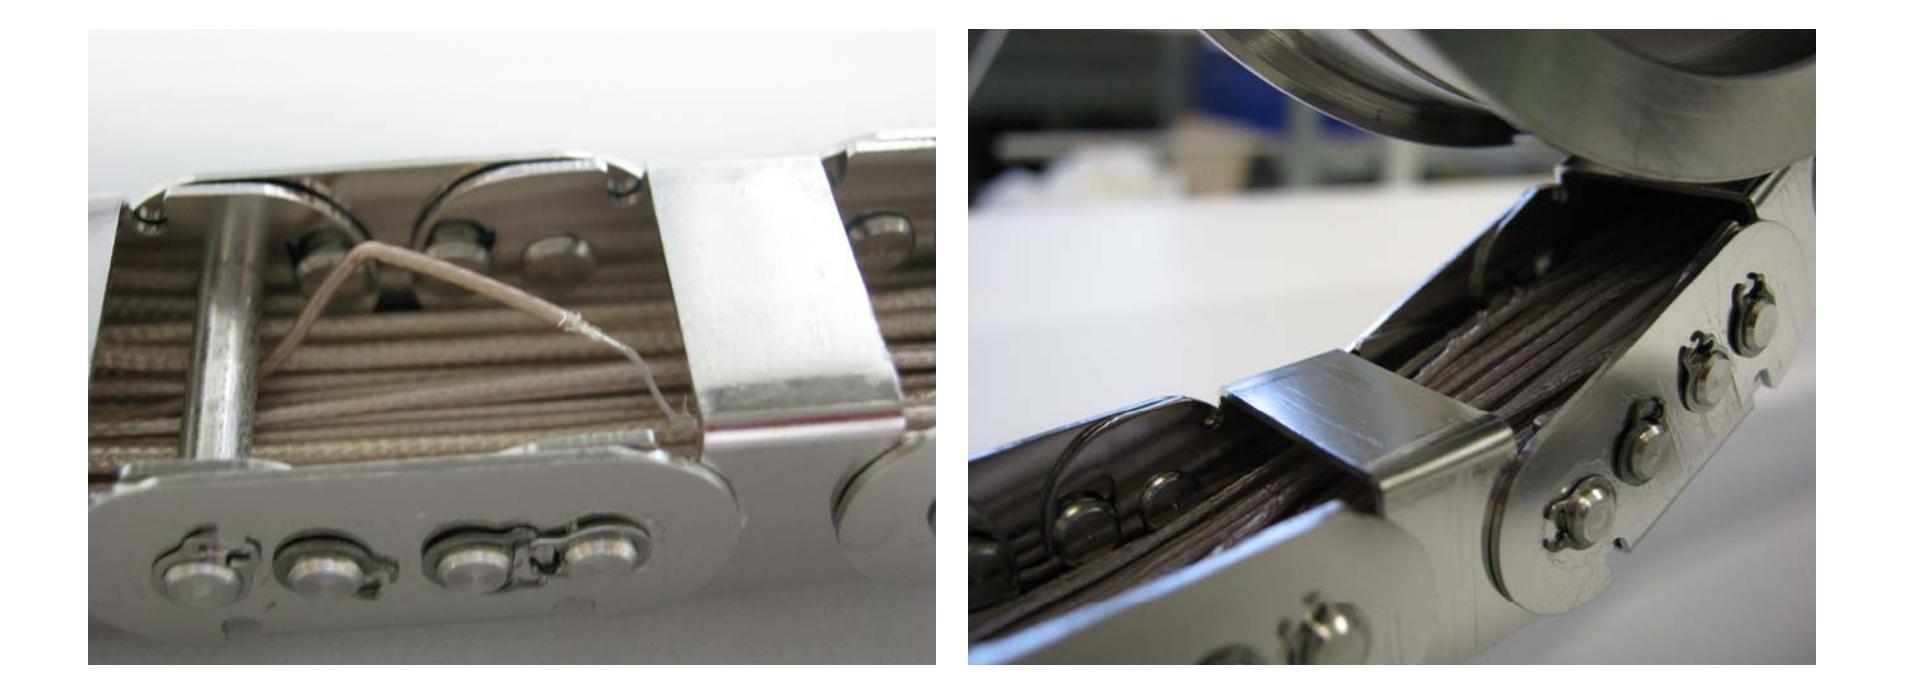
After one cycle: Two broken cables, many scratched. The system had been cycled 20 times before without seeing this problem. However, no bolts and half the amount of cables was installed.

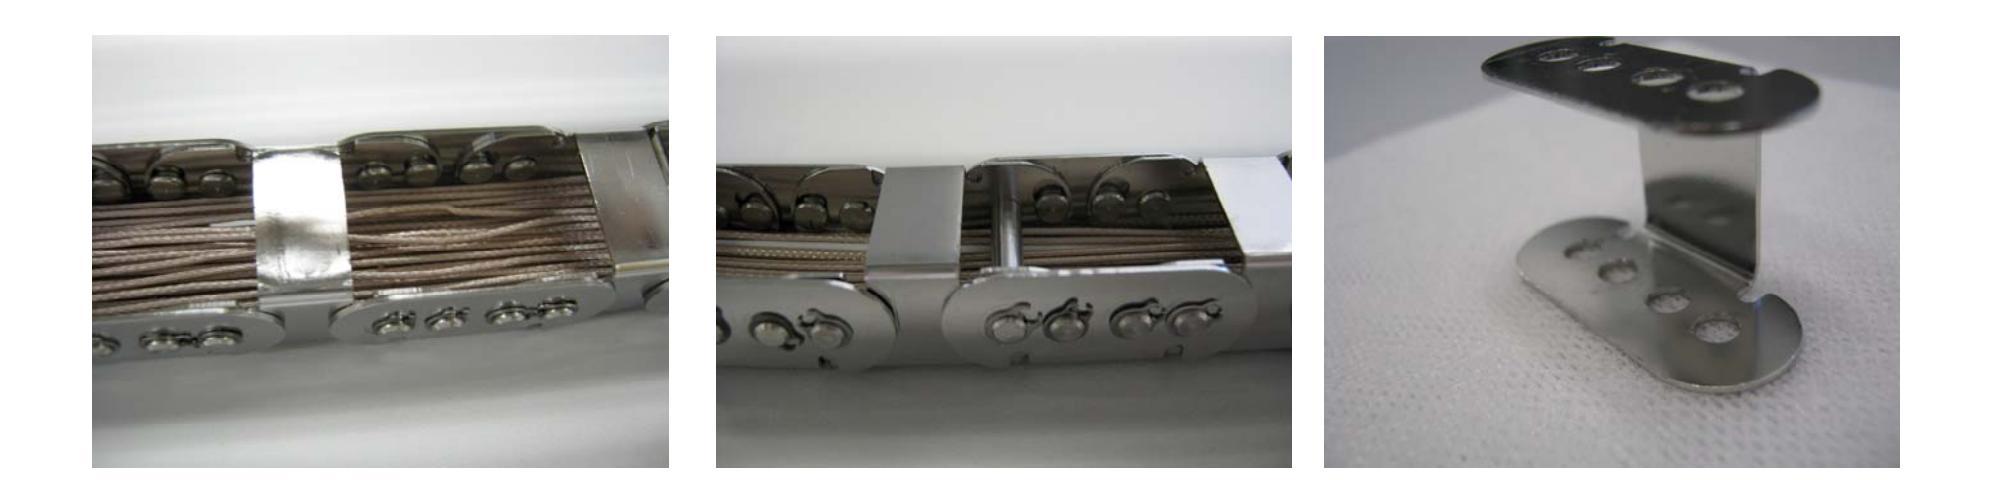
- The amount of cables was too high
- The bolts are counterproductive with respect of functionality of the cable chain
- The edges of the cable chain are too sharp

- 1. Remove half the cables. Bypass cables only!
- 2. Chamfer sharp edges
- **3.** Bundle cables in spiral coiled tube
- 4. Leave loop before strain relief

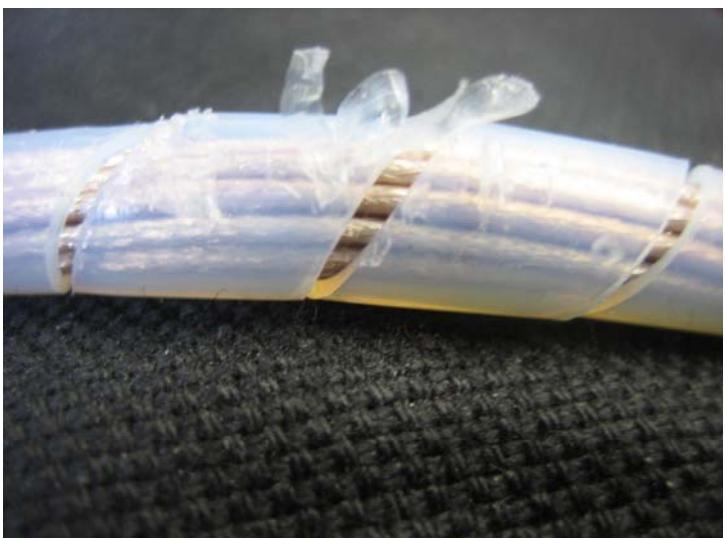
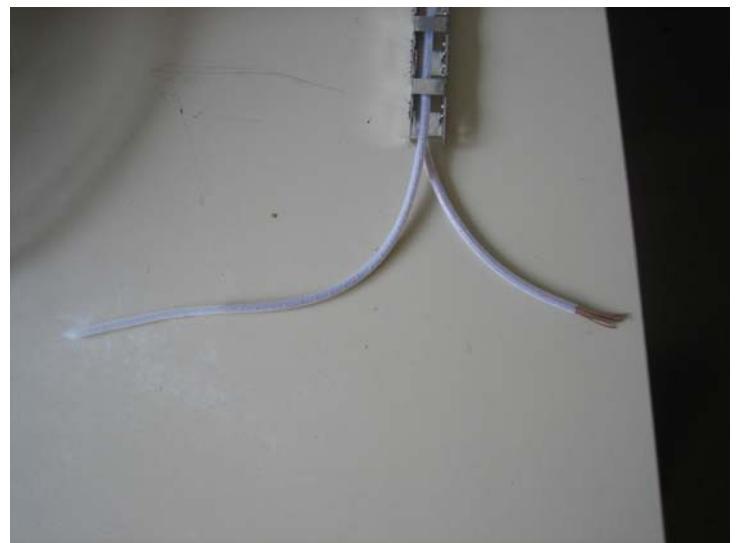
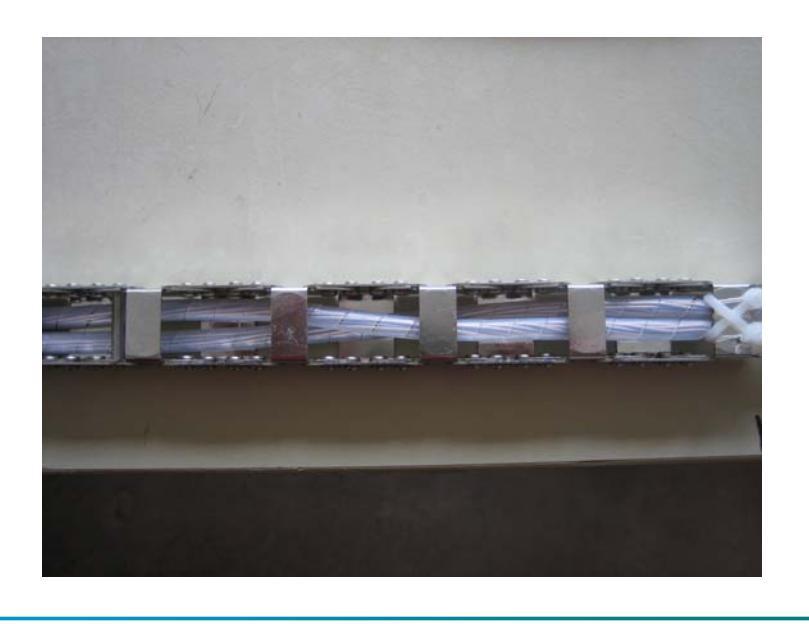
•20 LN cycles with subsequent 10 bending cycles each without bolts•10 bending cycles with bolts

- →Damage of PTFE piral coiled tube
- →Movement of spiral coiled tube
- \rightarrow Winding of bundles

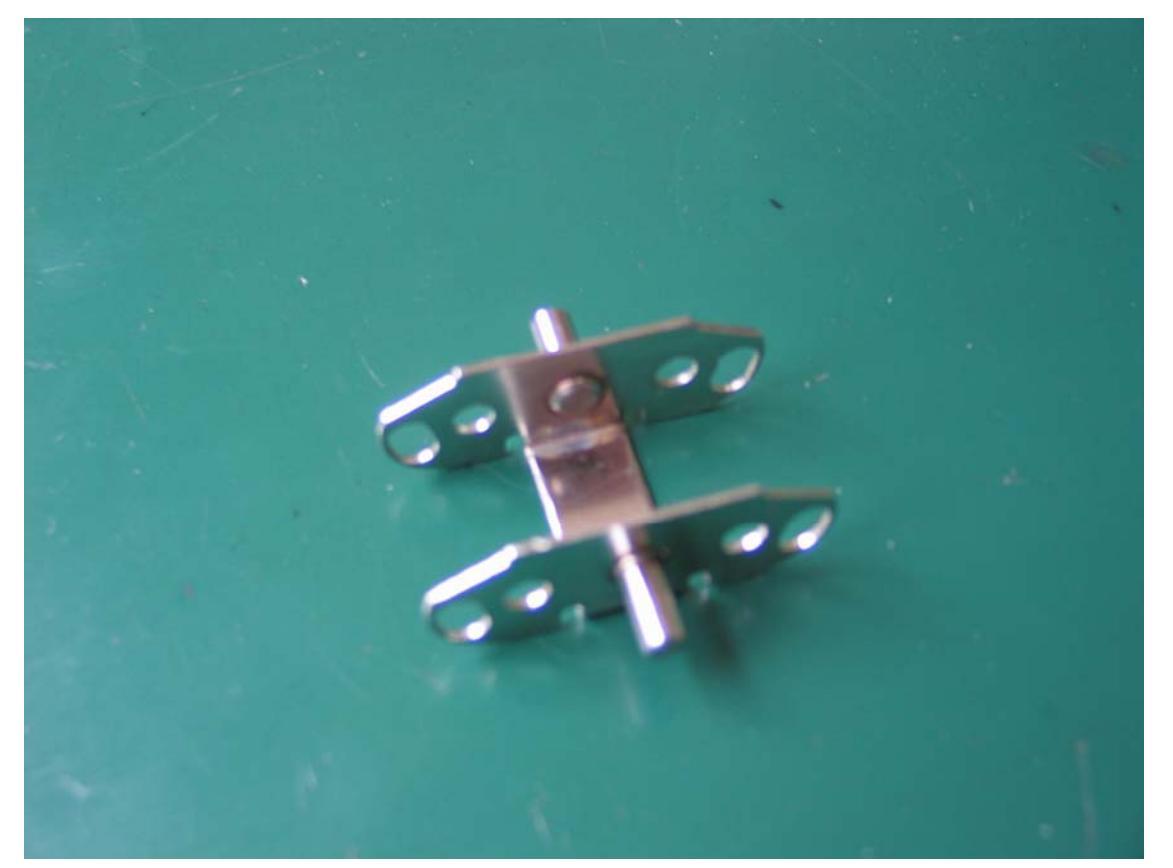
→ Cable bundles can freely move inside cable chain
