Status of WT and related issues

C. Cattadori on behalf of working group P.Martella, F. Potenza, M. Balata, L.Ioannucci, E. Bellotti

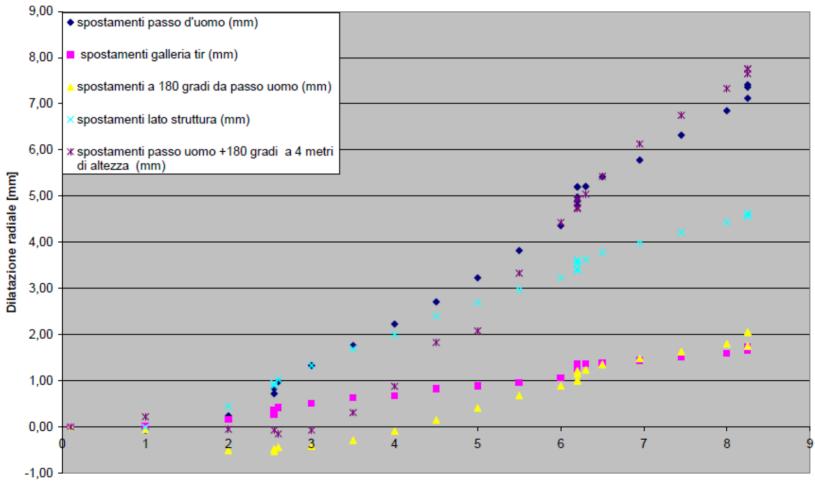
Dilatazione radiale WT

Measured deformations while filling and draining confirms that the tank deformations are in the elastic regime black : filling

red: emptying

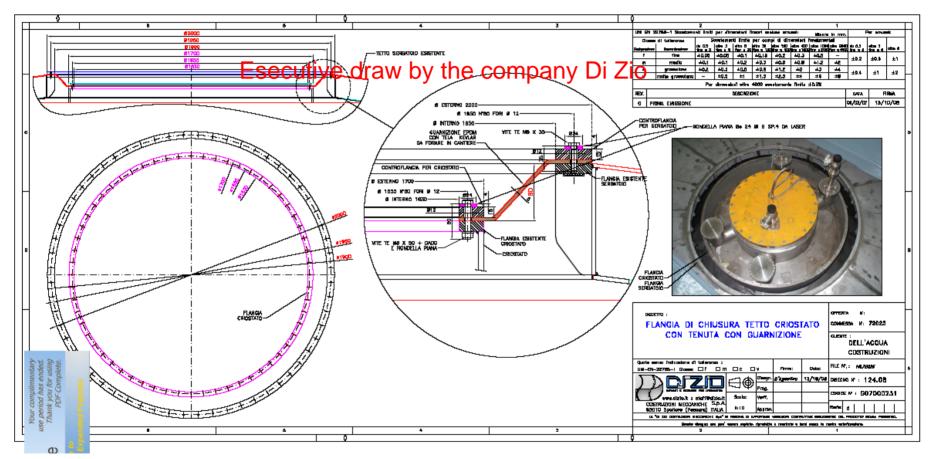
The current height difference between the two flanges is about 5 cm

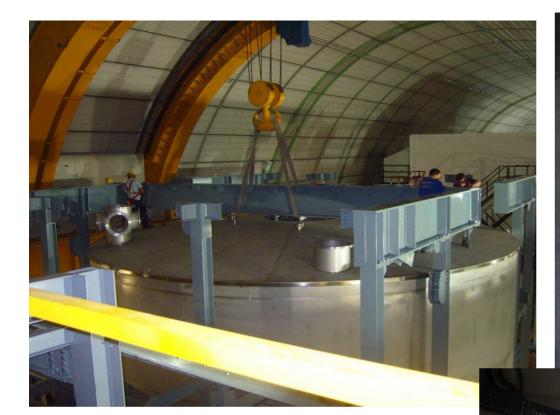
- Due to improper management of the work site, the WT top flanges (manhole and PMTs chimneys) have been kept open during the construction of the super structure and closed only prior the WT filling → iron powder coming from cutting the superstructure gridded floor entered in the WT, and in contact with water made rust/oxide mainly on the WT bottom plate and on the cryostat shoulders. Minor oxidation spots on WT and Cryostat vertical surfaces.

- iron particles deposited on the steel fell inside the tank during the building construction
 - Scratches in the steel plates by iron tools during the construction/transport of WT steel plates or cryostat transport.

Oxidation spot below top manhole before treatment

- A pickling and passivation procedure to remove oxides, passivate and clean the WT internal and cryostat external surface has been defined agreed and submitted to LNGS SPP and approved.
- The WT floor will be treated completely by REMOX (pickling chemical).
- The Cryostat and WT oxided scratches shoulders will be grinded
- Pickling: By AVESTA 601 product applied locally
- Passivation: By AVESTA 630 product. All the surfaces will be treated.
- Extracost: ~ 1 kEuro/day (for cleaning only). Responsibility of companies to some extent of the oxide problem (scratches).

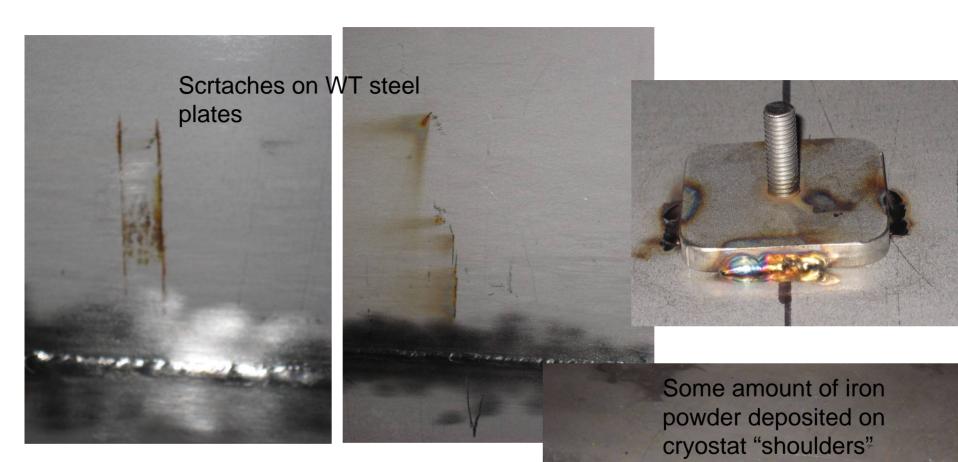
Oxidation spot below top manhole after treatment by REMOX
