# **Status of Water tank**

Francesco Potenza

Meeting GERDA - Assergi 09-11 June 2008

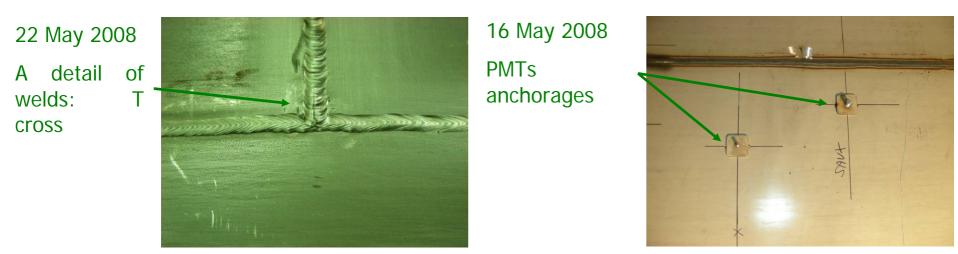
PMTs achorages have been welded at WT inner surface at floor level as far as the WT growed up.

The WT bottom plate un-flatness disappear after assembly of the 4° ring (full load).

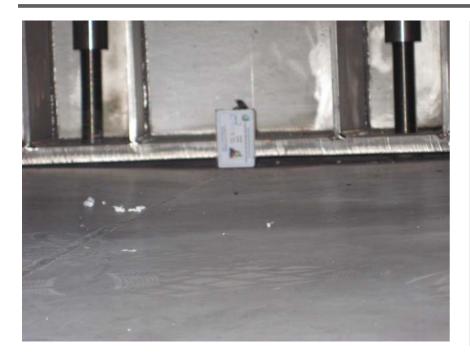
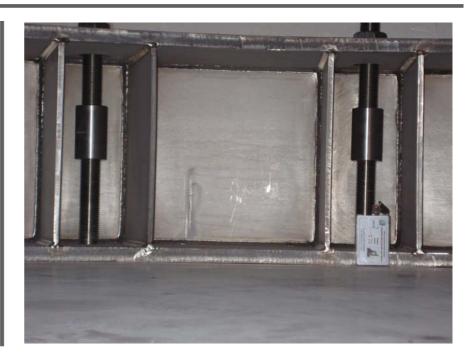
## The issue of the bottom plate flatness

- Cryostat installation showed clearly that the WT bottom plate (BP) was not flat at the radial distance corresponding to the crystat support (R = 2.1 m) in correspondance to the BP welds.
- After cryostat installation the cryostat-anchorages bolts were tighten (cryostat empty), and after cryostat filling (14 t Cu + 60 t LN) it was necessary to tight them further more to compensate for the bottom plate assessment.
- Structural analysis of the actual situation re-done

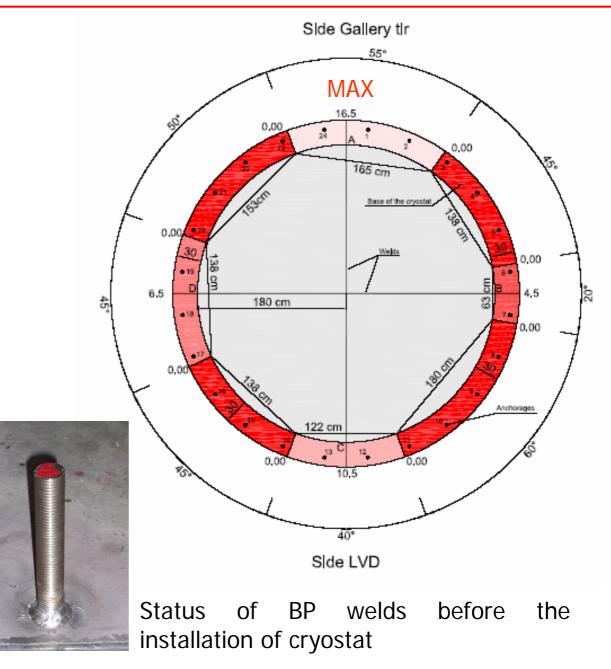
# **Un-flatness mapping**

The unflatness has been quantified by mapping with the purpose of long term monitoring of the BP assessment:

- max 16.5 mm
- min 4.5 mm

Do assessment cause stress on anchorages and BP welds?

→ Visual inspection of all the welds + sealing test to be performed after WT shell construction
