# Prototype detector testing in liquid argon (underground summer)

# Goals of summer measurements

GERDA meeting, Milano, Nov 14, 2006

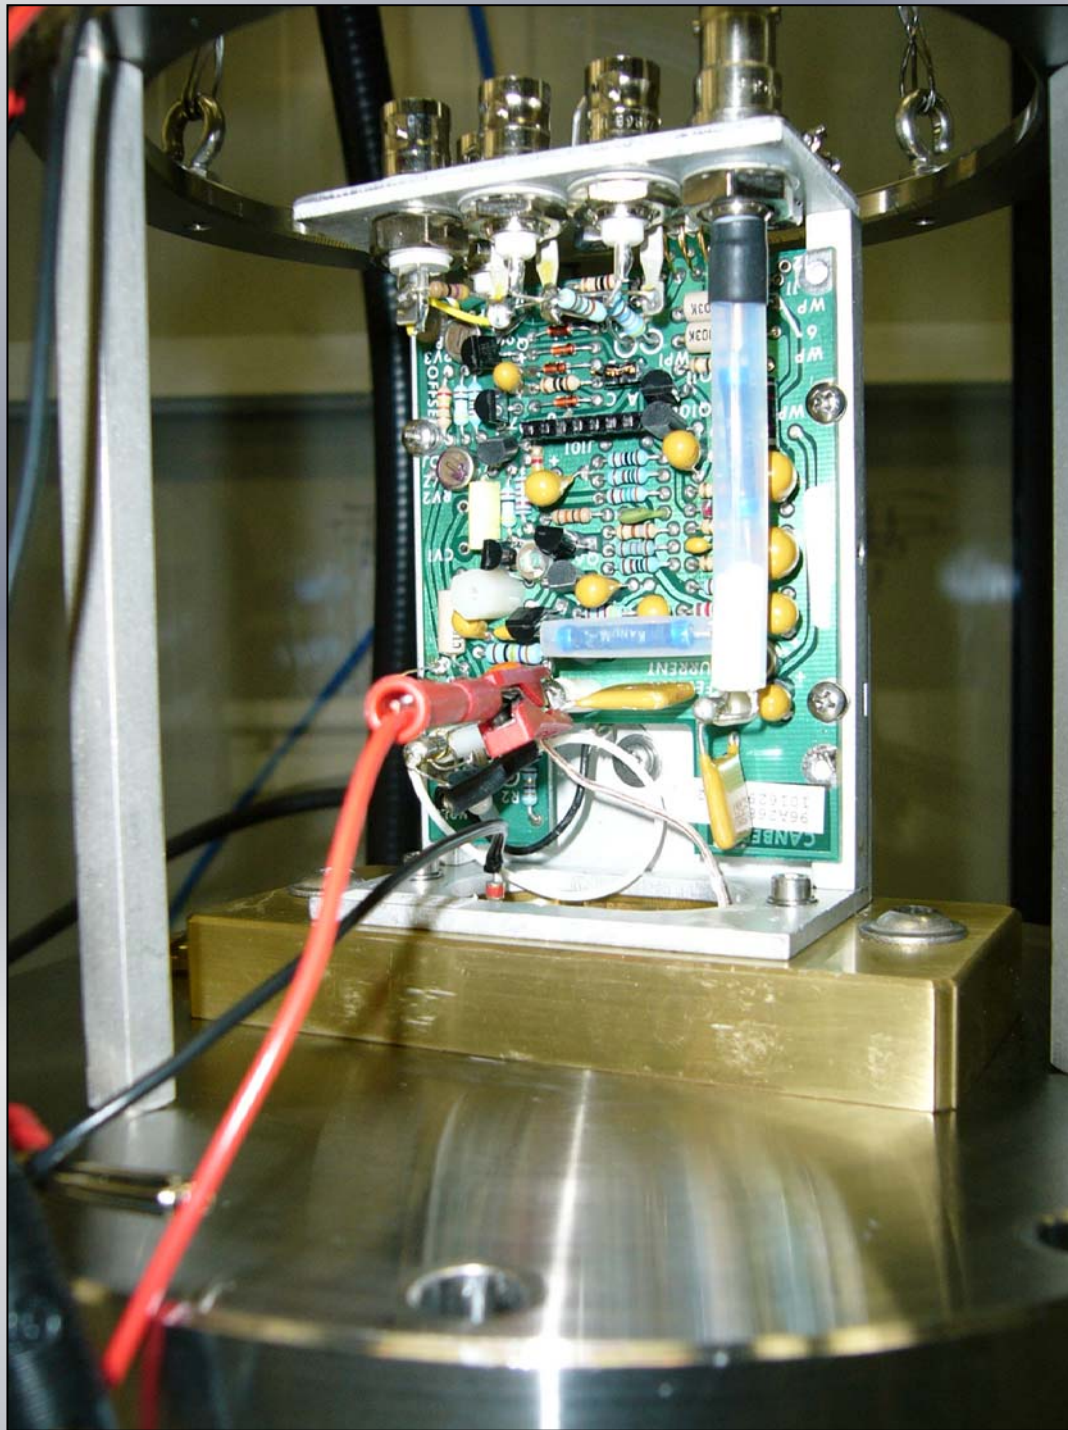
1. Breakdown in argon gas (not liquid!!!)  
after 2000 V

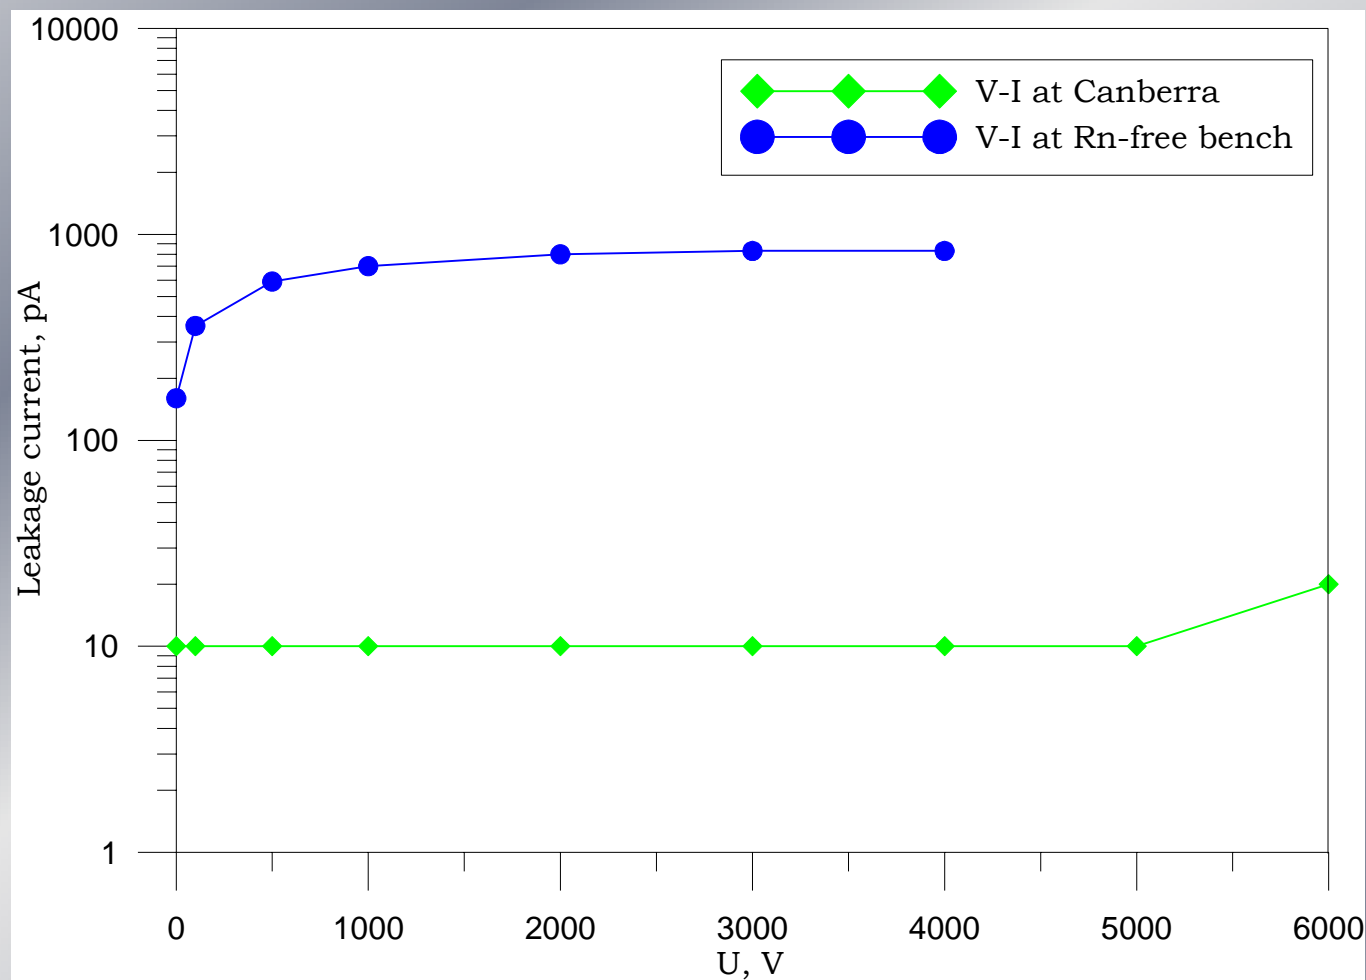
# Refurbishment of detector (new implantation and passivation)

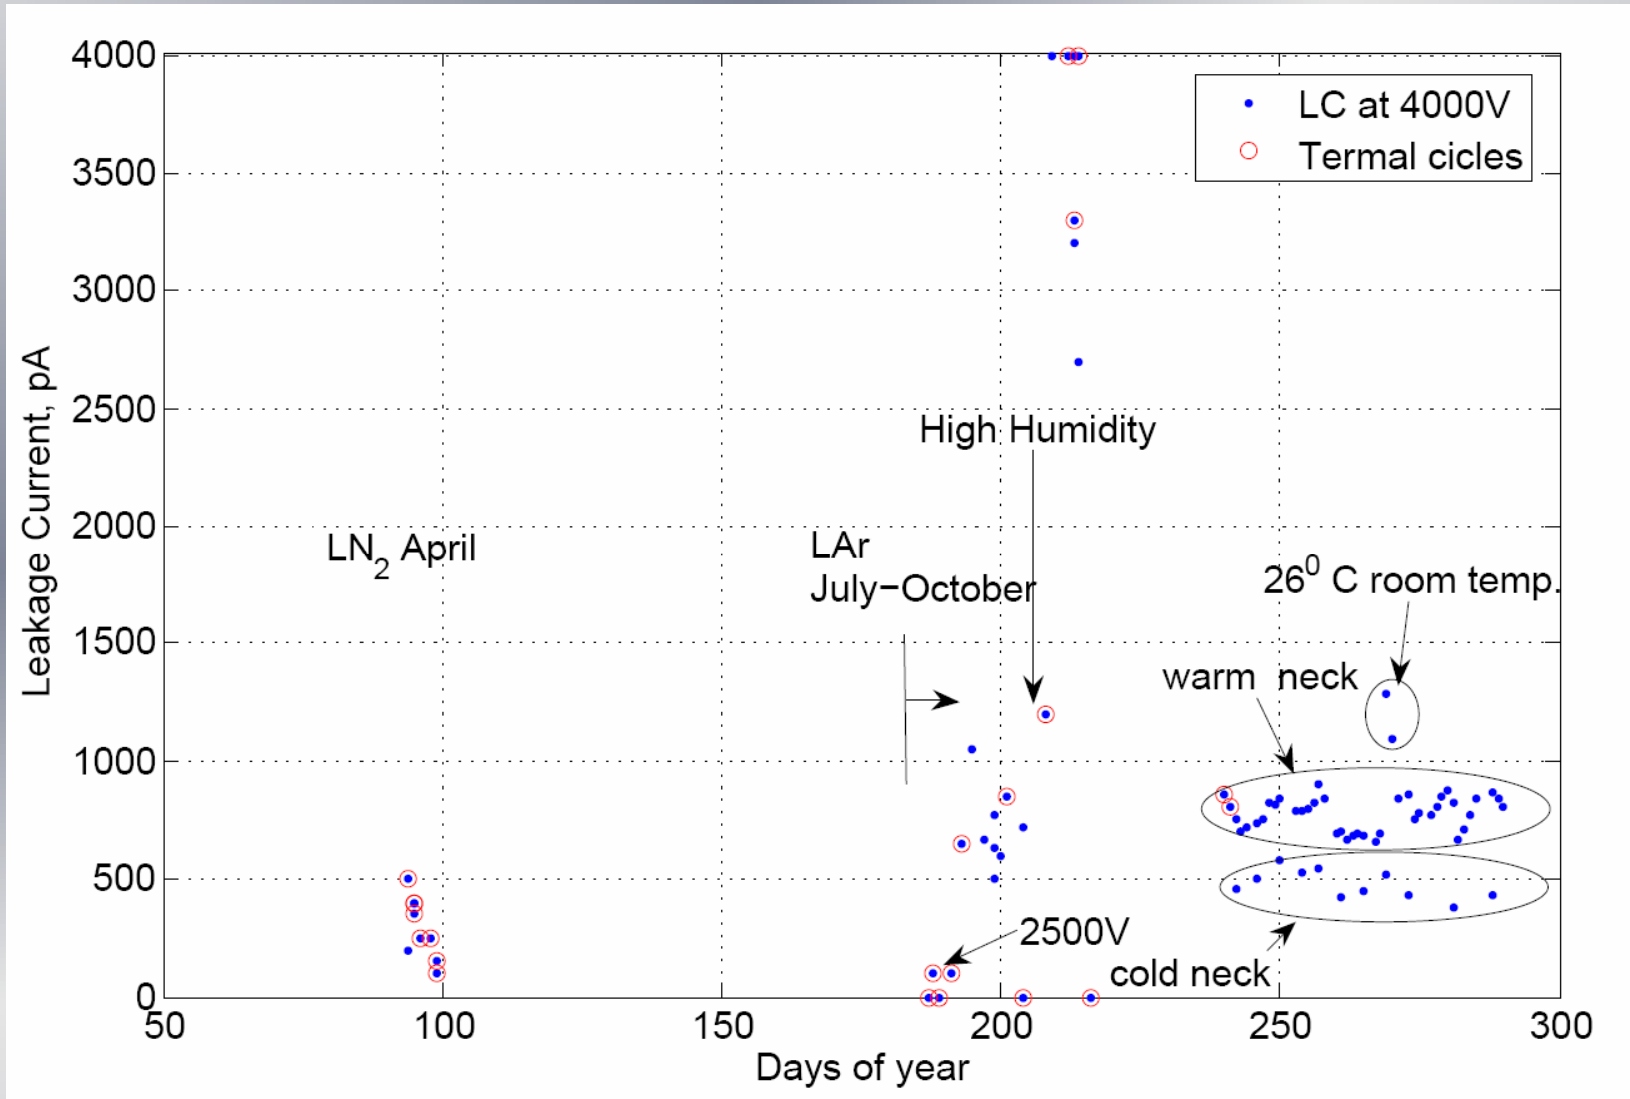
# Leakage current history of prototype

- Breakdown in argon gas – solved
- No other specific argon problems
- Bending of support – solved
- Leakage current was stable during 2 months
- IR shield needed
- Boiling protection needed

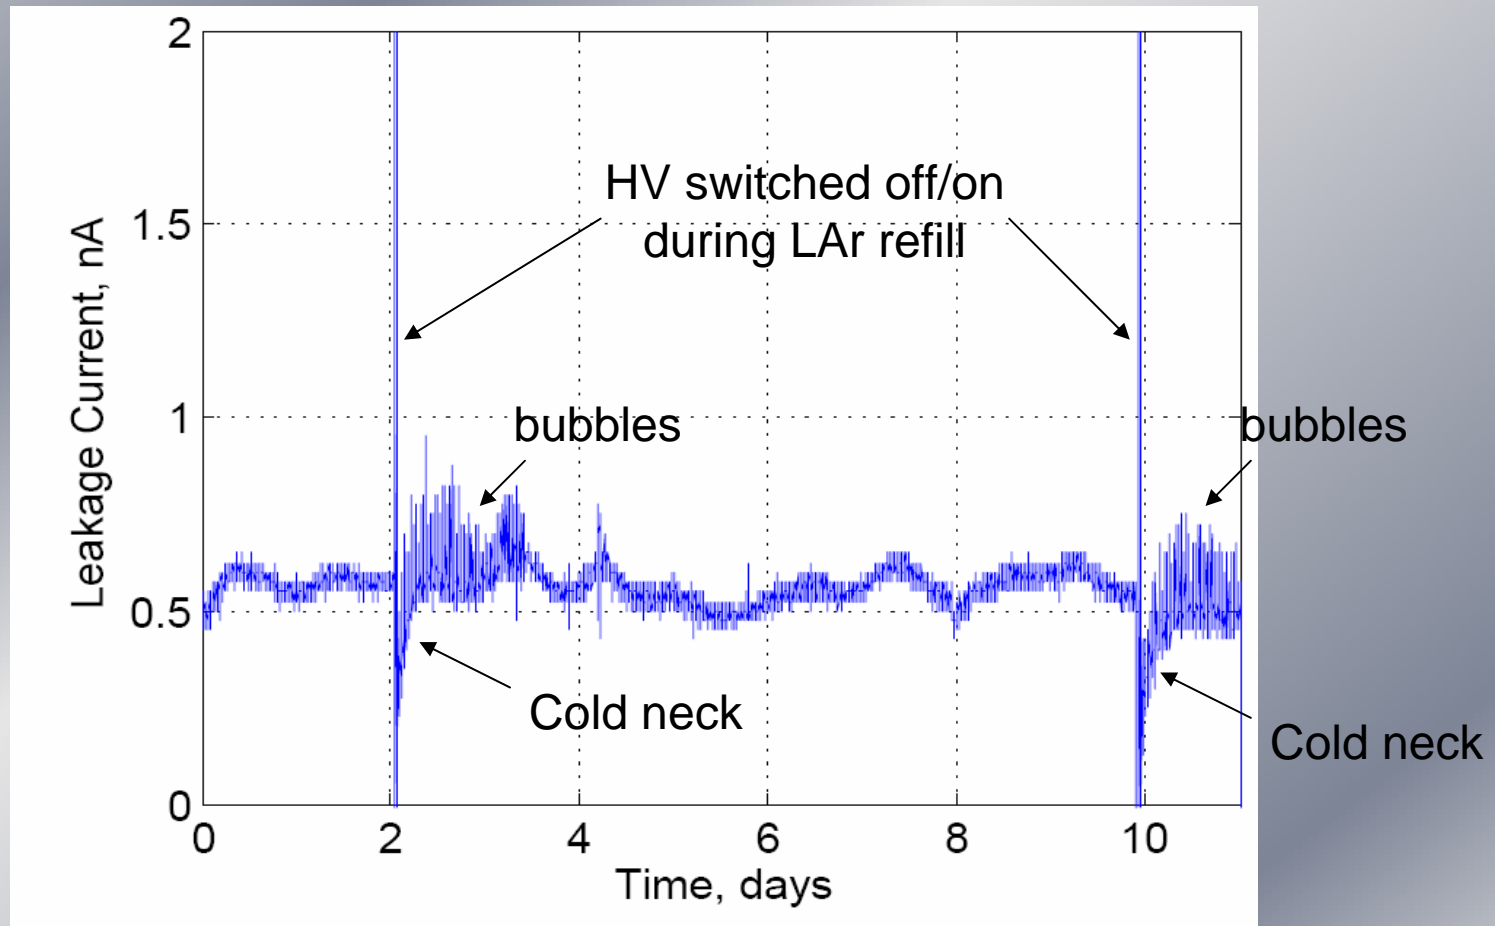
# Leakage current of prototype

Leakage current measured once per minute
