News from the Cryostat corrosion

Bernhard Schwingenheuer, MPI-K Heidelberg

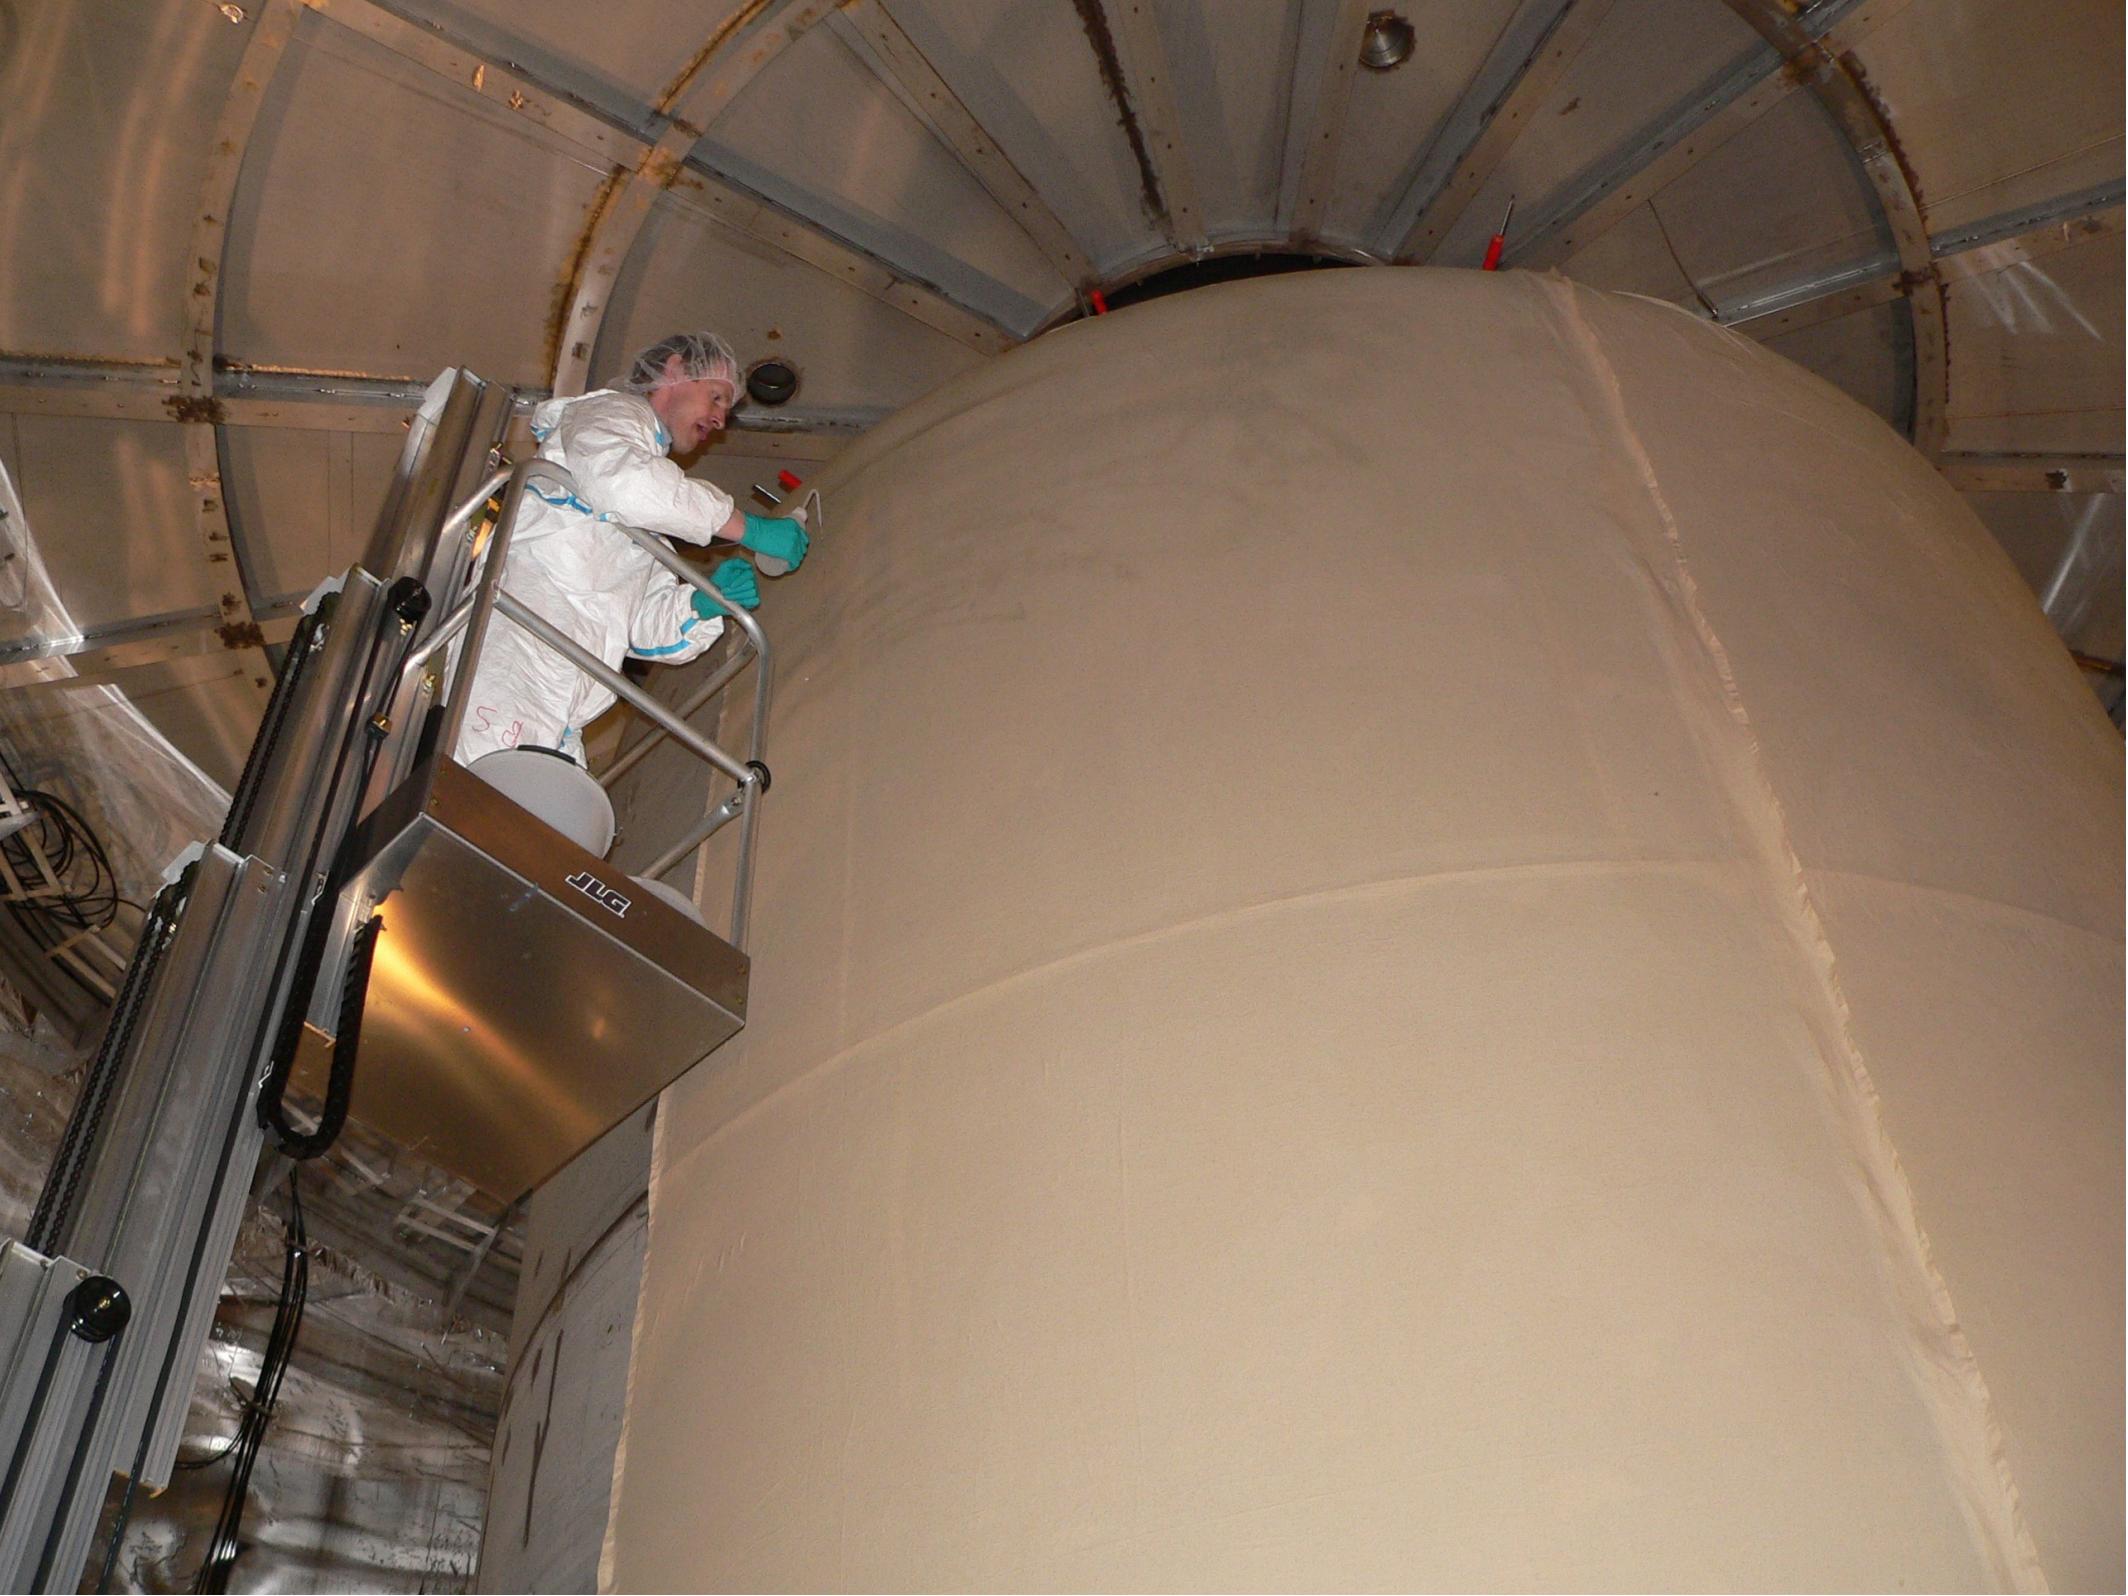
- many corrosion spots on cryostat visible after water tank was drained
- 1st treatment of cryostat by DiZio in March:
grinding + local pickling with Avesta 101 paste + global treatment with Remox
+ passivation with Avesta 630 + rinsing with deionized water from Borexino
- 2nd treatment by ourself of more than 100 spots end of March:
grinding + local pickling with Avesta 101 paste + passivation with Avesta 630
+ rinsing with deionized water (only top head + cylinder),
a final inspection with grinding of additional spots
- corrosion test proposed by TÜV: cover cryostat with wet blankets for 8 hours
result for 2/3 of the cylinder area + neck: found about 30 corrosion spots,
most of them in old spots (previous grinding not deep enough),
1/3 of them new spots

**Proposal: stop treatment and go on with
Jakodur + VM2000 foil installation**
