TG5 Review

- **Clean Room Status**
- **The Temporary Lock System**
- **The Final Lock System**

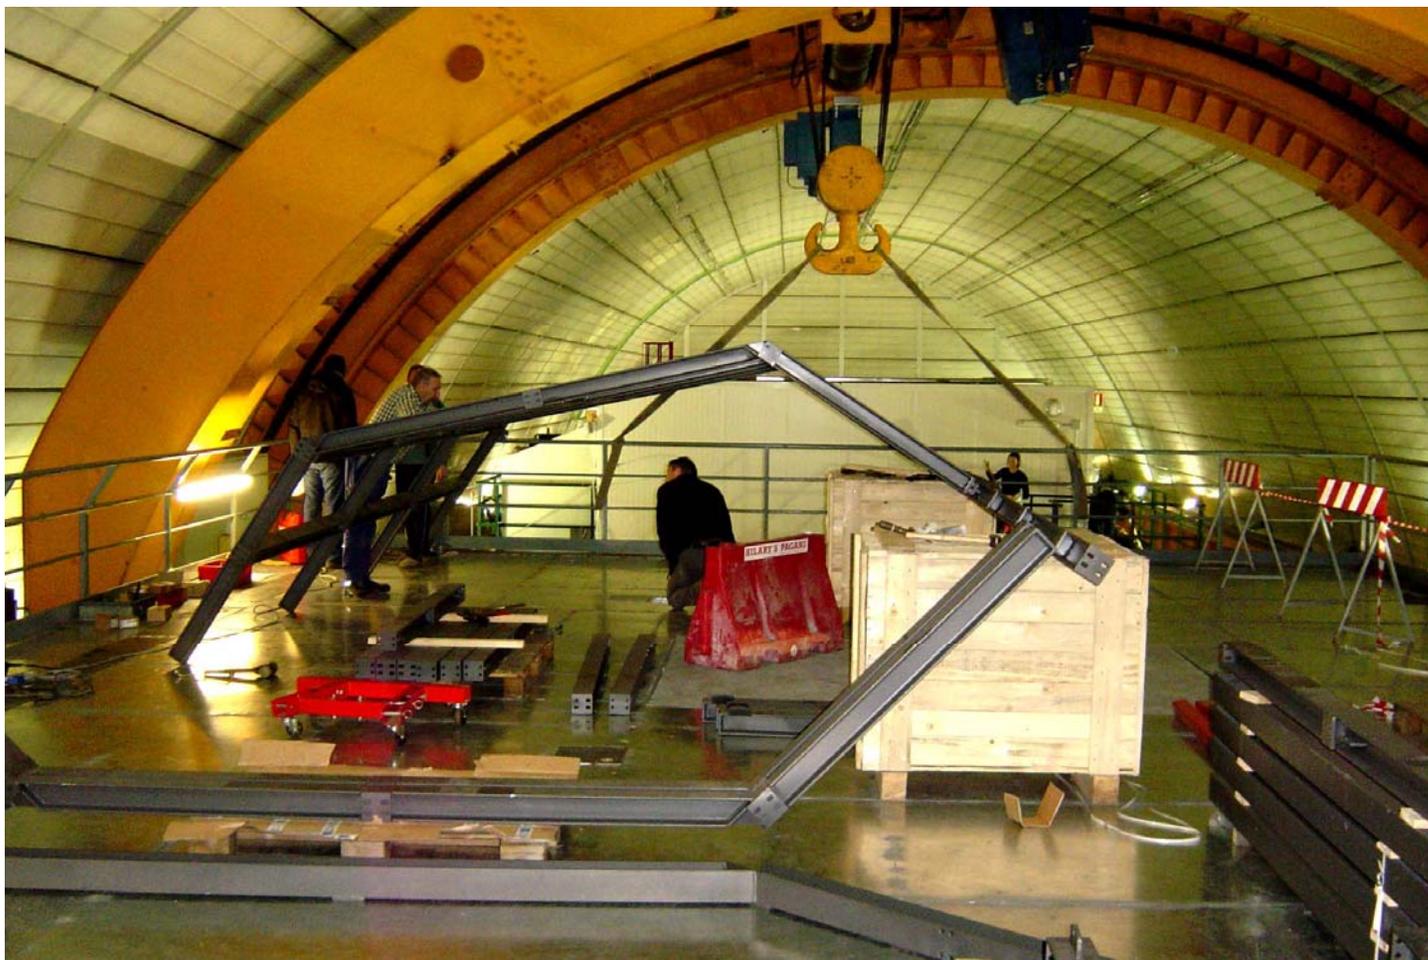
First delivery of clean room beams on 2nd of Feb. 2009. Mounting of steel structure began on 3rd of February already (picture) .

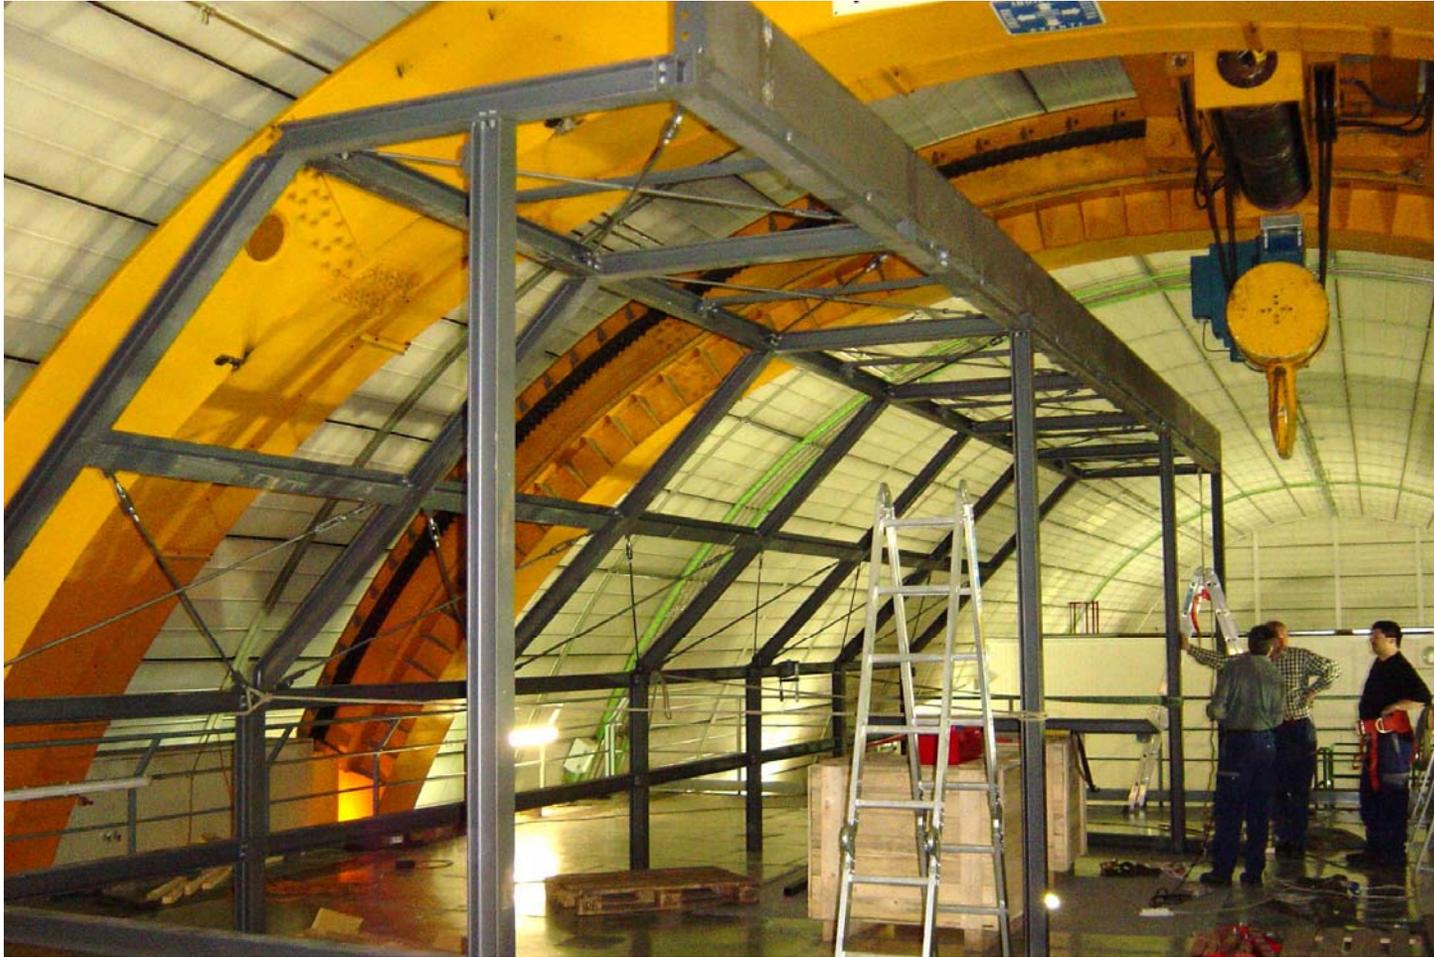
Steel Structure status as of 4th of February 2009

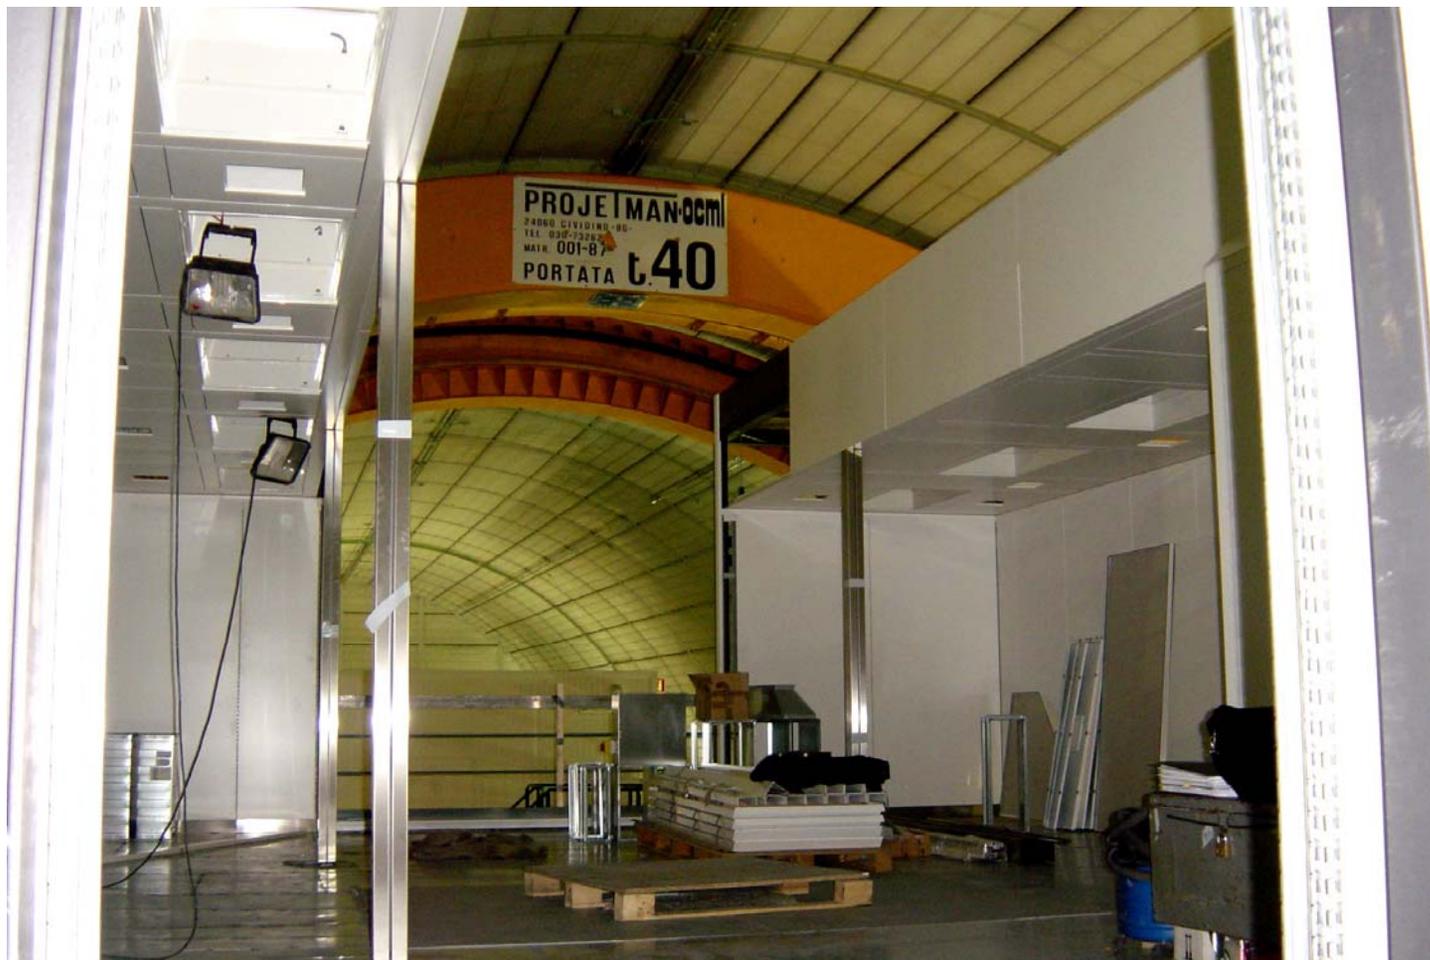
Inside of clean room with ceiling removed. Status as of 4th of March 2009

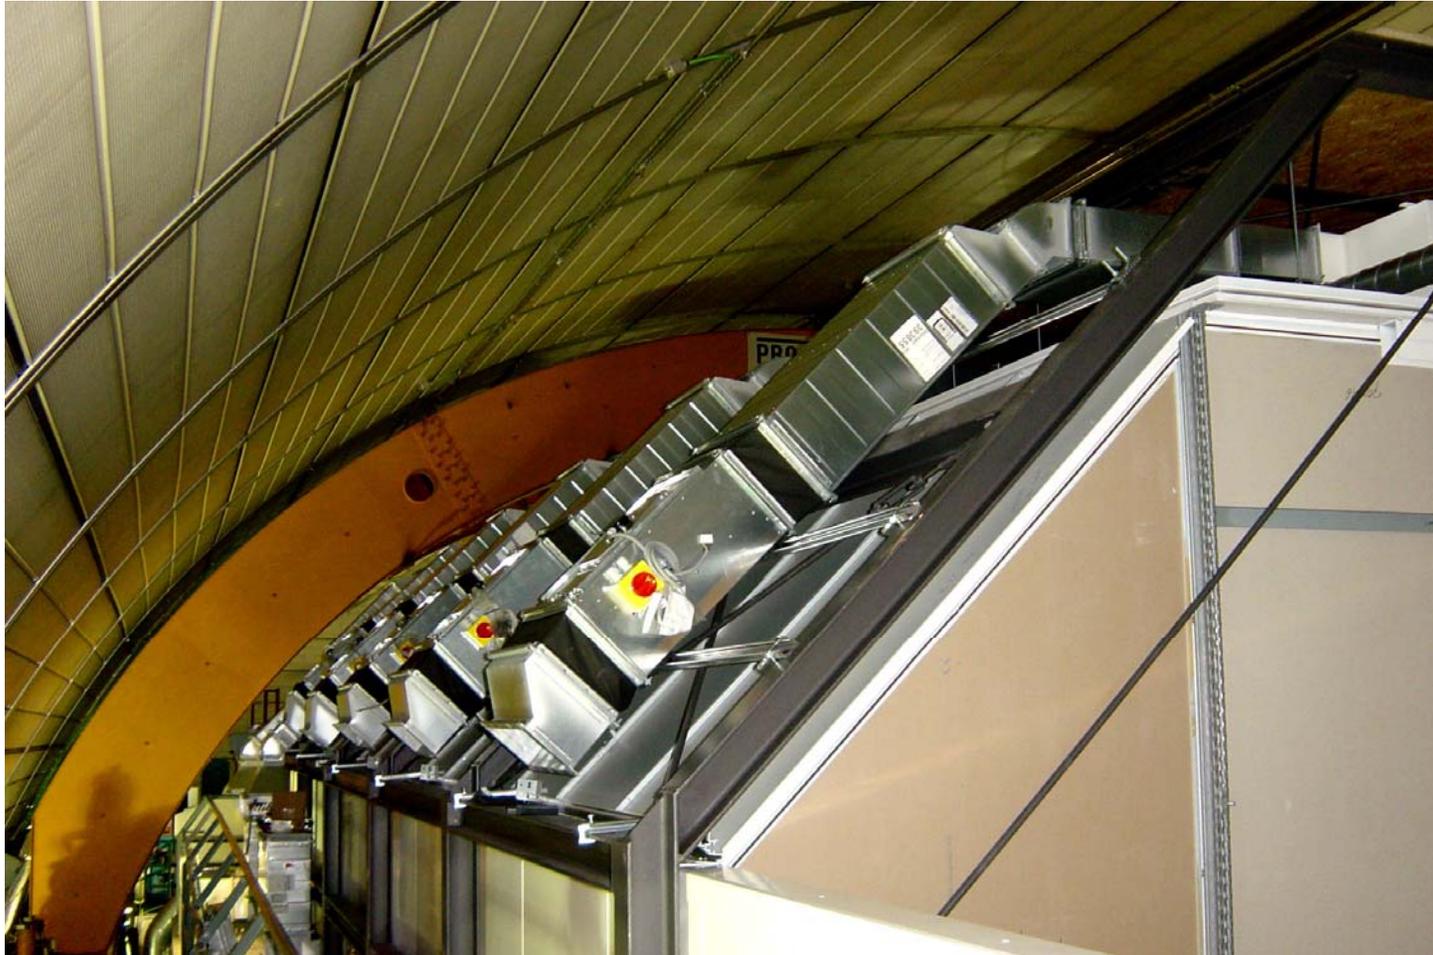
Ventilation system on east side as of 6th of March 2009

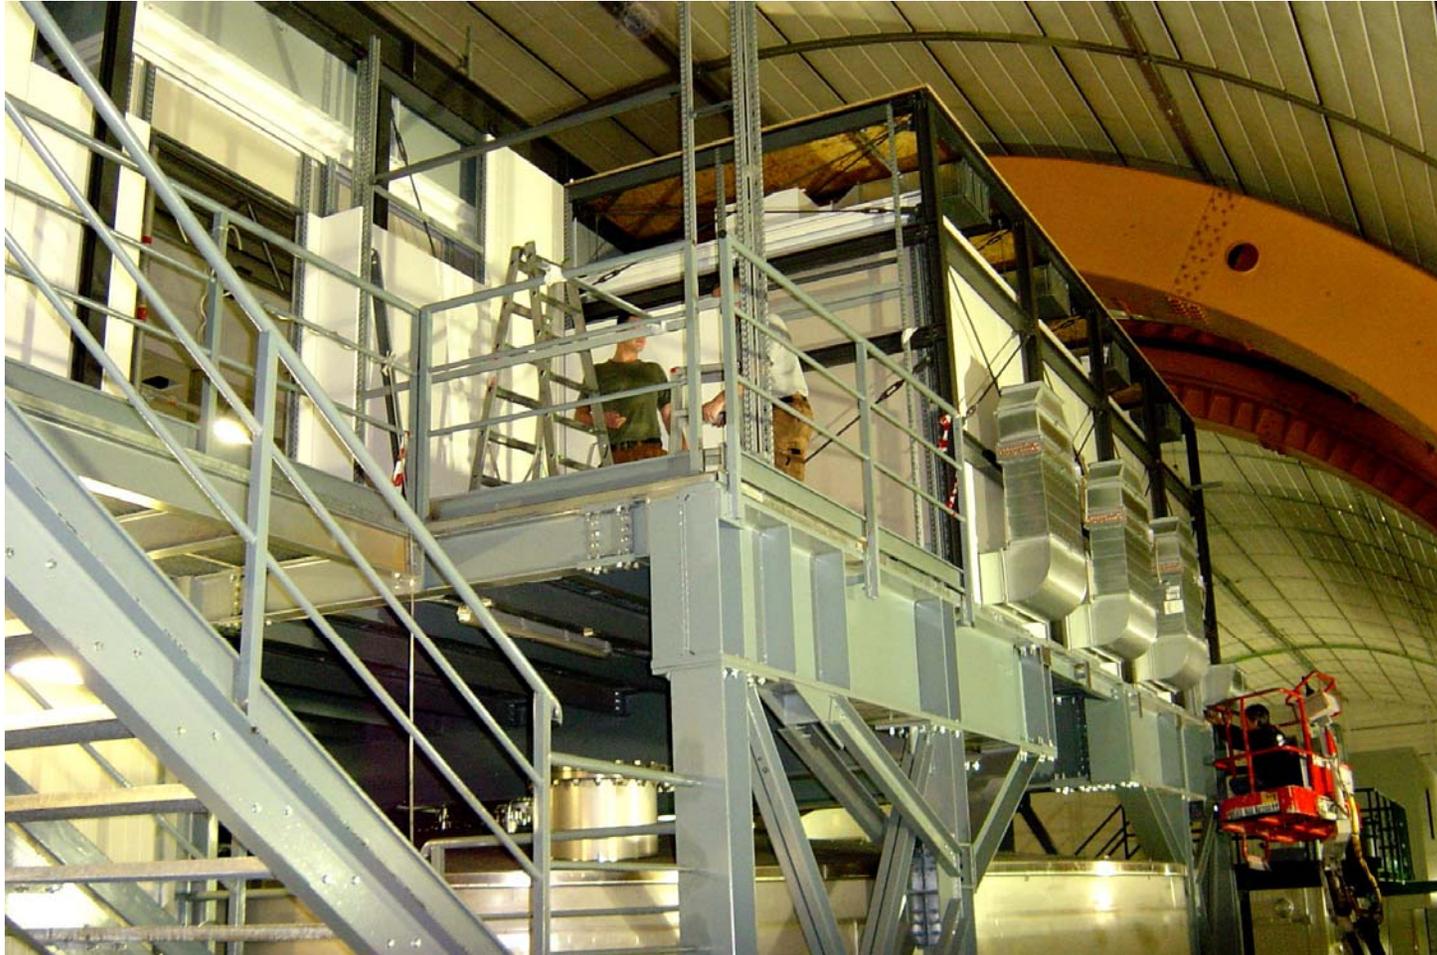
Ventilation system on west side as of 6th of March 2009

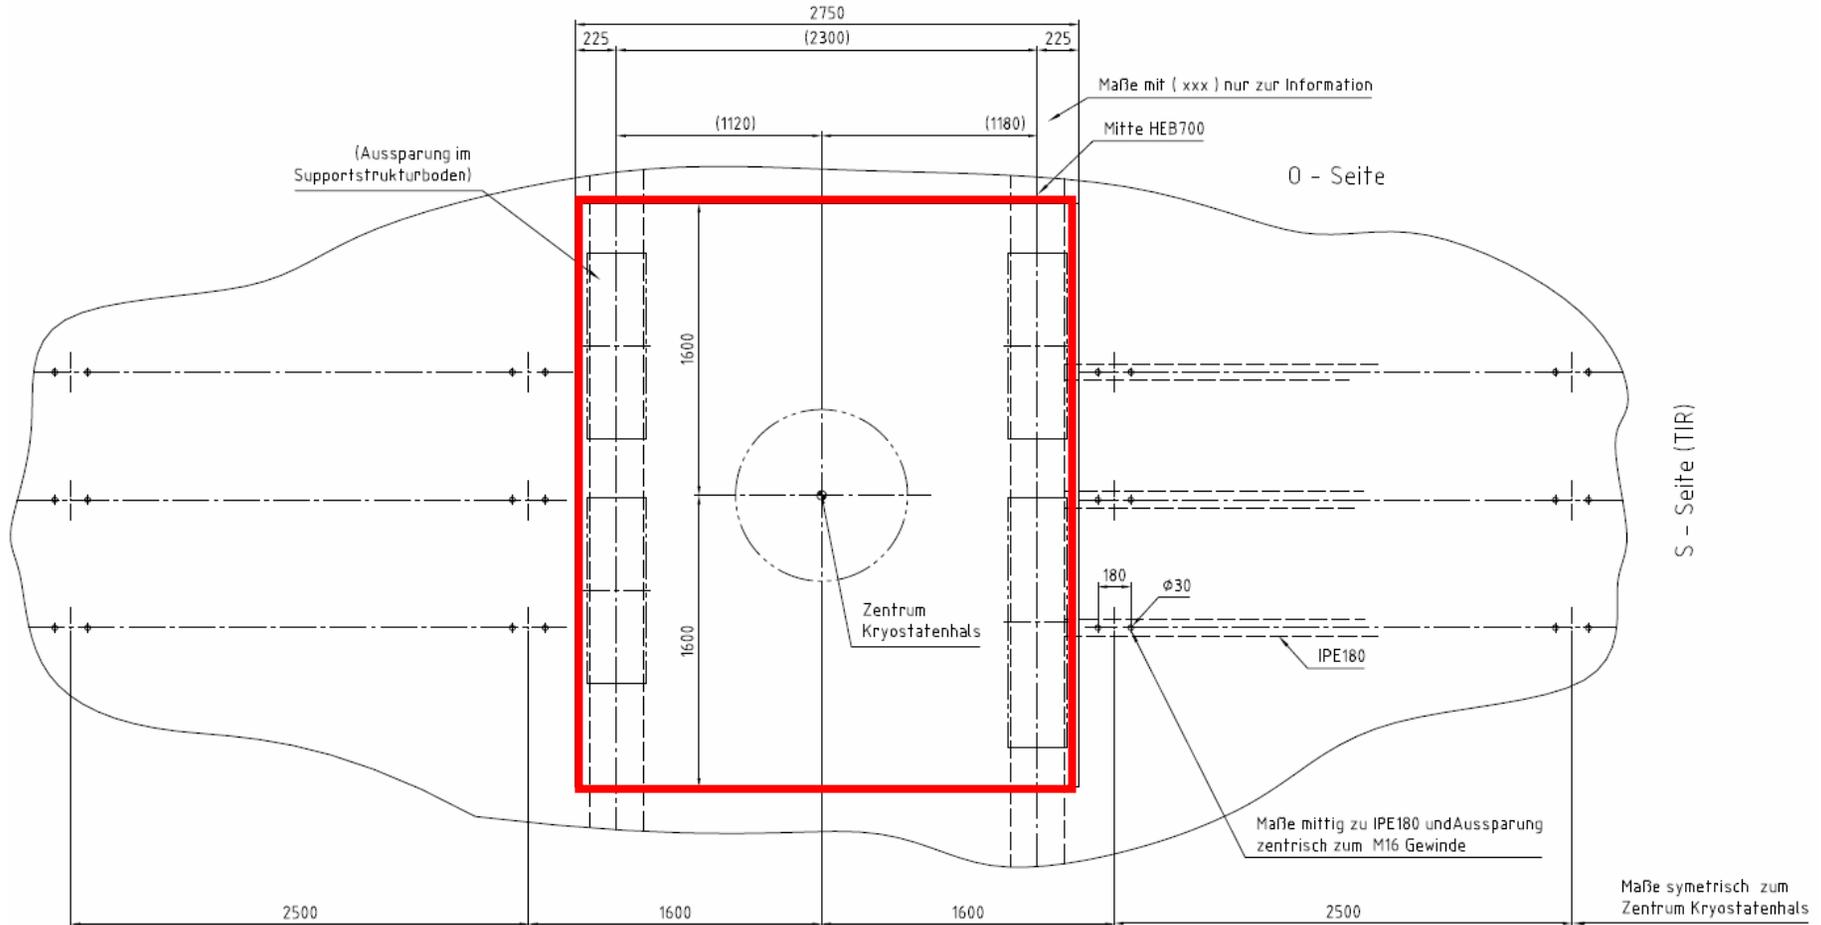
Clearing in the clean room floor will be 2.75m x 3.2m. This gives a clear interface between Becker company and GERDA collaboration.

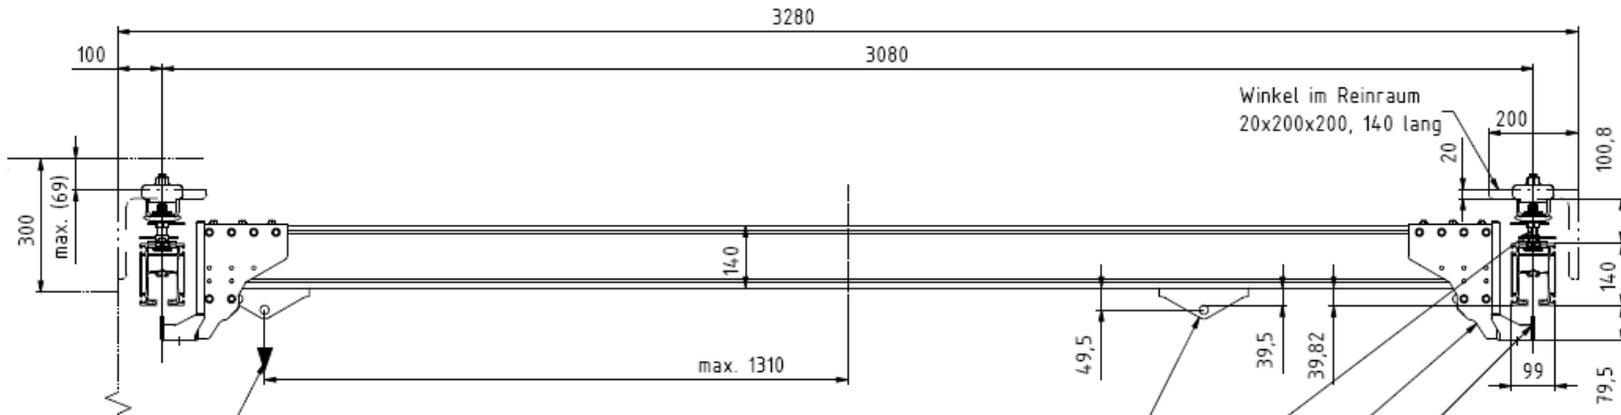
The crane system has been ordered. Installation after approval of the clean room in May 2009.

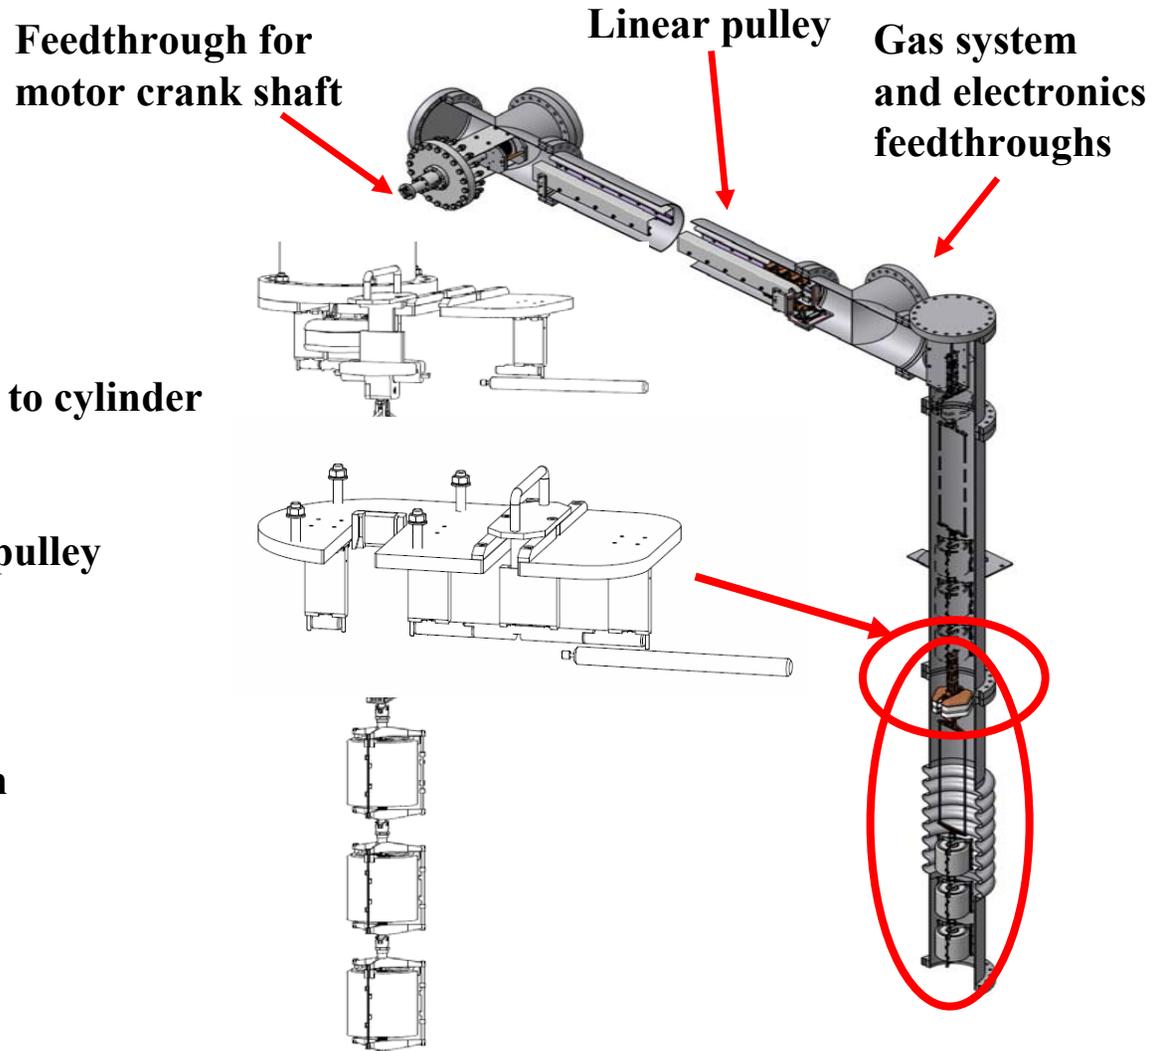
Linear Pulley – String Adapter:

- Linear pulley in upper position
- Uninstall removable cylinder
- Mount linear pulley –string adapter to cylinder
- Place string onto adapter
- Move string from adapter to linear pulley
- Slightly lower linear pulley
- Remove adapter
- Bring linear pulley to upper position
- Close removable cylinder

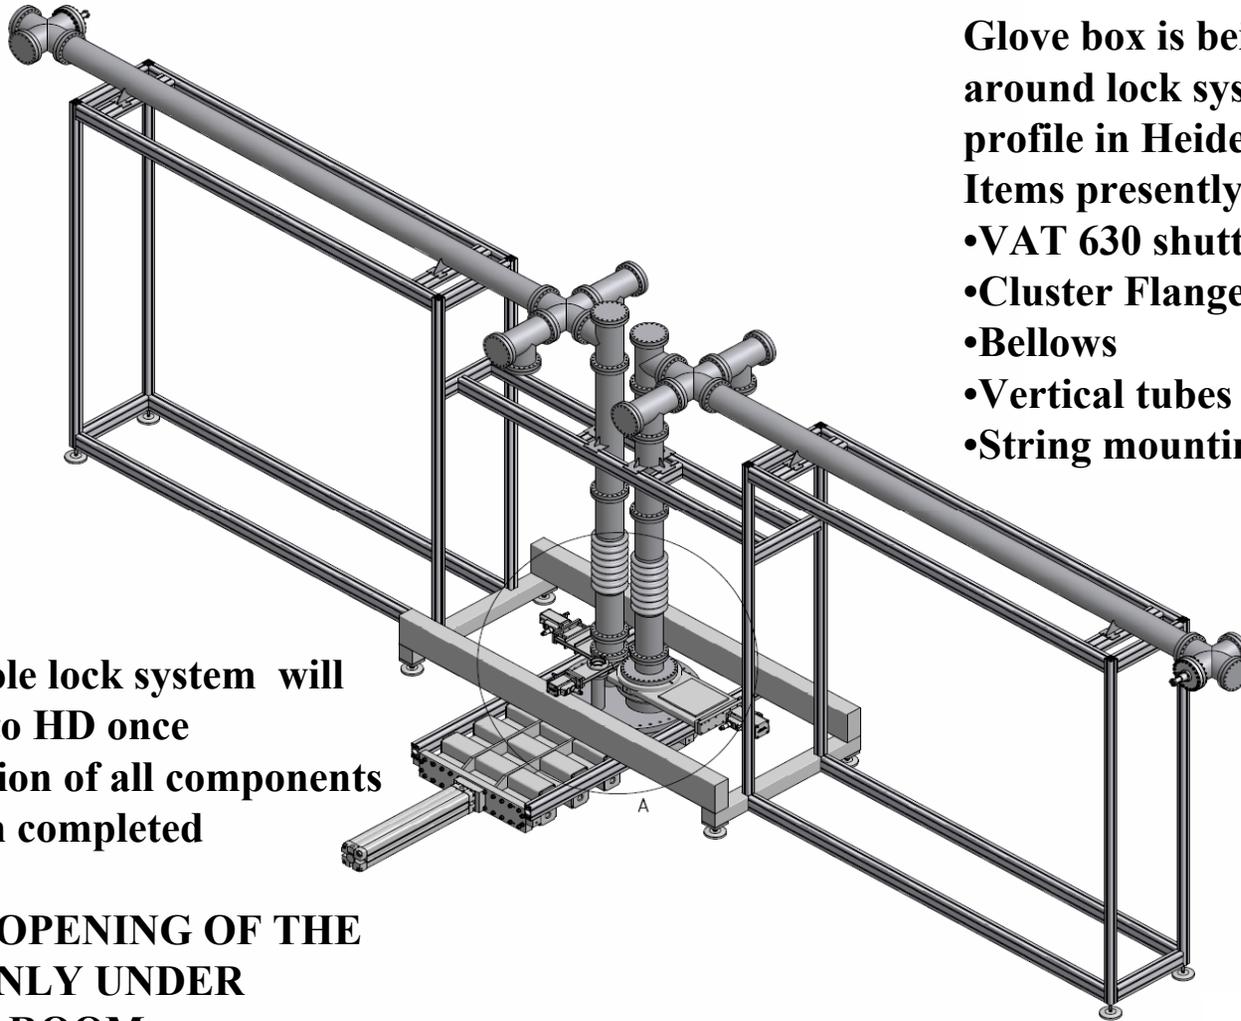
Glove box is being assembled around lock system on ITEM profile in Heidelberg.

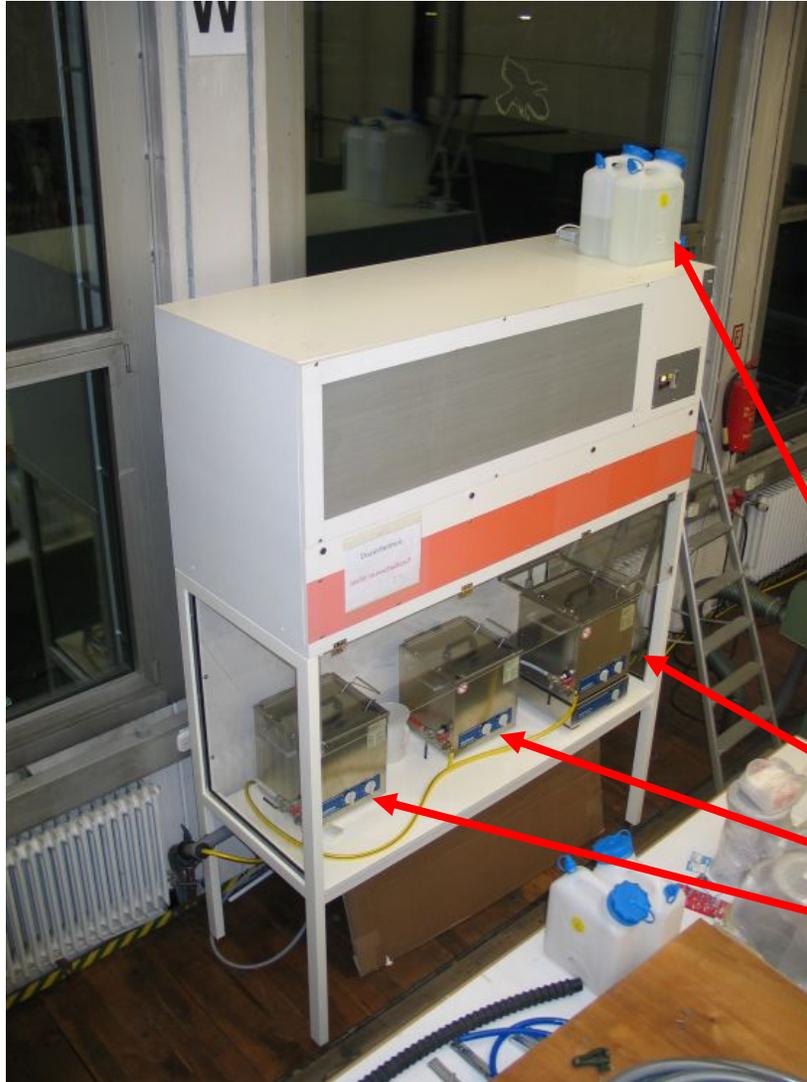
All inner welding joints have been pickled and electropolished by Polygrat!

All parts have been cleaned in Ultra sonic bench and rinsed with deionised water underneath a flow box.

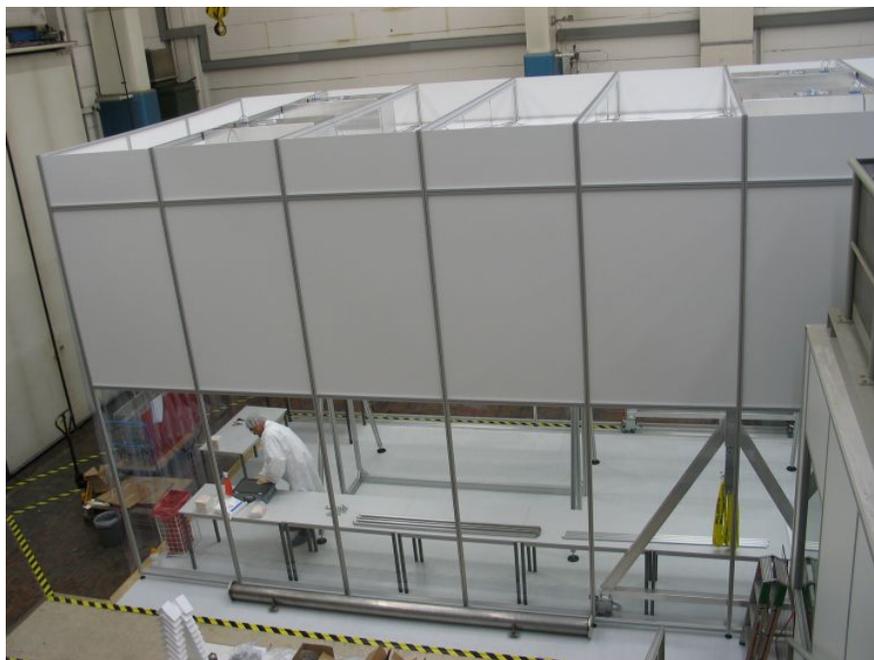
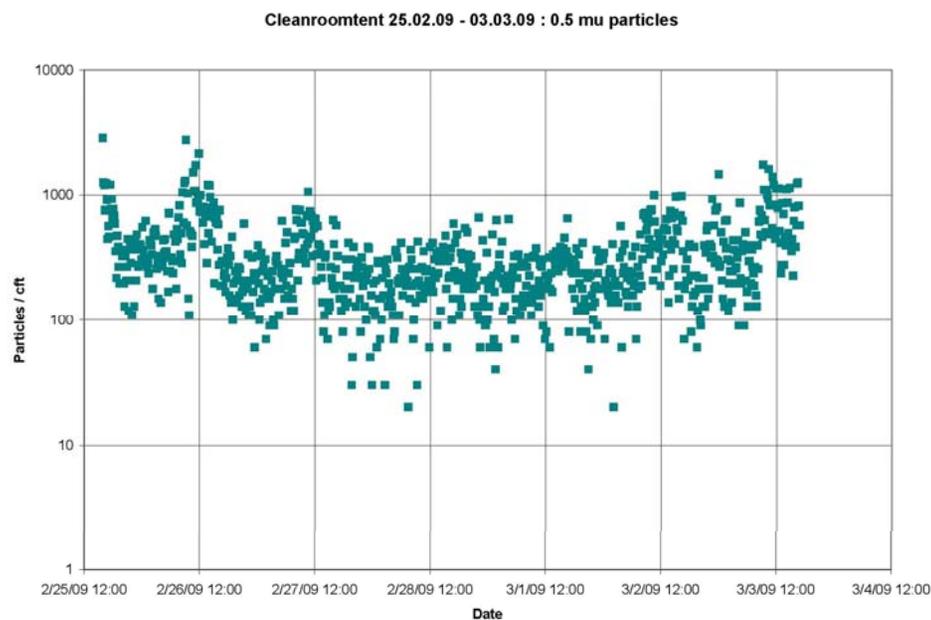
All assembly works have been carried out in a specially built clean room cabin.

Even during assembly class 10.000 could be maintained!

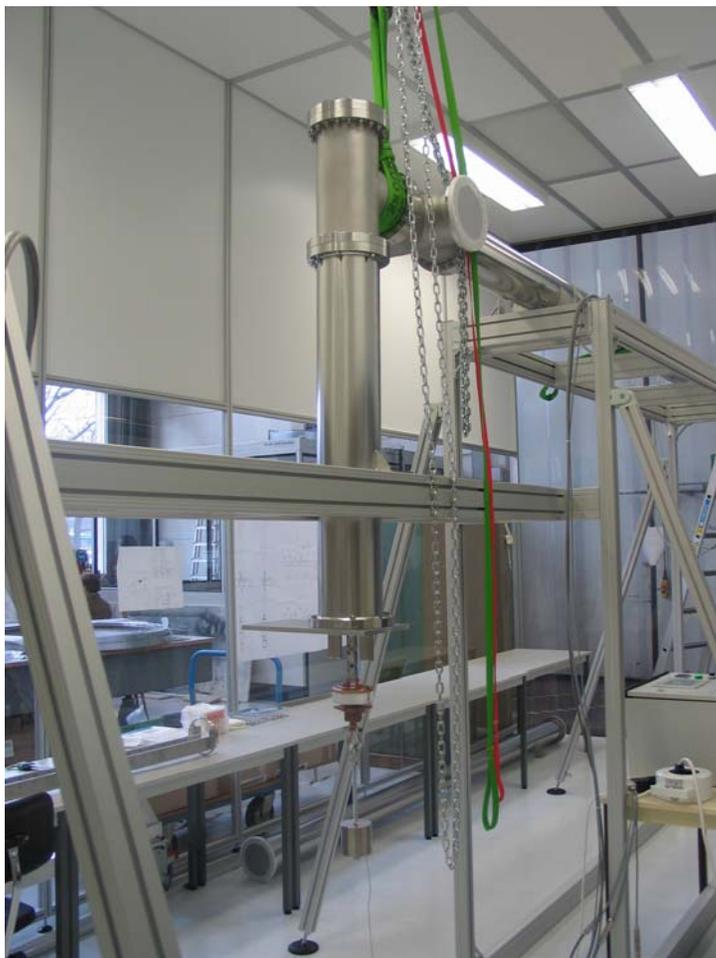
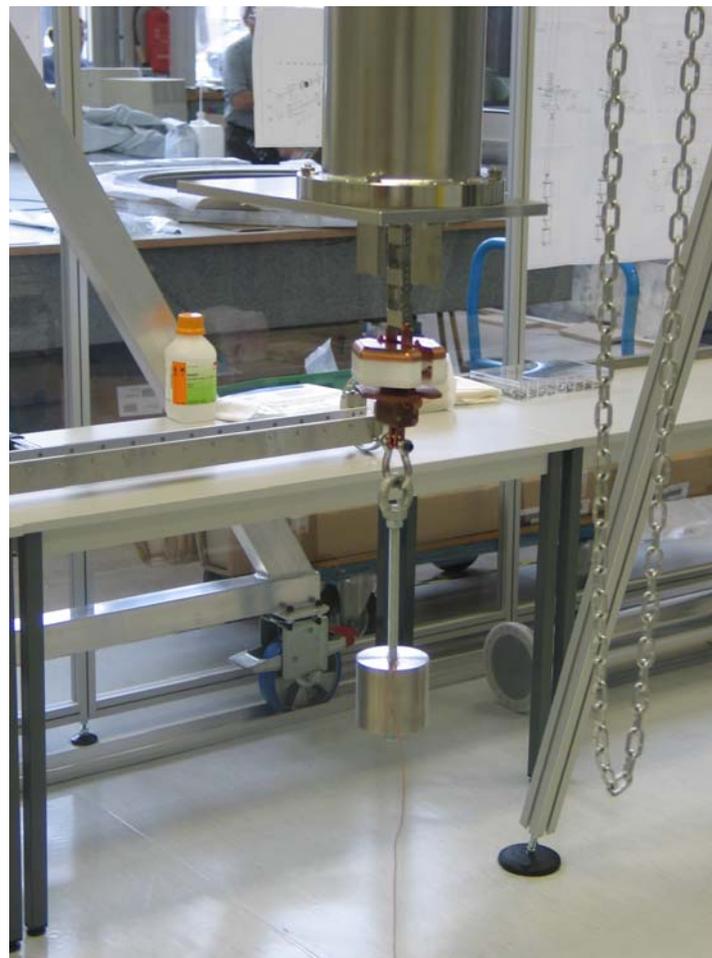
One complete cable arm has been assembled without cables. PLC test are done with this one presently

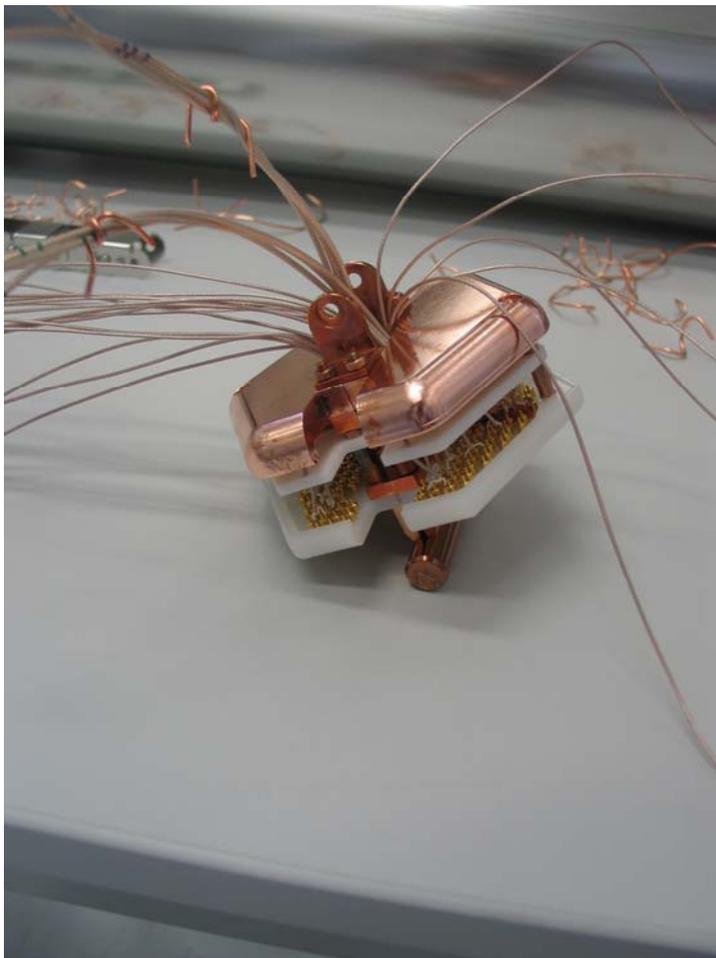
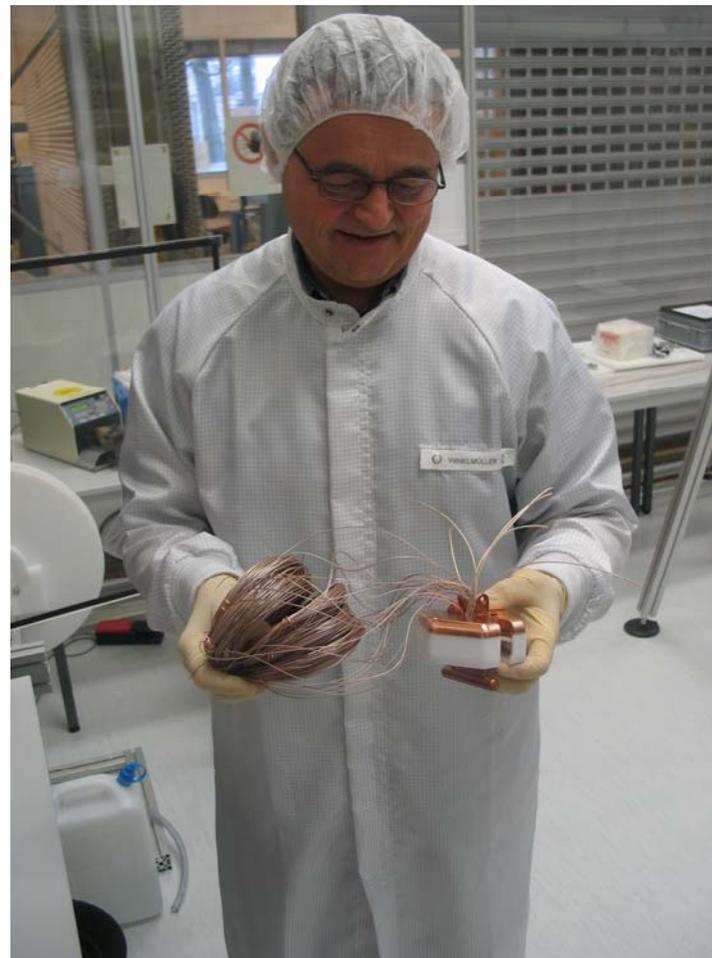
Both cable trees have been prepared. Cables have been soldered to the matrix.

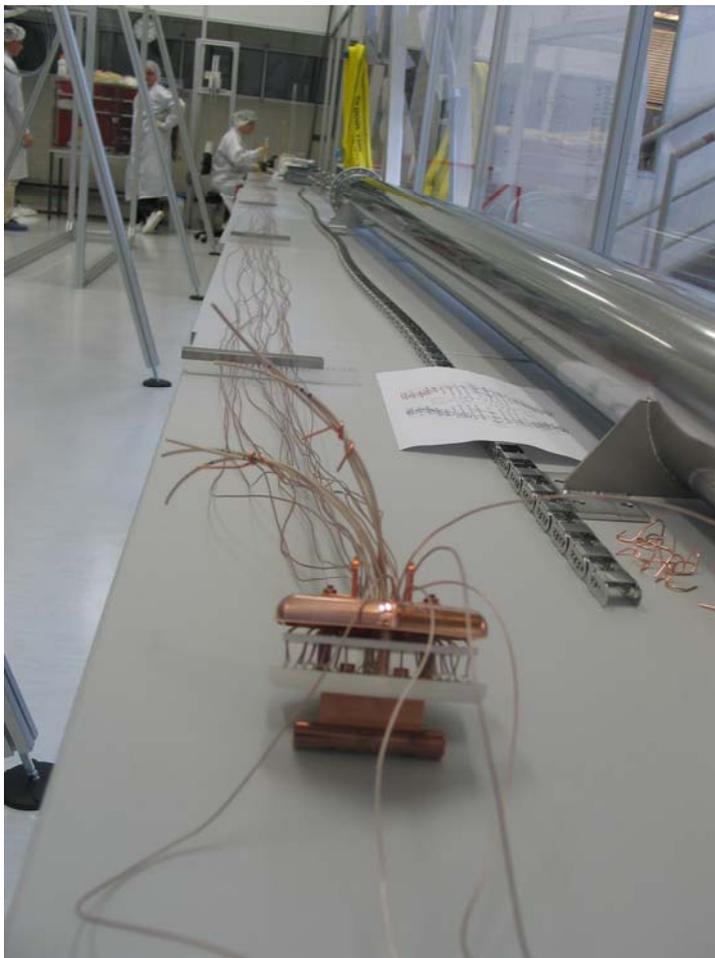
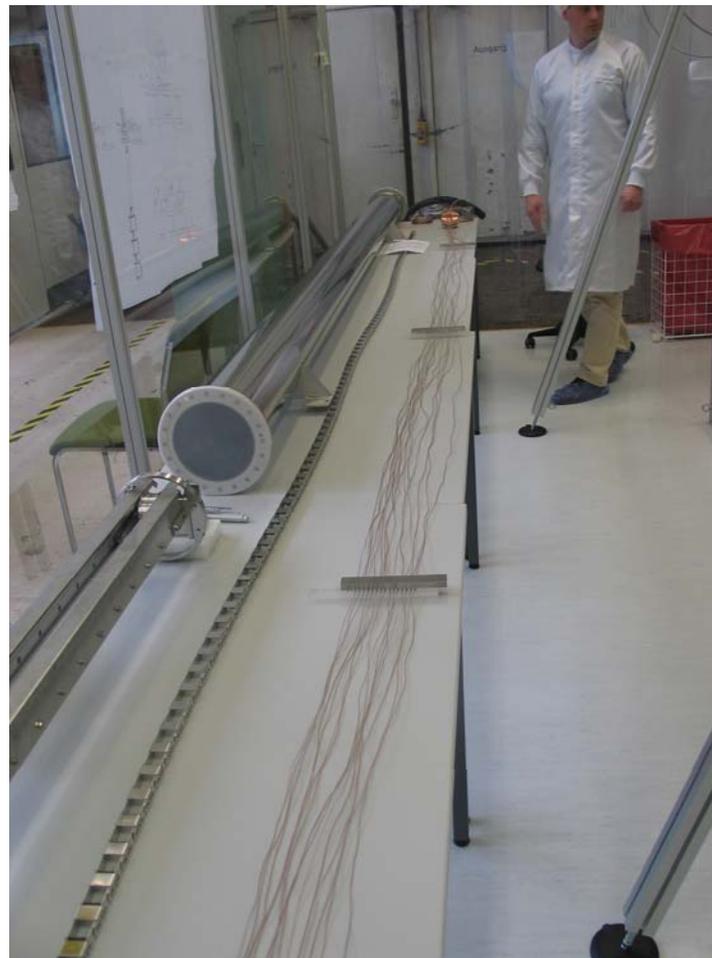
Second cable arm has been preassembled and is presently being assembled with the completed cable chain

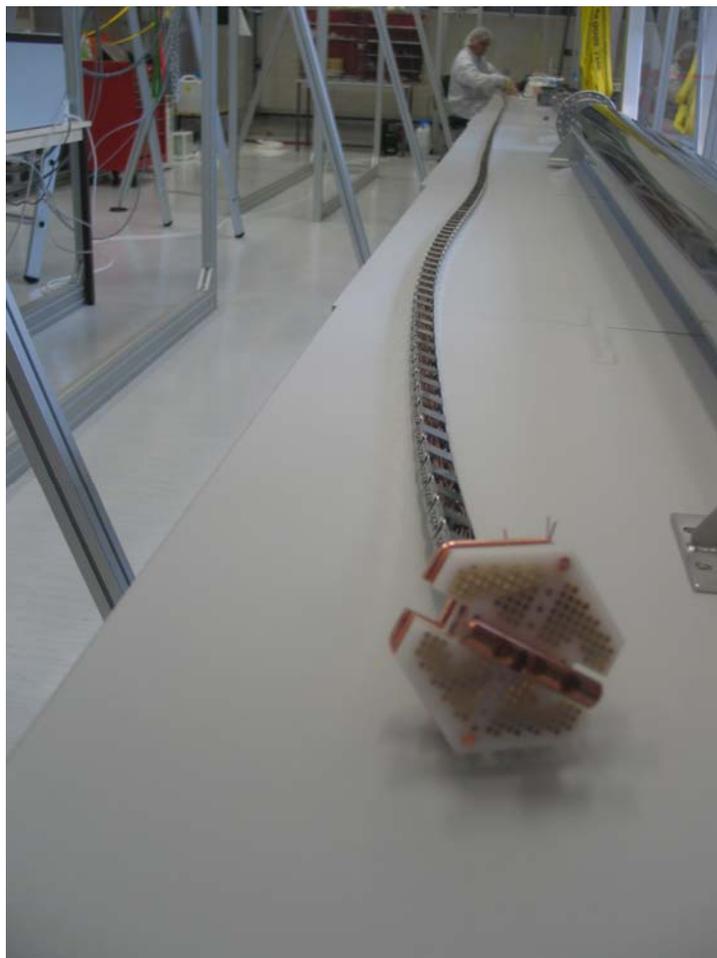
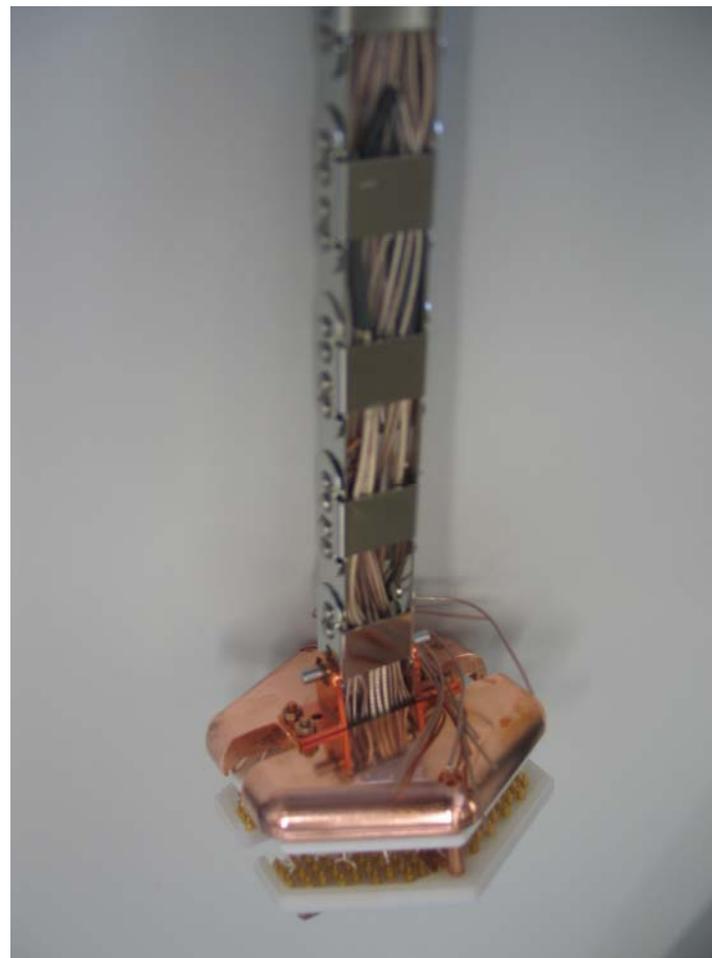
First cable chain is finished. It is currently being installed. HV cables still need to be implemented!

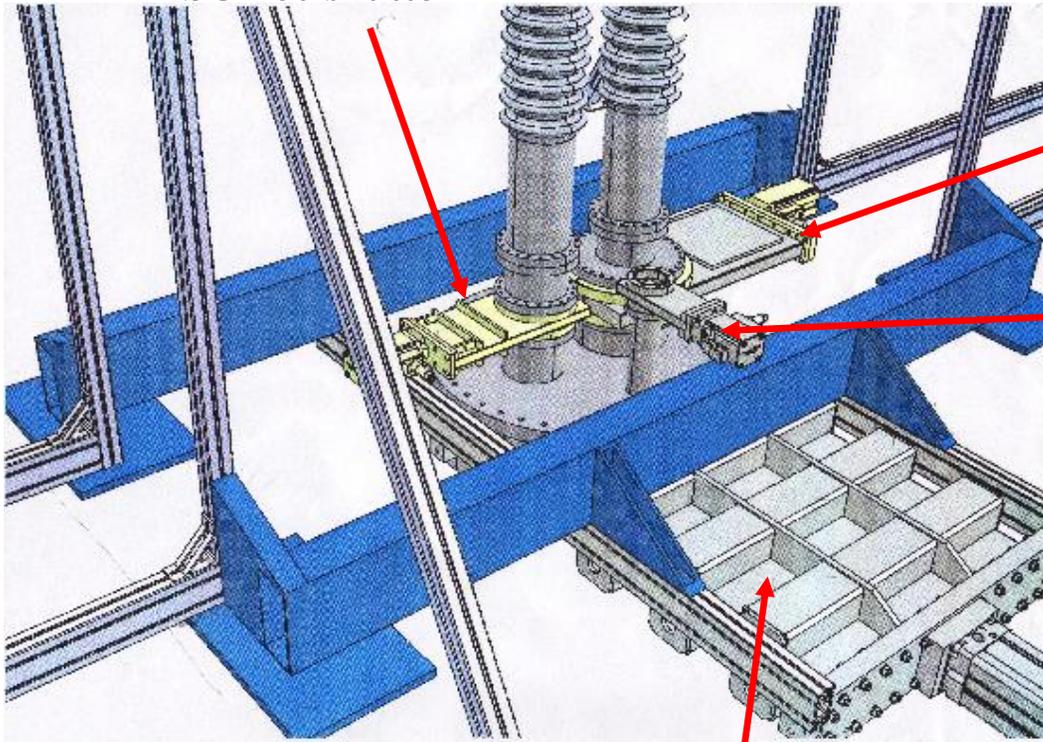
ISO 160 shutter

ISO 250 shutter

ISO 63 shutter: Port for calibration source (LNGS design)

Shutter support with adjustable feet. Design by LNGS (Donato Orlandi). Adjustable feet important for installation sequence! ✓

ISO 630 shutter

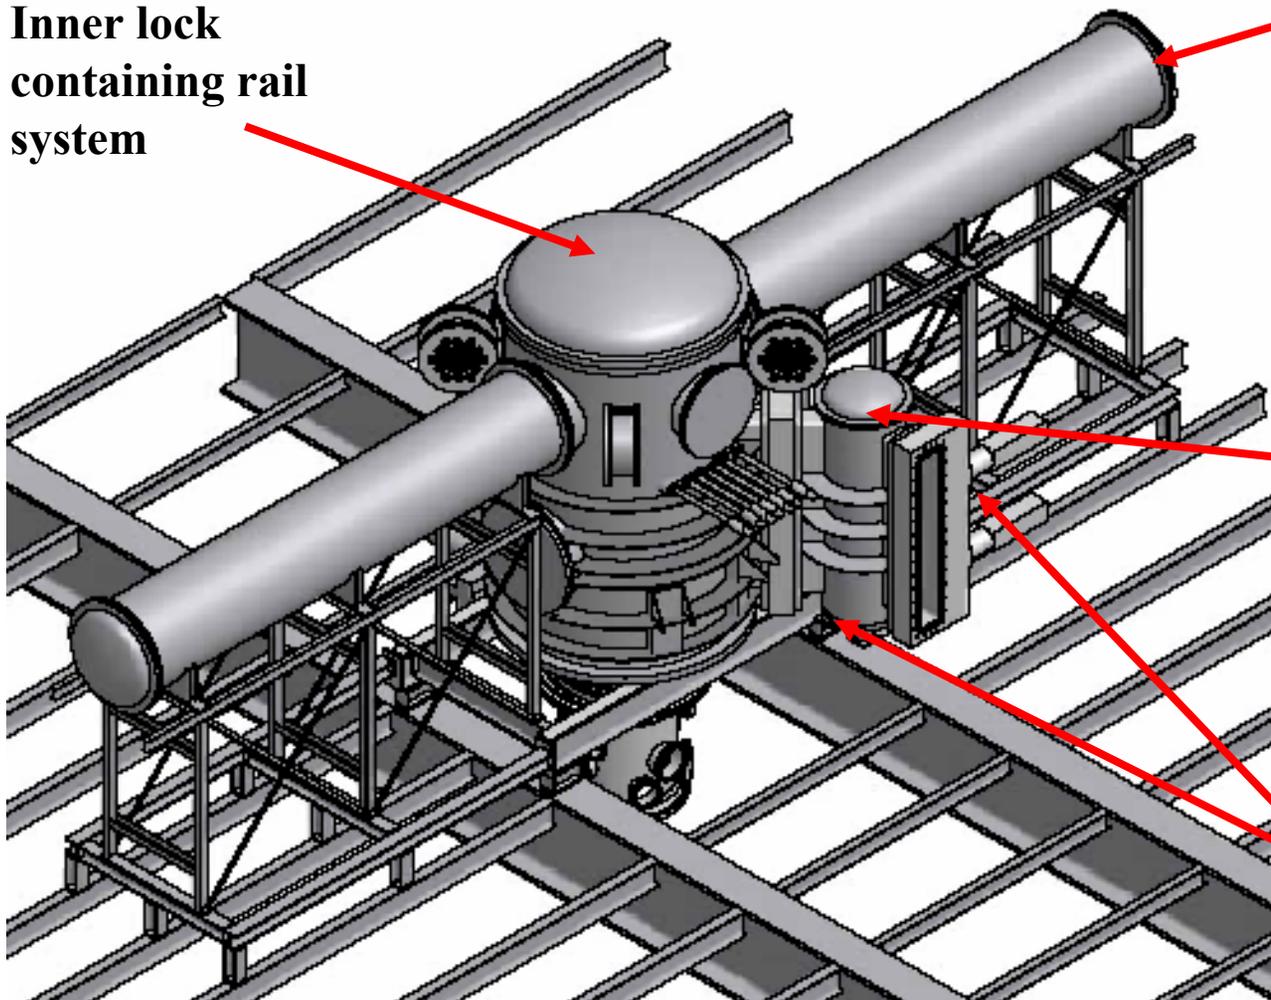
Inner lock
containing rail
system

Cable Arm
containing Linear
pulley system

Outer lock

Rectengular
shutters

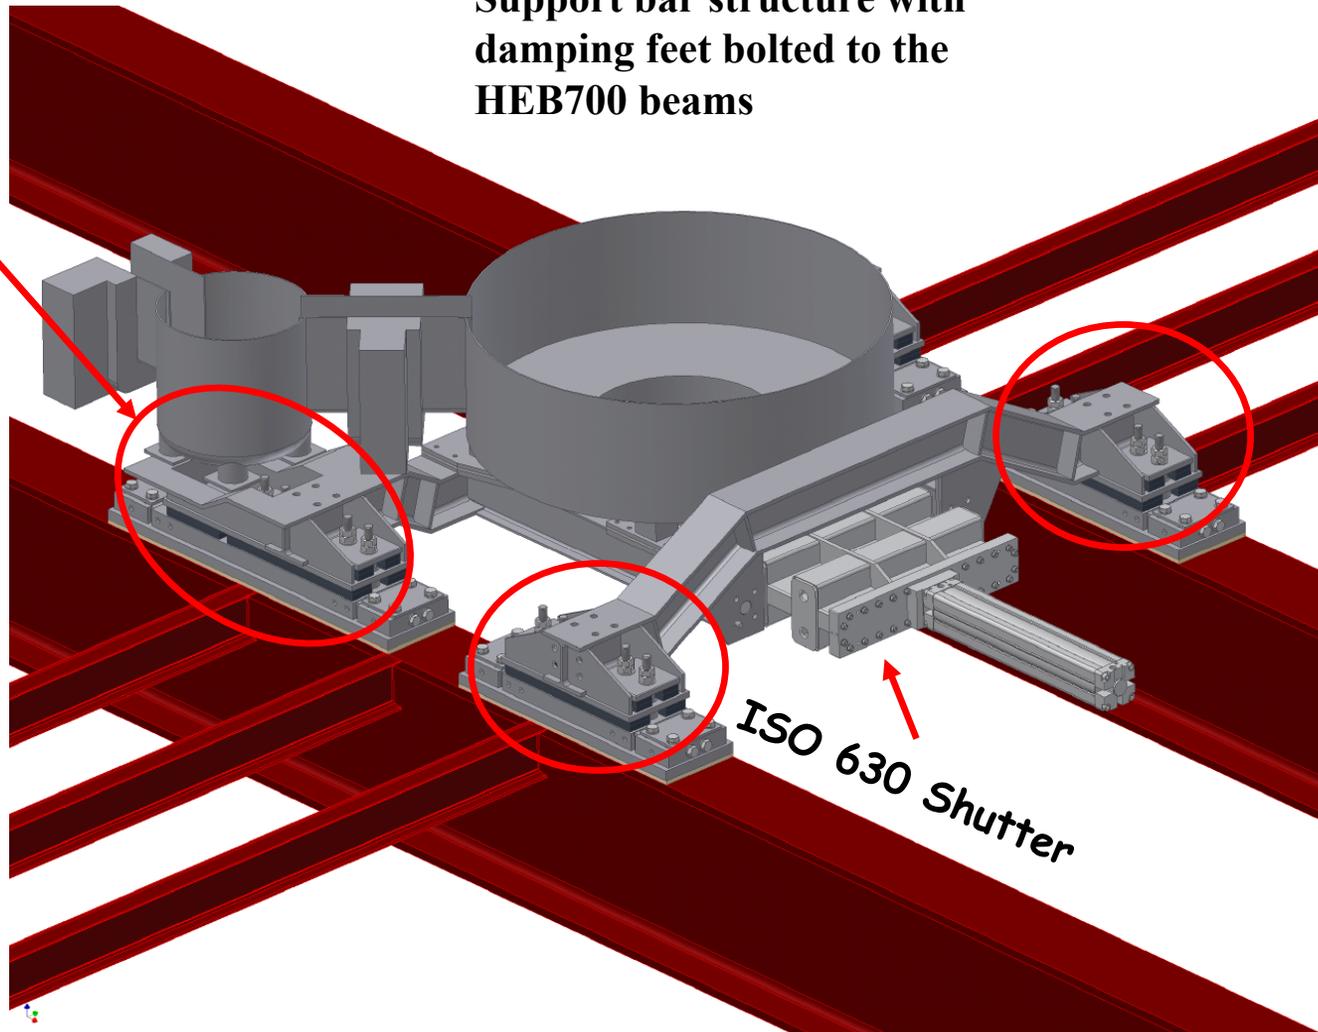
Superstructure-Lock Interface

Damping material
Sylomer

Support bar structure with
damping feet bolted to the
HEB700 beams

ISO 630 Shutter
