TG5 Review

- **Clean Room Status**
- **The Temporary Lock System**
- **The Final Lock System**

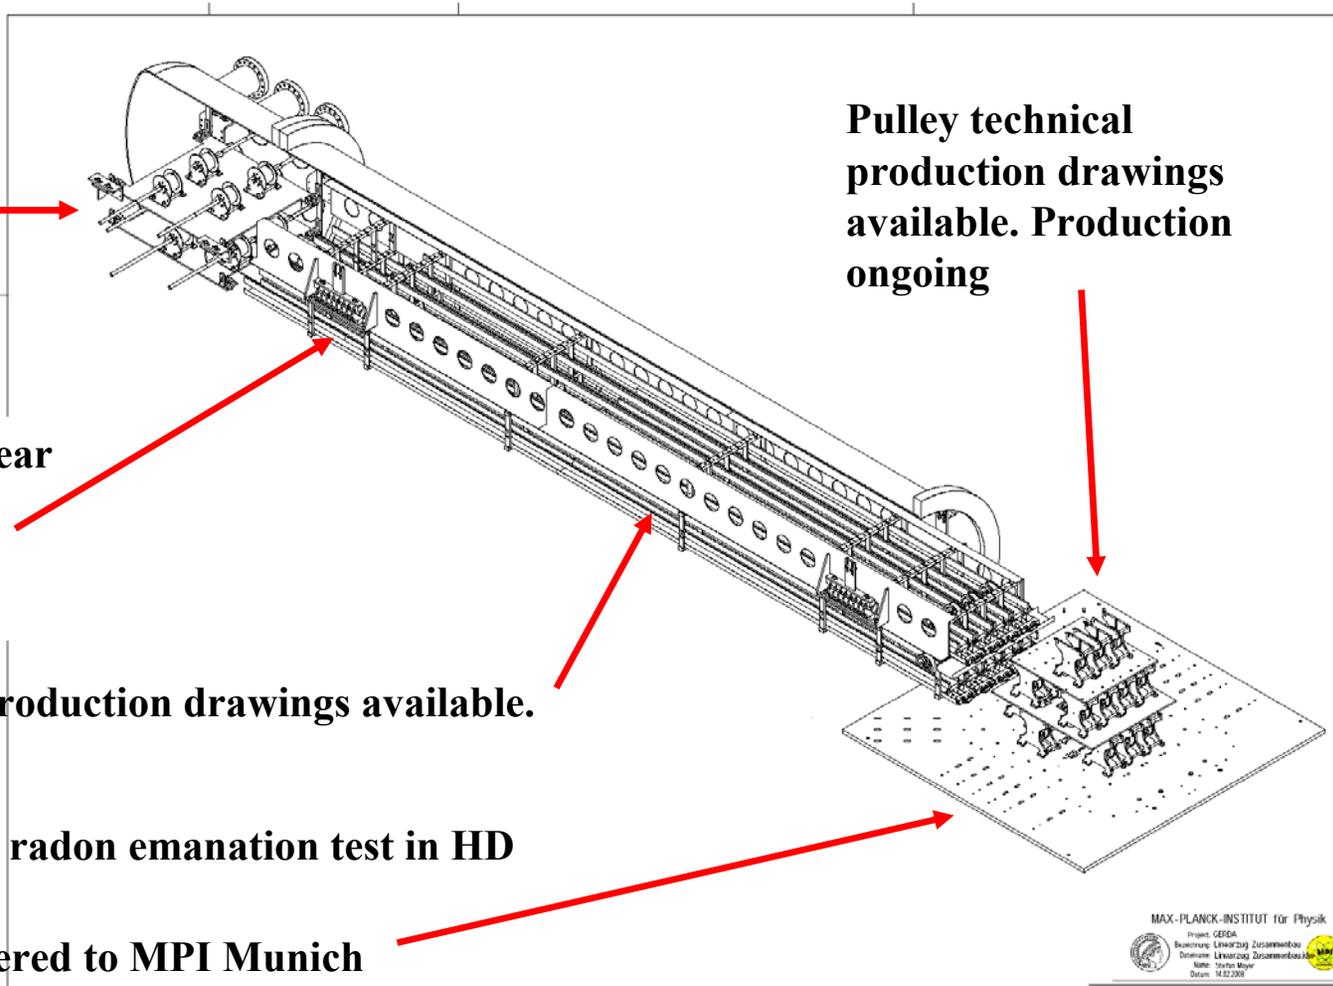
Feedthroughs for pulley motors: technical Production drawings available.

Spring suspension for linear pulley presently being manufactured at MPI Munich workshop

Linear Pulley technical production drawings available. Production ongoing

Base plate has been delivered to MPI Munich

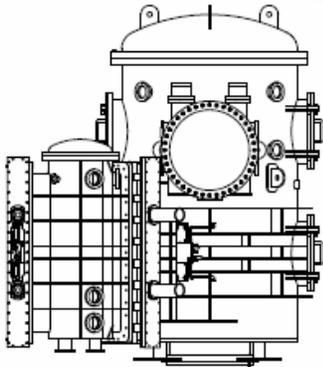
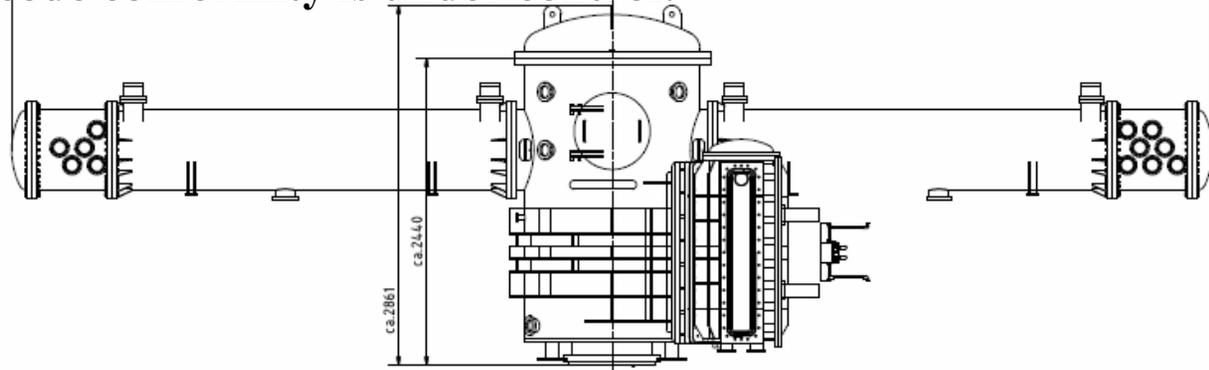
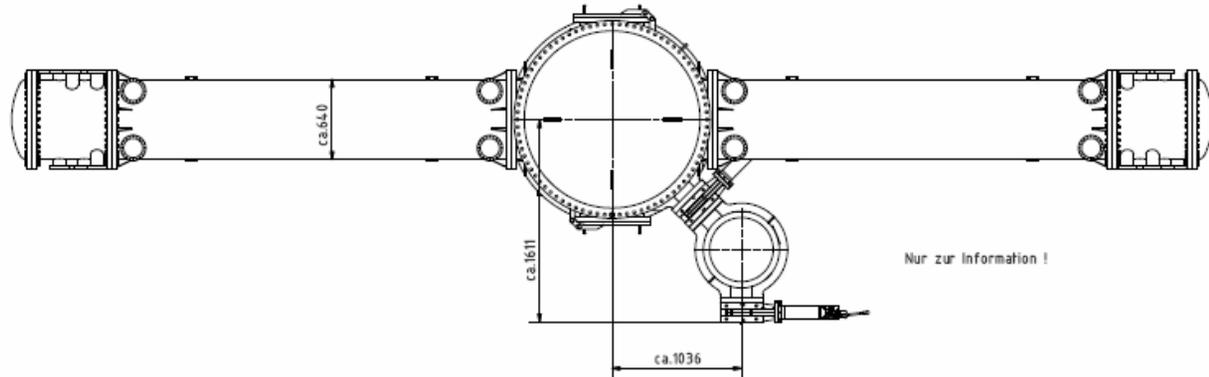
**Design has been finished since quite a while.
Pressure code conformity is under control!**

- ✓ → Extraction of technical production drawings from model
- ✓ → Calculation of deformation at vacuum and at 1.5bar (2.2bar) overpressure
- ✓ → Adjustment to pressure code conformity
- ✓ → Welding instructions
- Approval of design by TueV
- Tender documentation
- Accompanying production
- Final TueV approval
