Clean Room and Lock System

Status report and

GERDA

Commissioning Lock

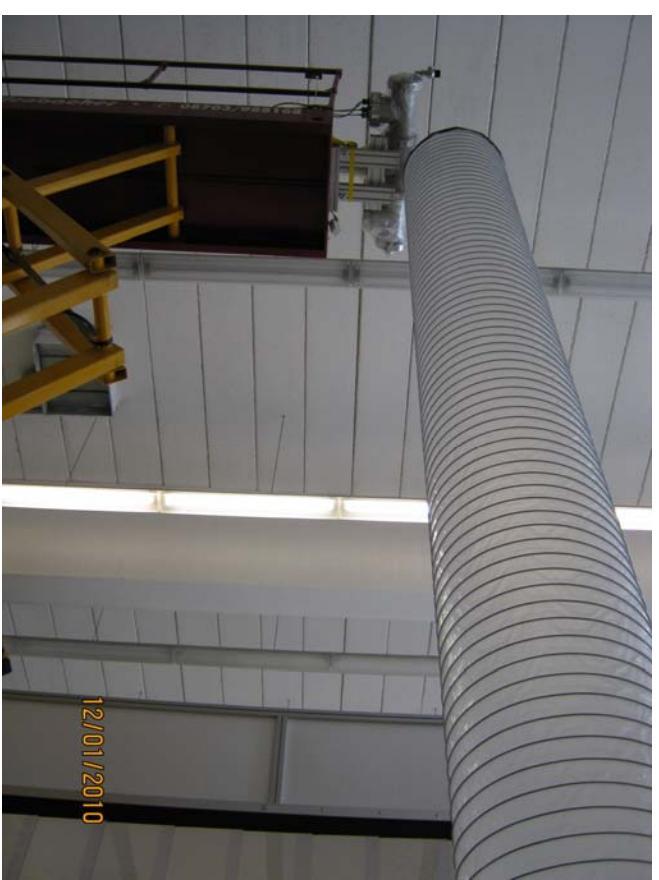
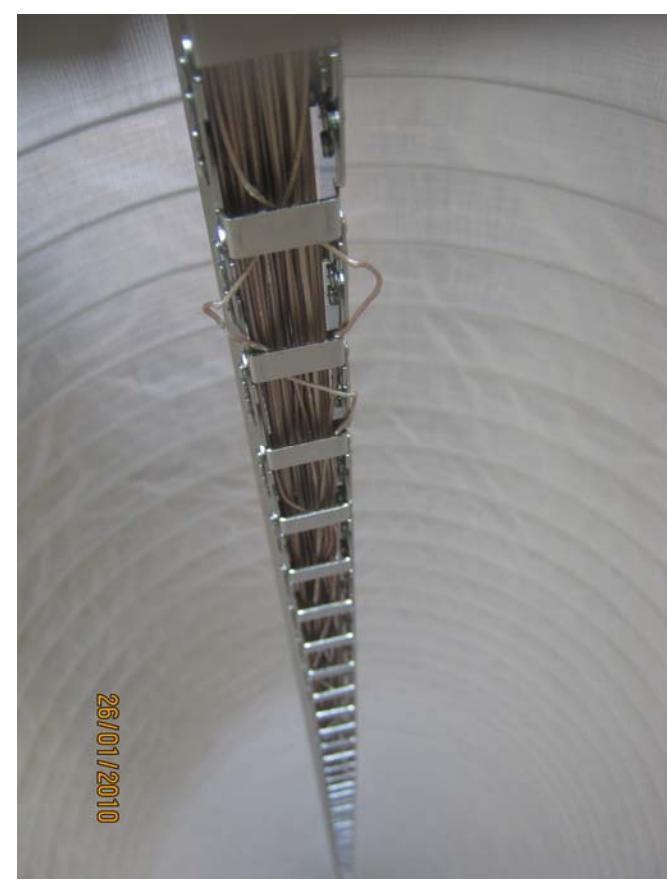
After few cycles cables started moving out from cable chain. At mounting cables had not been tightened much
 → Cable rearranged during movement and were damaged, partly at sharp edges of cable chain

Did complete remount (including laser welding to matrix). Introduced bolts to keep cables from sharp edges. Tightened cables properly.
→Commissioning lock back on hoist on 12th of February

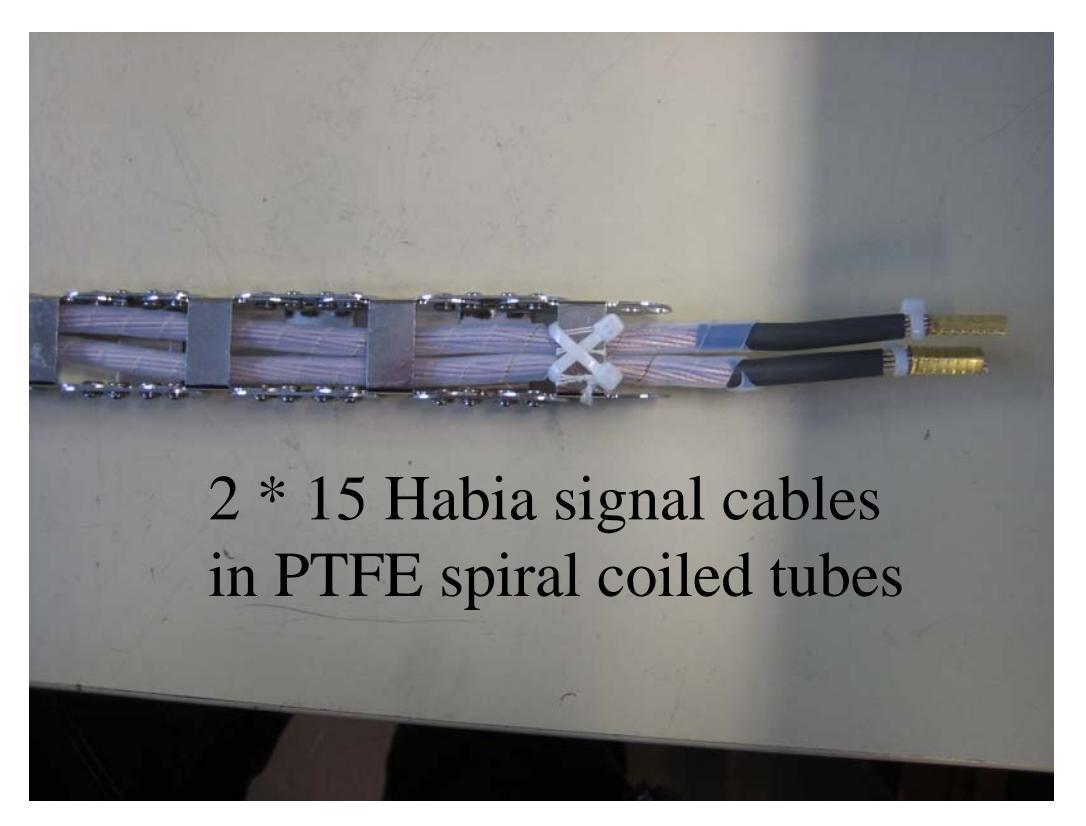
Commissioning Lock Actions Taken:

•20 LN cycles with subsequent 10 bending cycles each without bolts•10 bending cycles with bolts

- →Damage of PTFE piral coiled tube
- →Movement of spiral coiled tube
- \rightarrow Winding of bundles

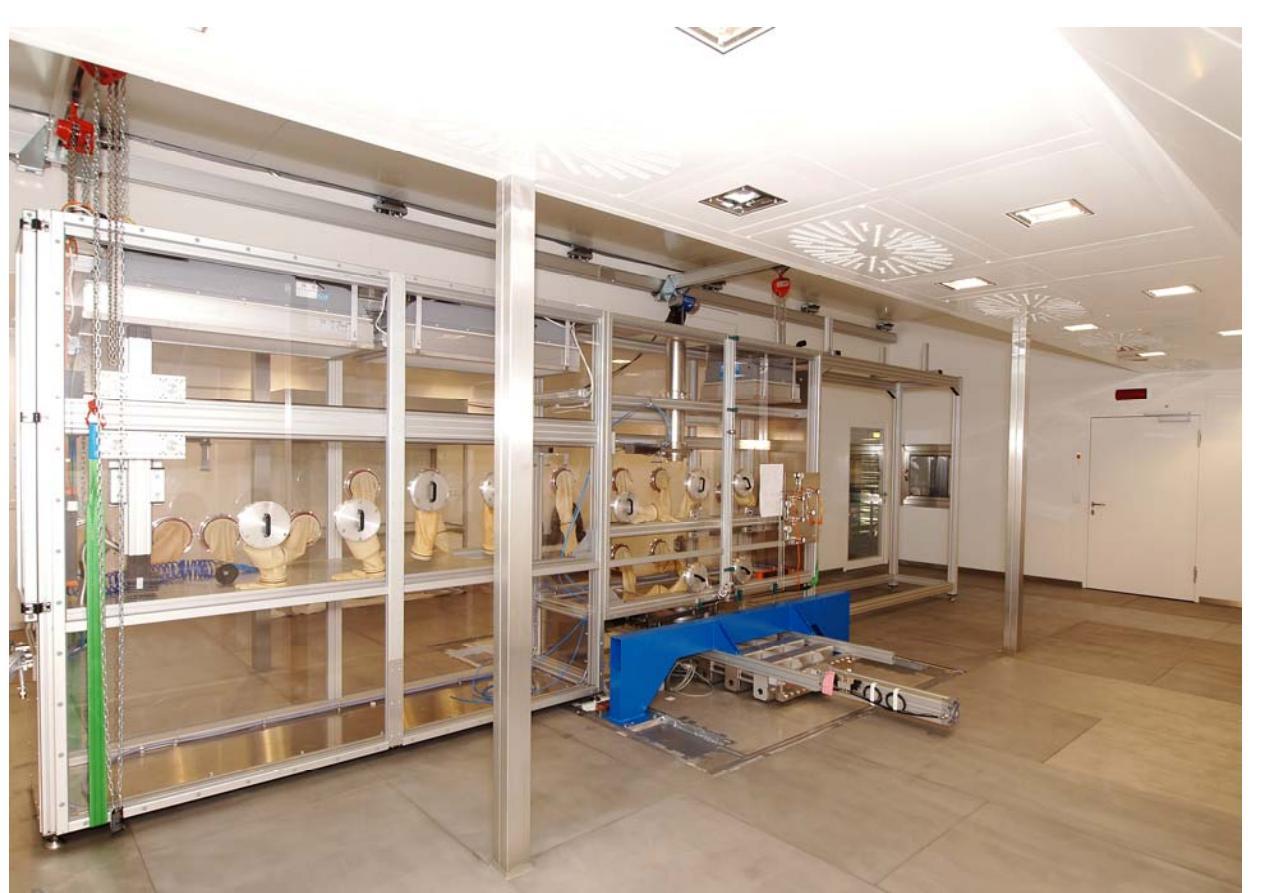
Clean Room Status

Clean room has been cleaned. Not perfect, but please respect clean room rules from now on.

→ Presentation, Discussion and training of rules on Wednesday

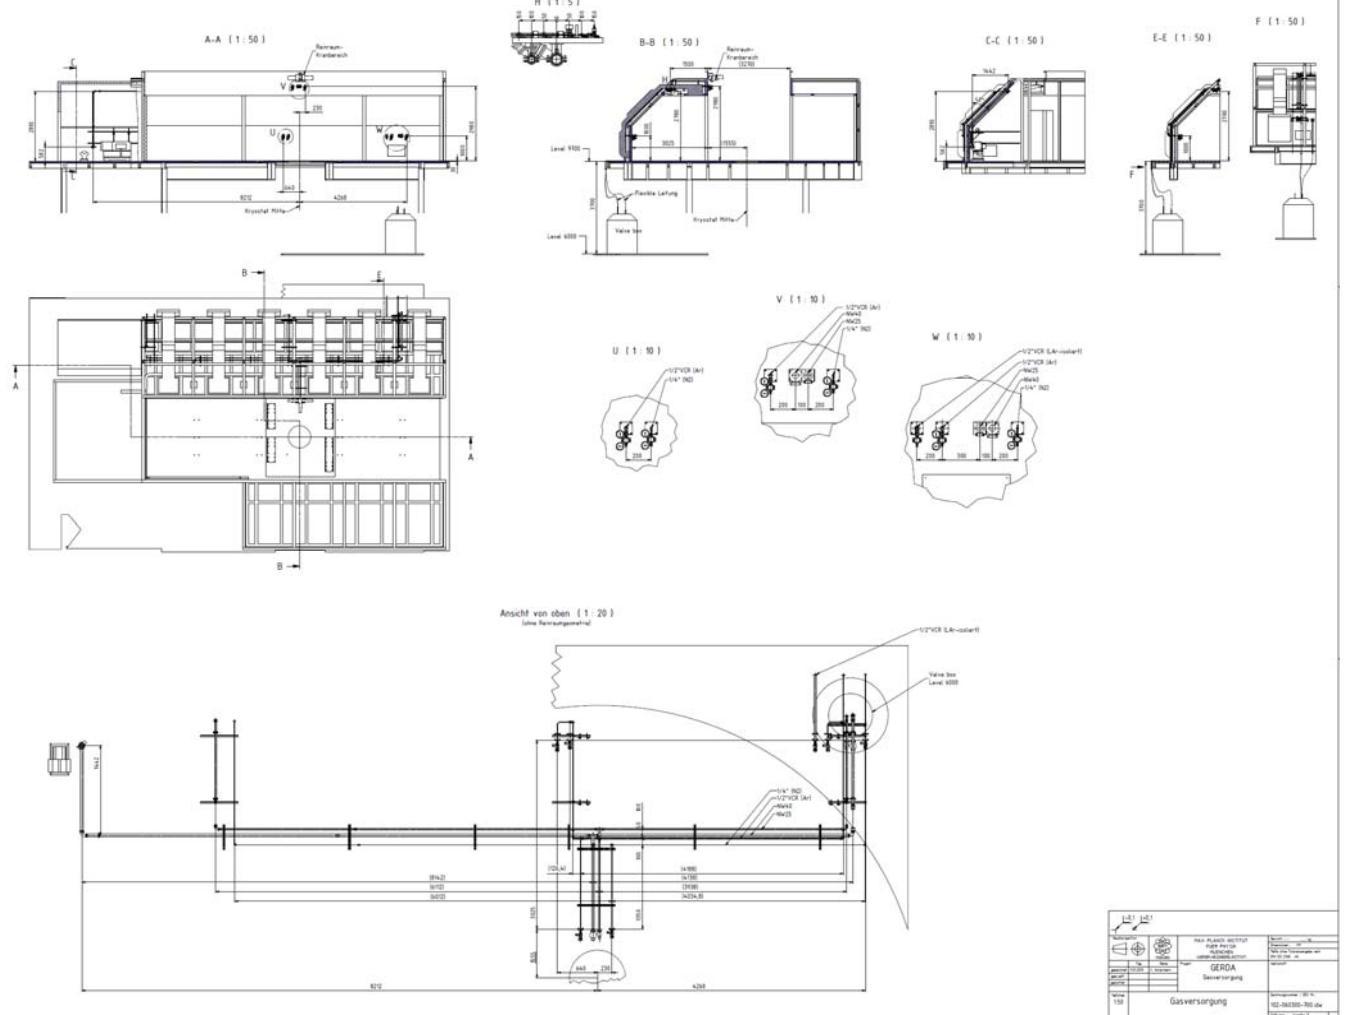
Clean Room Status

Mounting of external gas and vacuum supply is going to be mounted by Linde. Will be finished CW10 (?).
