Status of WT and related issues

C. Cattadori on behalf of working group P.Martella, F. Potenza, M. Balata, L.Ioannucci, E. Bellotti

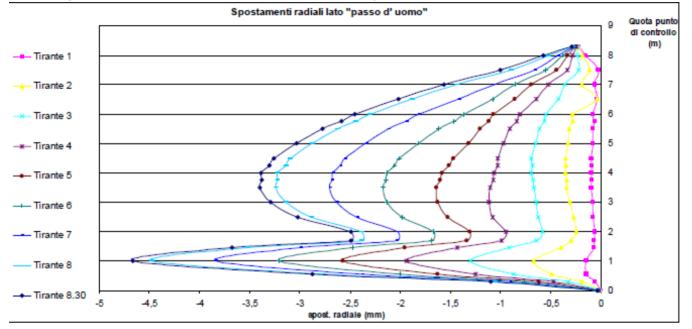
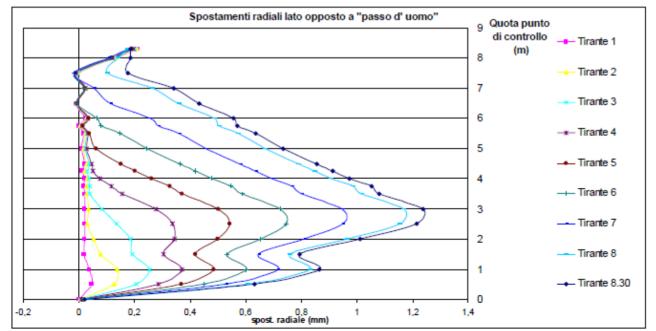
Expected deformations (from finite element analysis code)

Measured deformations

Measured deformations while filling and draining confirms that the tank deformations are in the elastic regime black : filling

red: emptying
