# Update on Cryostat & Cryogenic Infrastructure

B. Schwingenheuer  
(K.T.Knöpfle)  
MPI-K Heidelberg  
11 March 2009, Padova

# Corrosion of the cryostat

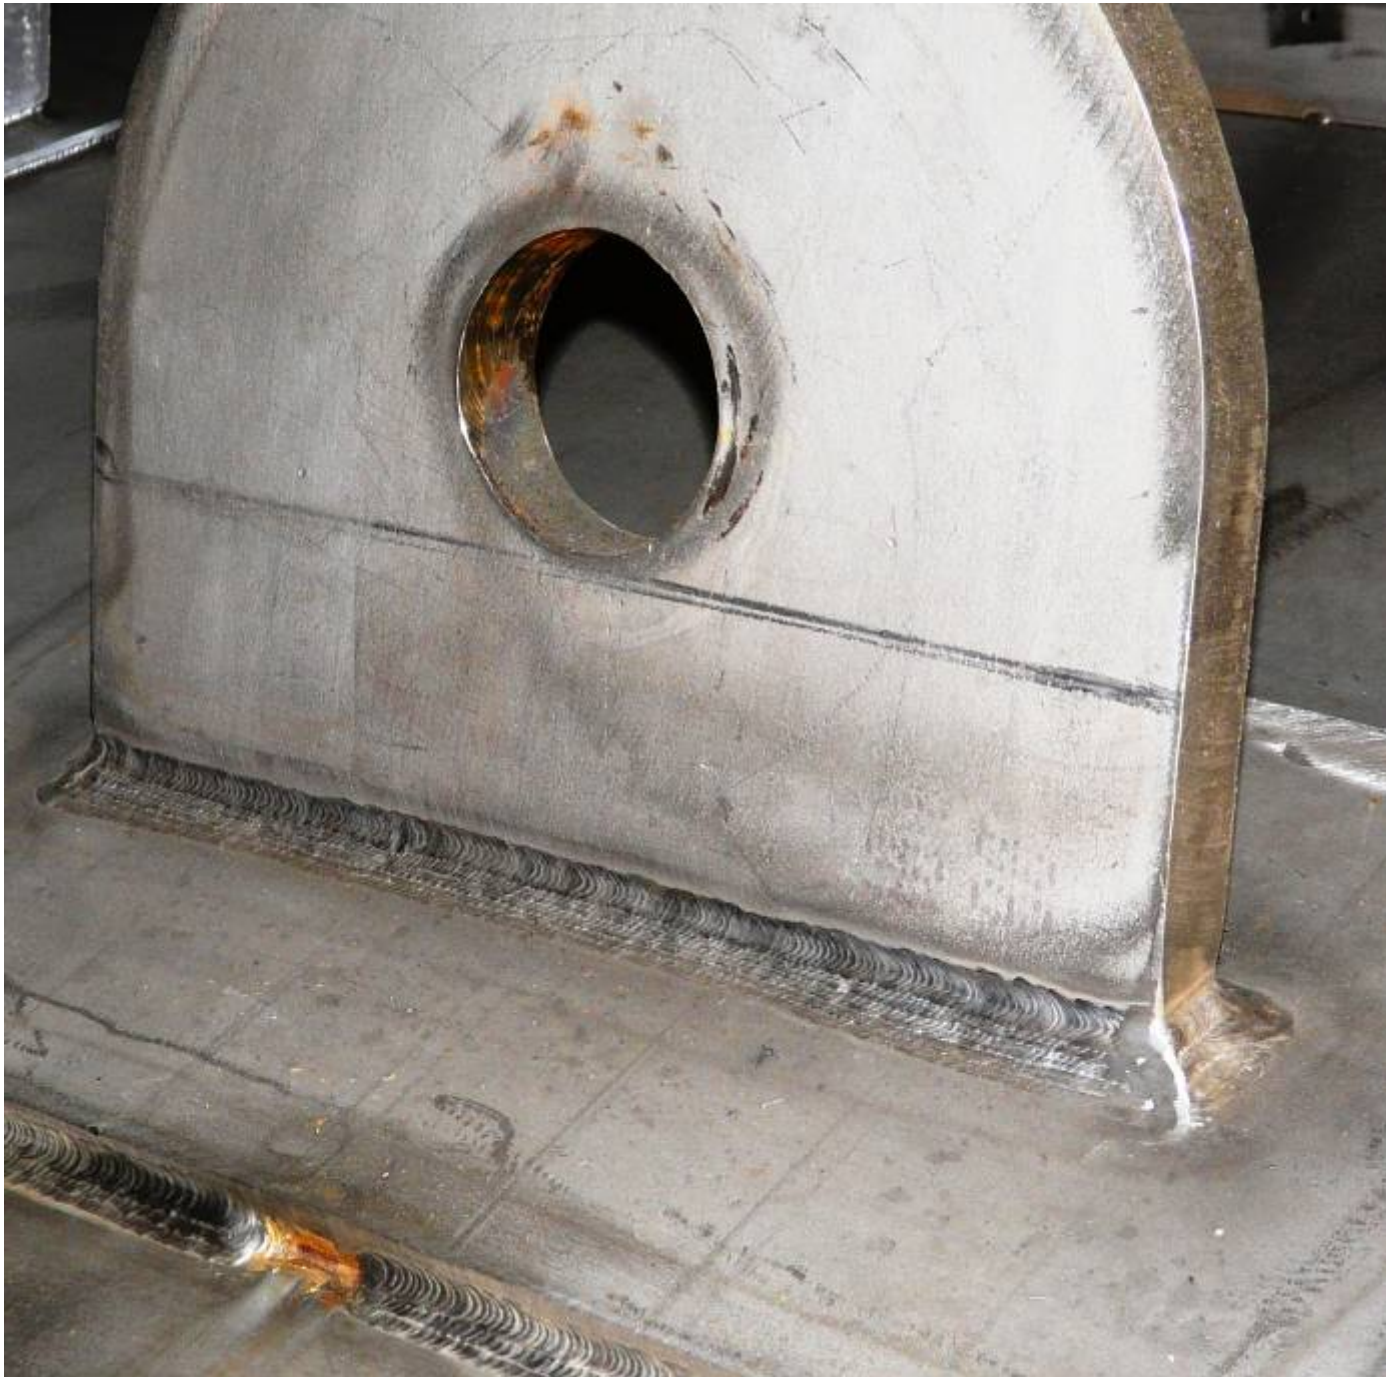
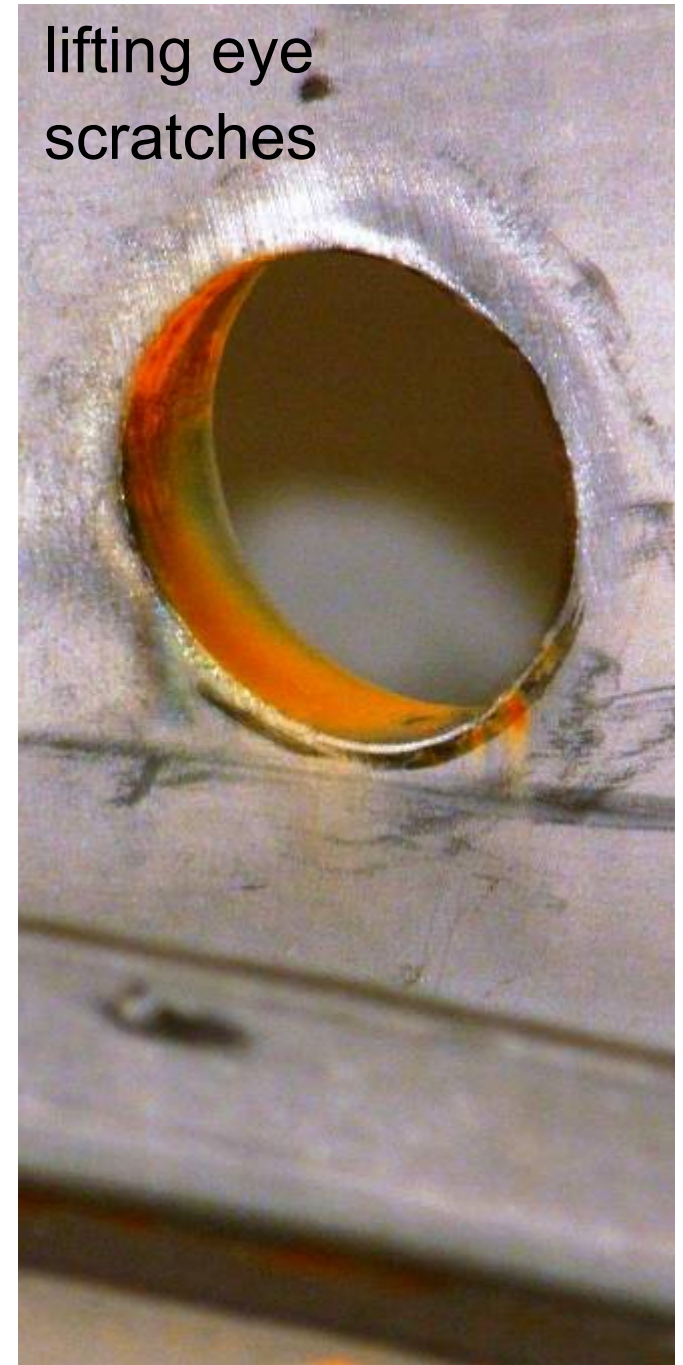
# Corrosion of the cryostat

- surprisingly large corrosion on cryostat:  
reasons: (1) debris from works on platform  
(2) carbon steel enclosures  
(3) insufficient pickling & passivation  
(4) scratches  
(5) debris in water or moved by water from bottom of WT to cryostat  
treatment = grinding + pickling + passivation
  - cryogenic pipes + valves box will be installed in week 12 by DeMaCo
  - storage tanks installed - exhaust gas heater waiting for installation
  - PLC ready for commissioning at LNGS
  - other piping ready for installation middle/end of April
  - mechanical shroud design for Rn shielding still to be tested (end of March)
- final installation after clean room is available, time estimate = 4 weeks,  
start filling of cryostat end of June?
- installation further improved w.r.t. safety
  - draft available on 'GERDA Alarm Levels and Corresponding Actions'

Reason for Bernhard being at LNGS  
where repair is in progress.

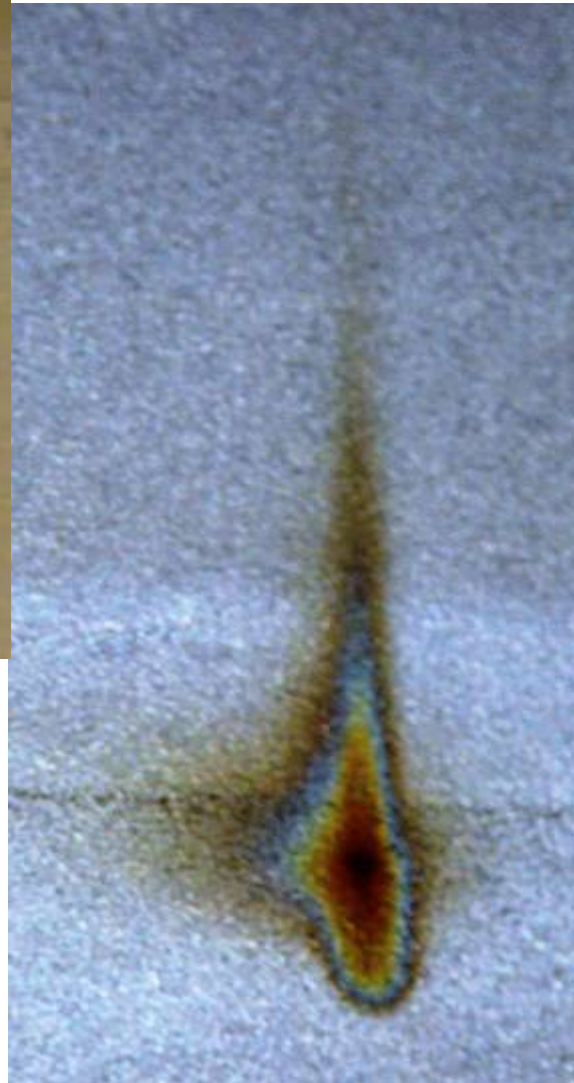
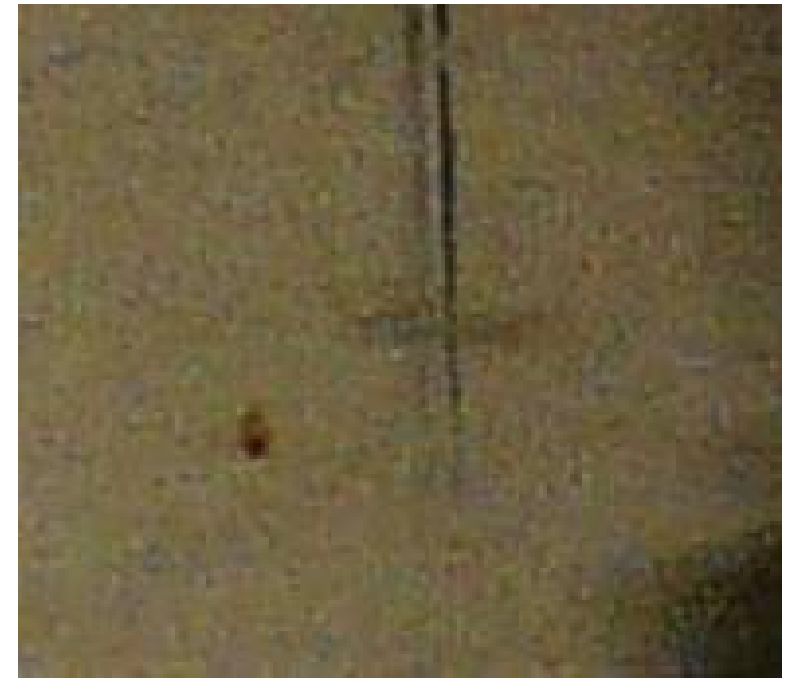
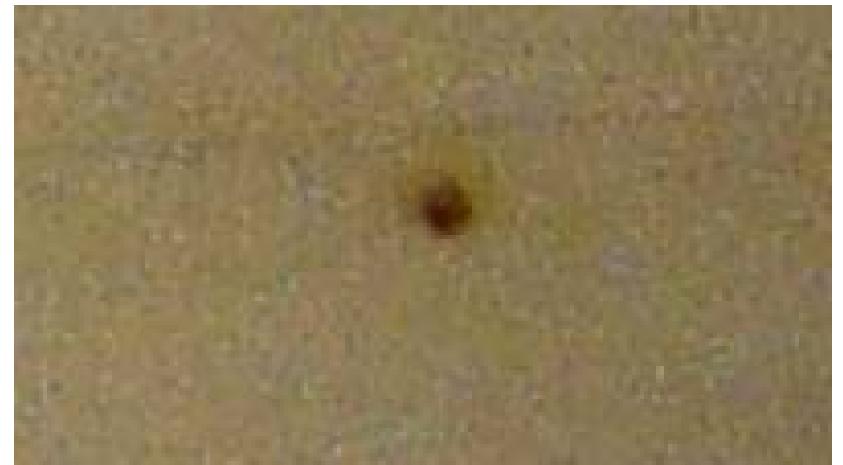
cylindrical shell  
steel enclosures

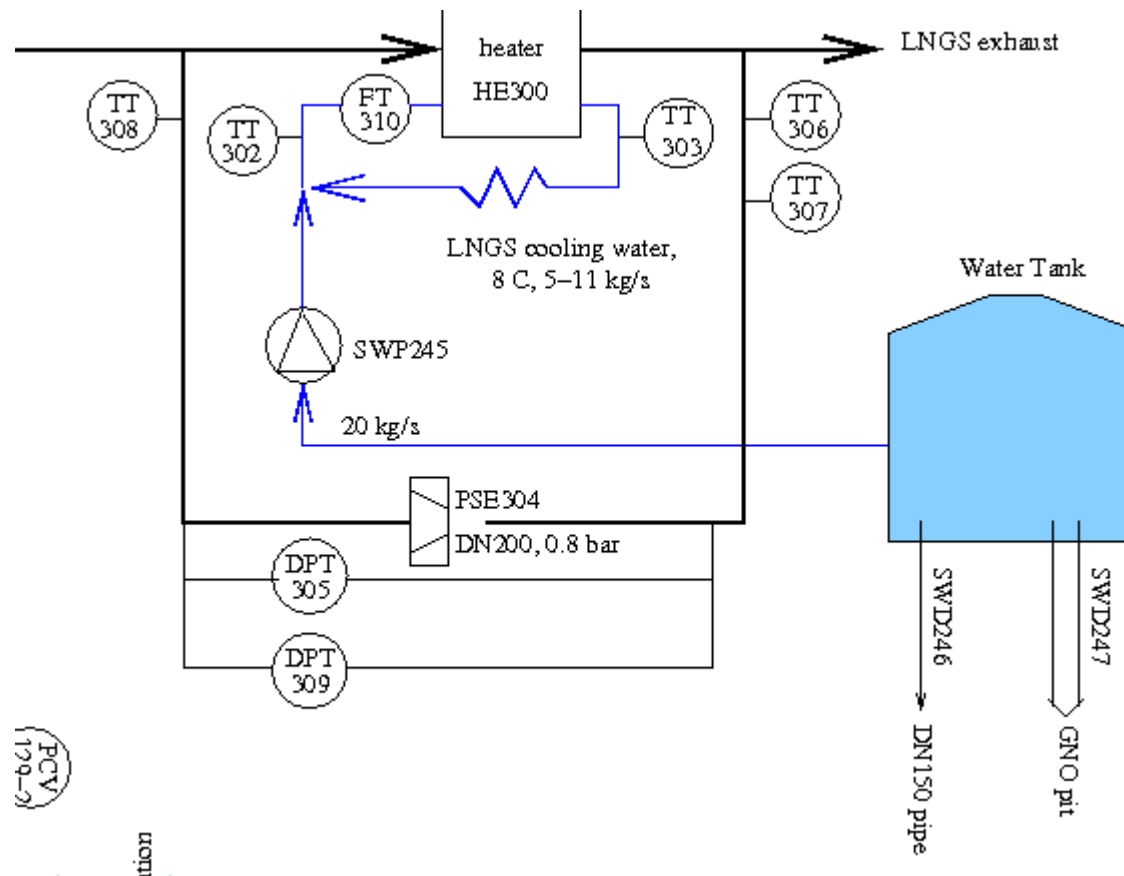
- Added:
- 2 temperature sensors at heater output
  - 2 differential pressure sensors for rough measurement of gas flow rate
  - temperature sensors for cooling water
  - cooling water flow meter
  - water pump for heating by water from water tank
  - rupture disk in bypass of heater for the case of clogging

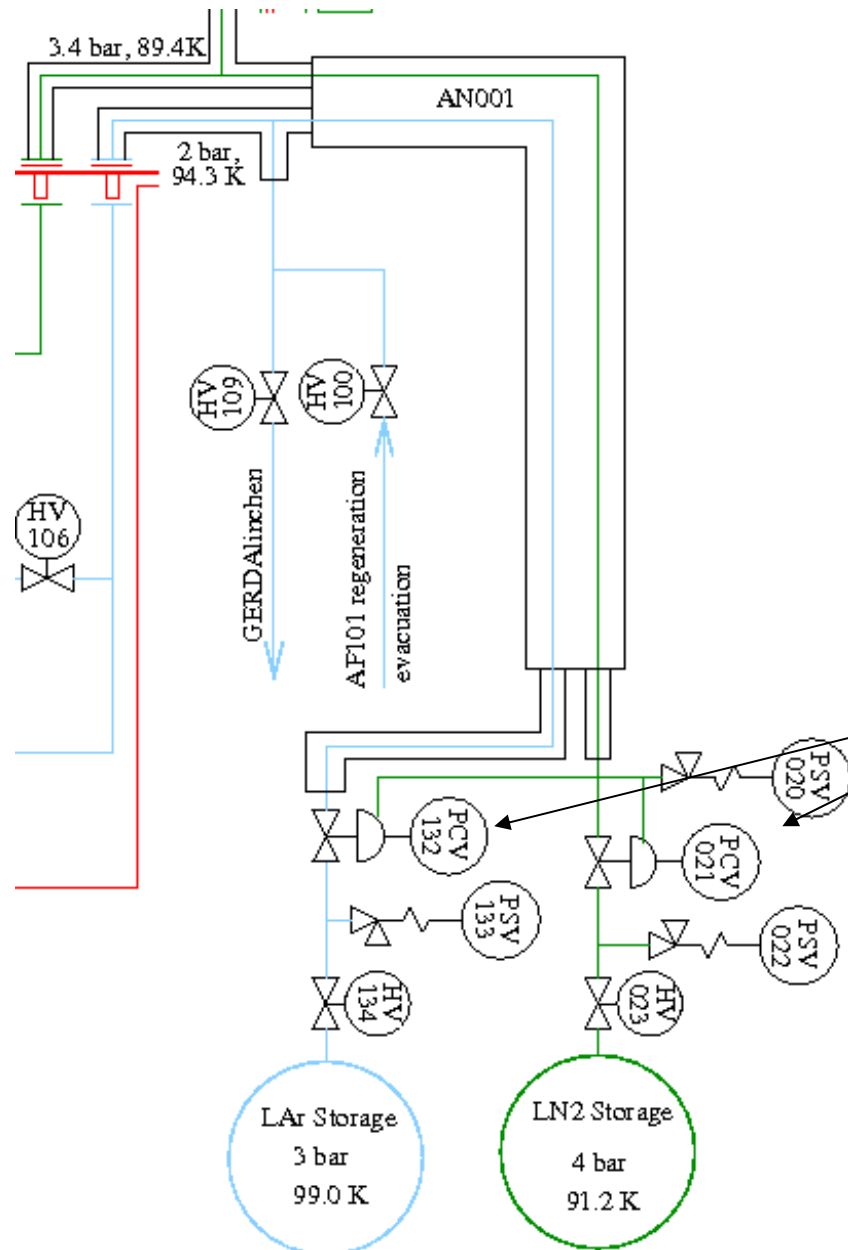
Added 2 pressure controlled valves  
- open if pressure in LN2 pipe high

In case of rupture of the tri-axial line  
- pressure in LN2 drops  
- both valves close

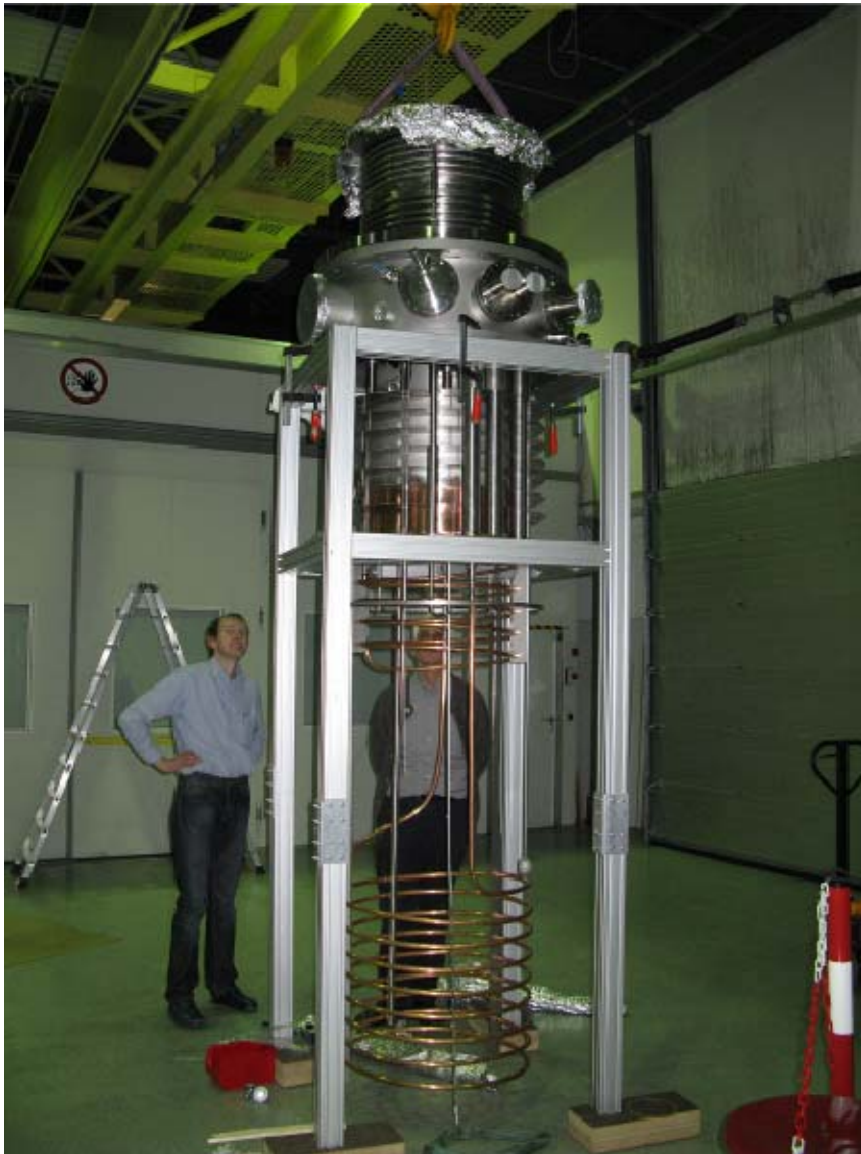
Missing: shroud to keep Rn away from crystal array
