Status of IGEX detectors

O.Chkvorets
On behalf of TG-1 of GERDA
collaboration
Heidelberg, Feb 20, 2006

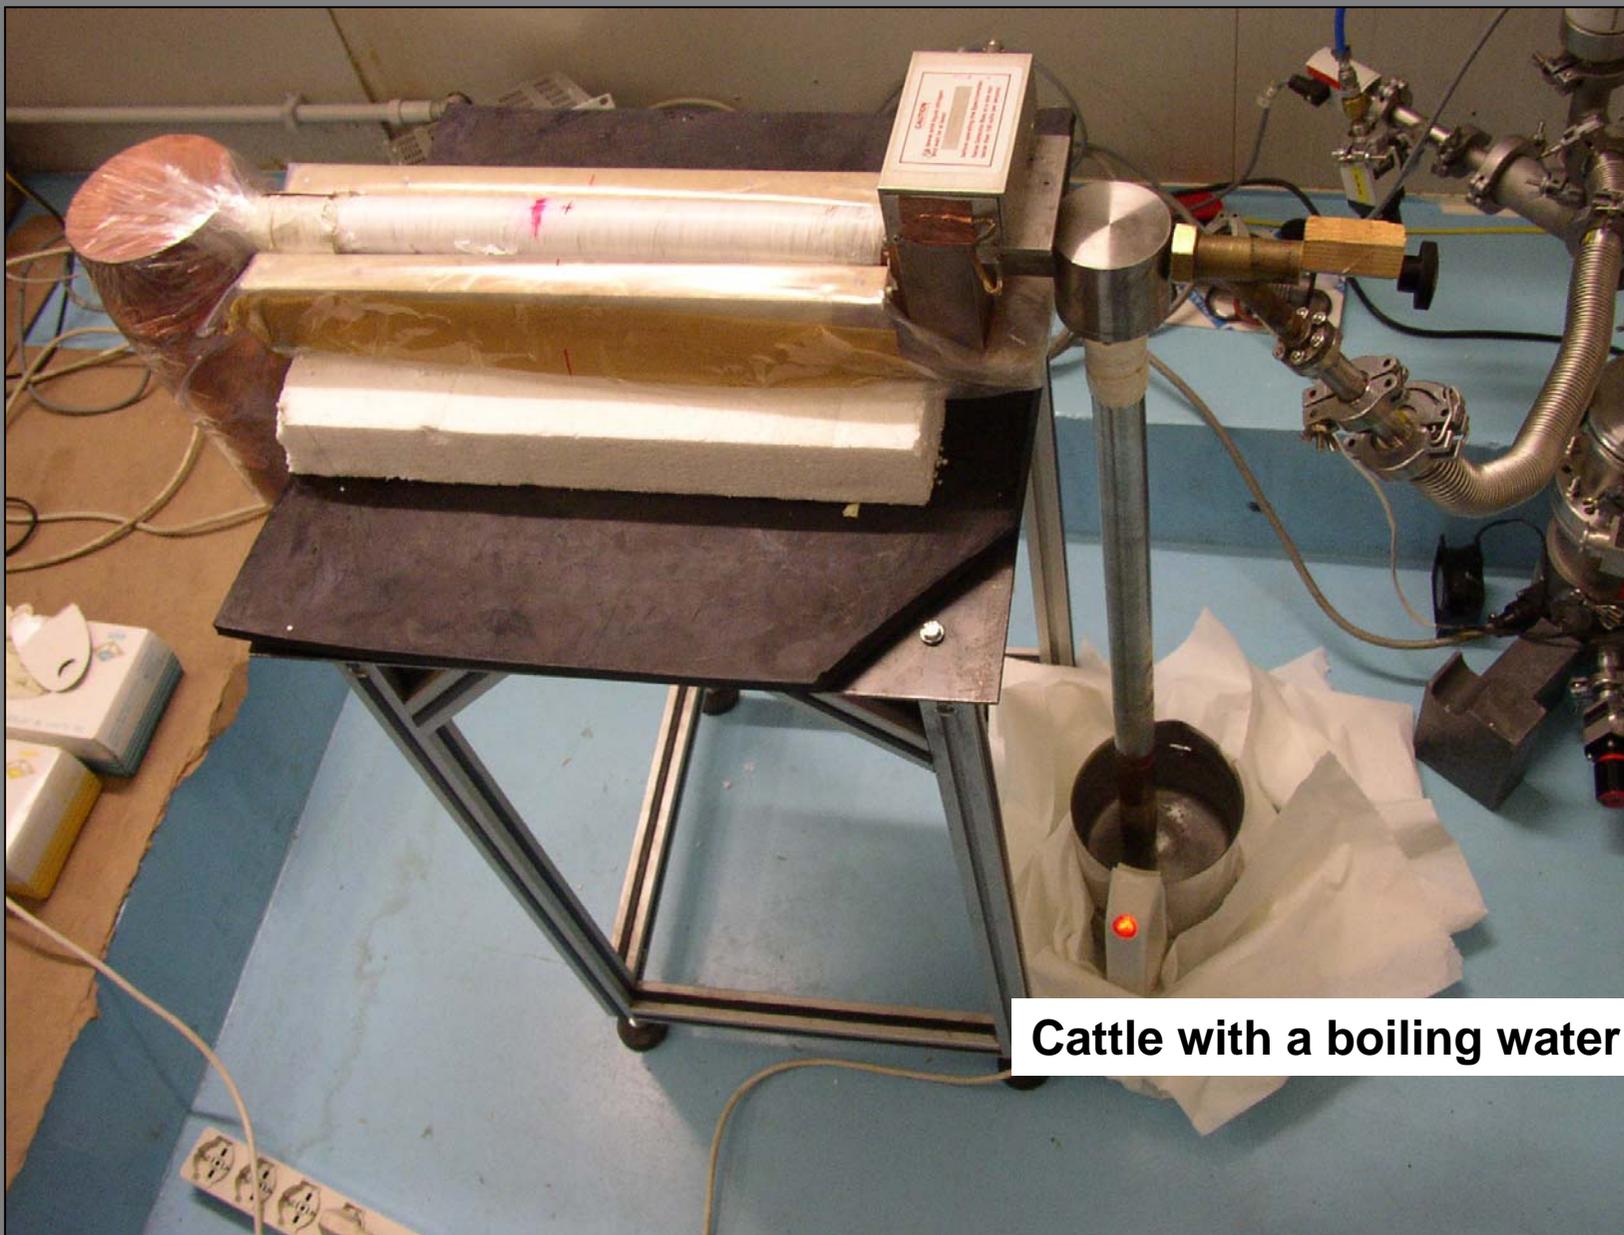
Heating the cryostats

Cattle with a boiling water

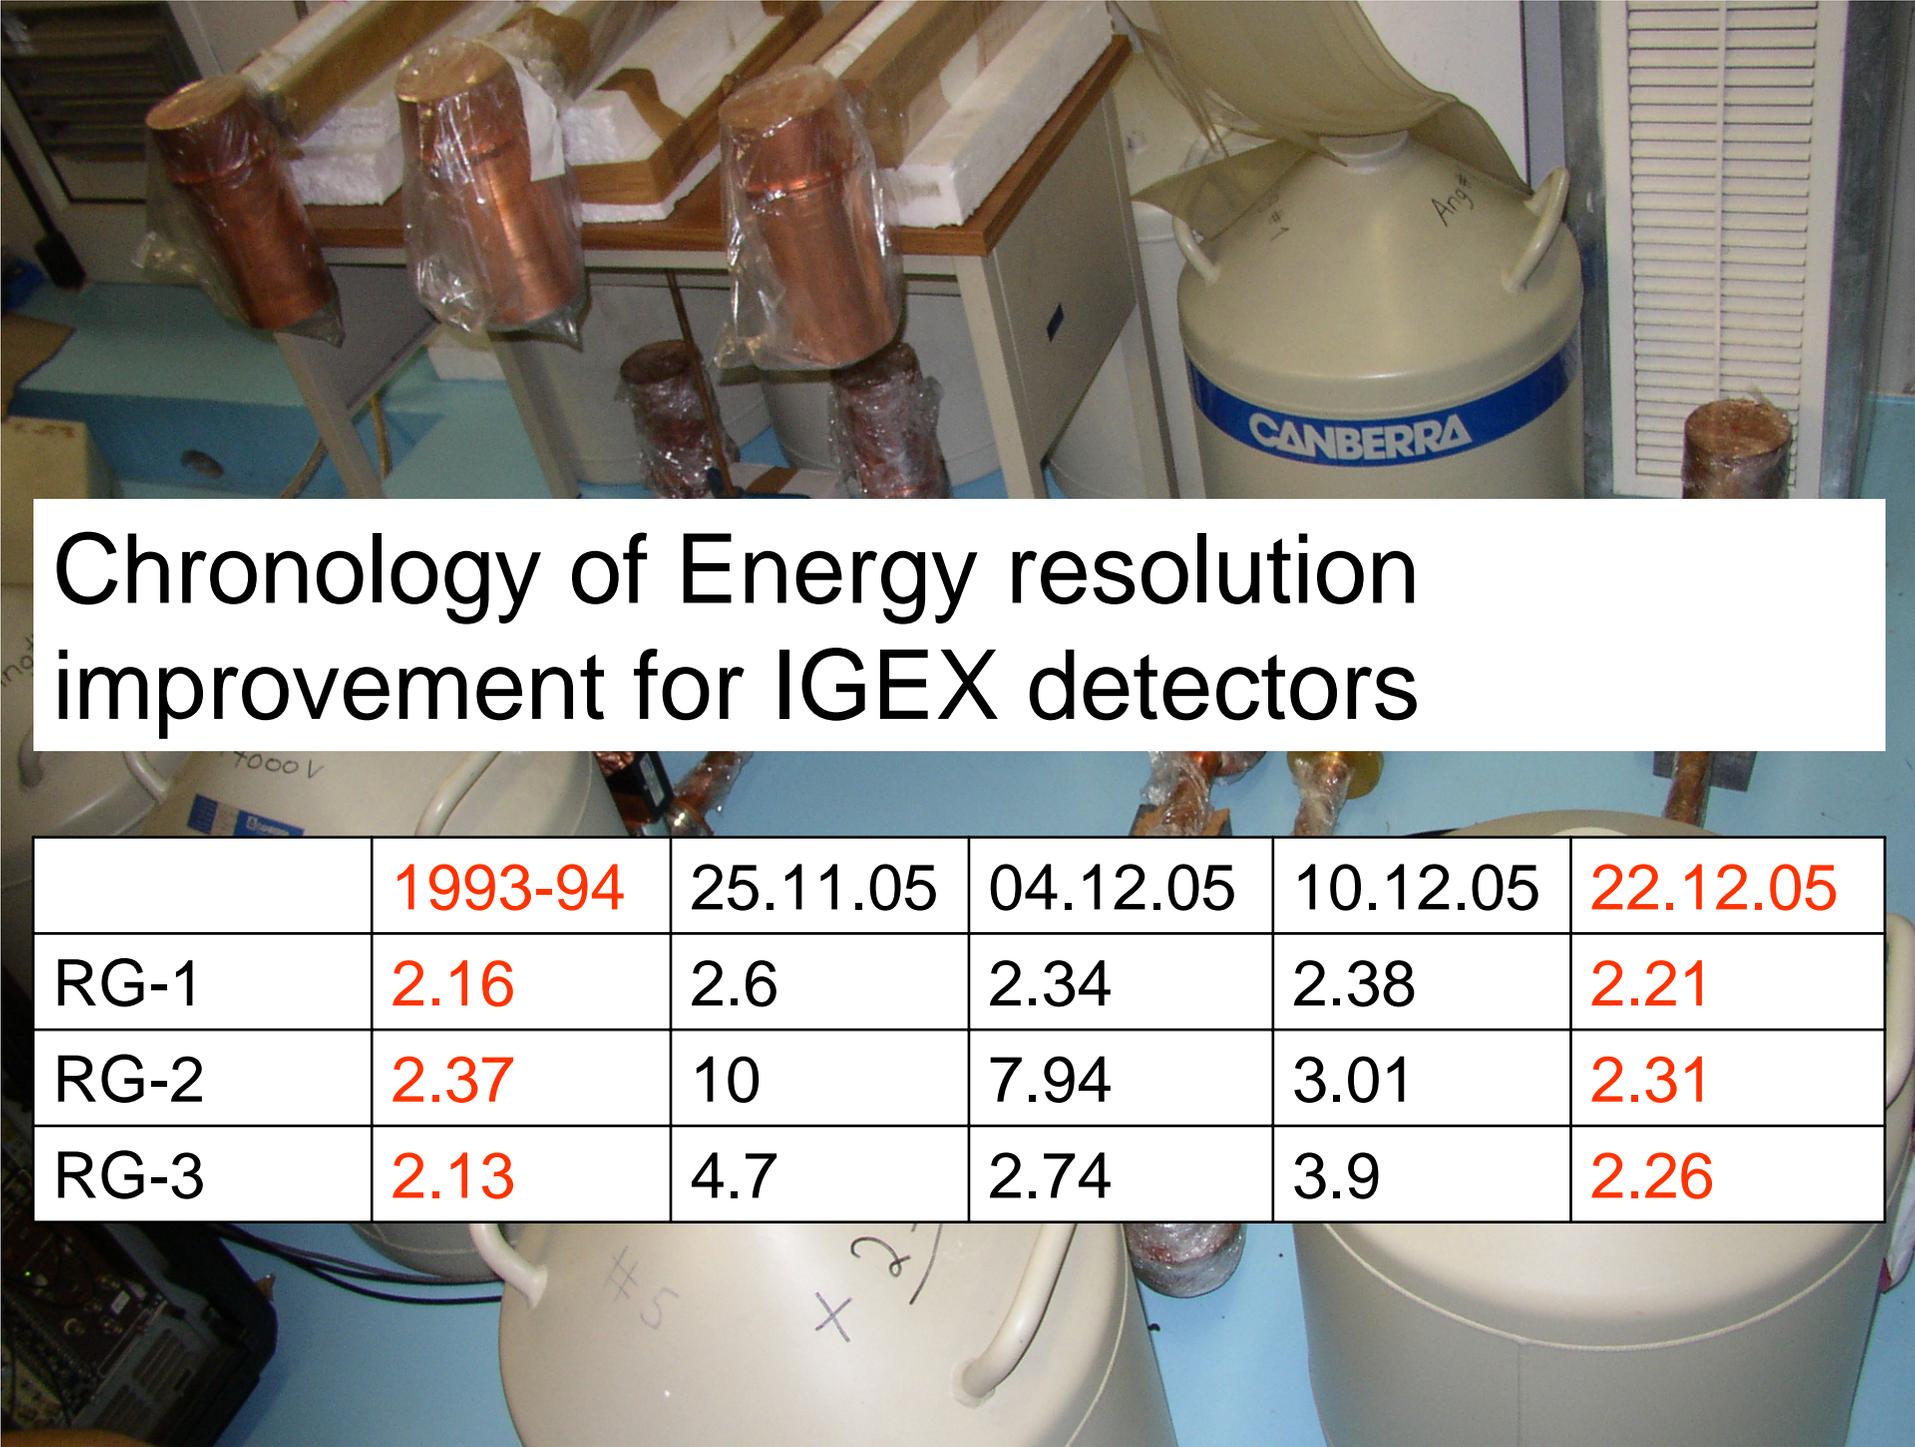
Chronology of Energy resolution improvement for IGEX detectors

1993-94	25.11.05	04.12.05	10.12.05	22.12.05
RG-1	2.16	2.6	2.34	2.38	2.21
RG-2	2.37	10	7.94	3.01	2.31
RG-3	2.13	4.7	2.74	3.9	2.26
