# **Status of Water tank**

Francesco Potenza

Meeting GERDA - Assergi 09-11 June 2008

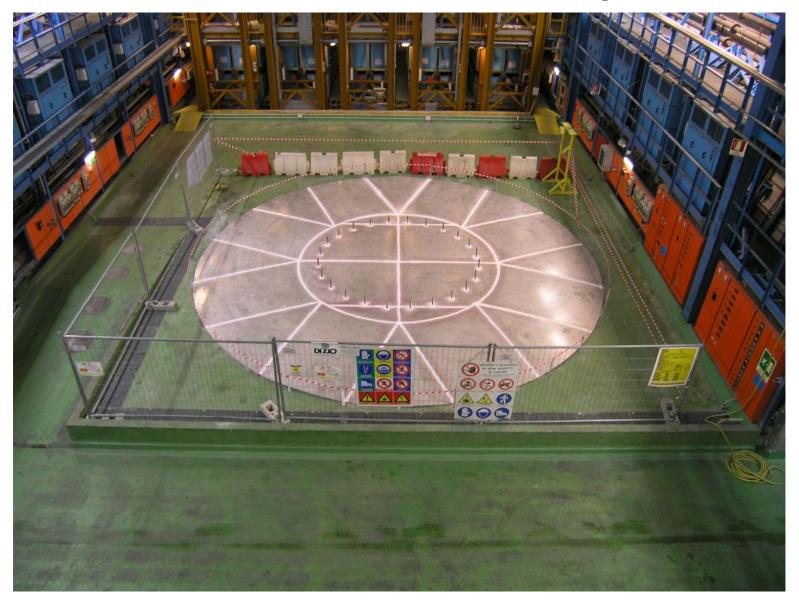
#### Status at 30 July 2007

#### A view from above of the buildingsite

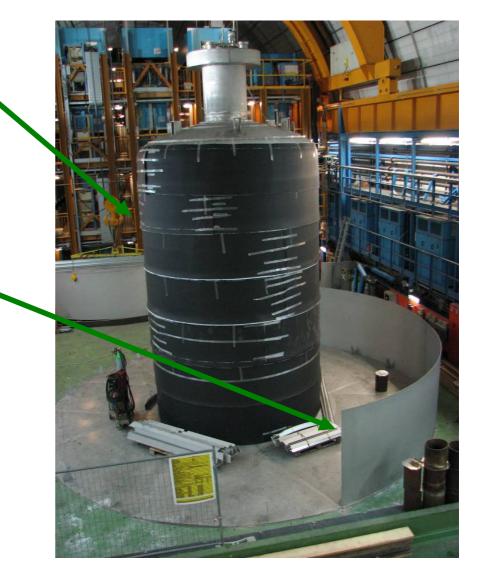
#### 30 April 2008

Cryostat surface covered accidental impacts with a material (C0 Class) for safety.

Then assembly of the first (top) ring of the WT shell (tickness=5mm).

WT shell: 5 rings (4 x 2 m + 1 x 0.3 m): total lateral height of 8.30 m

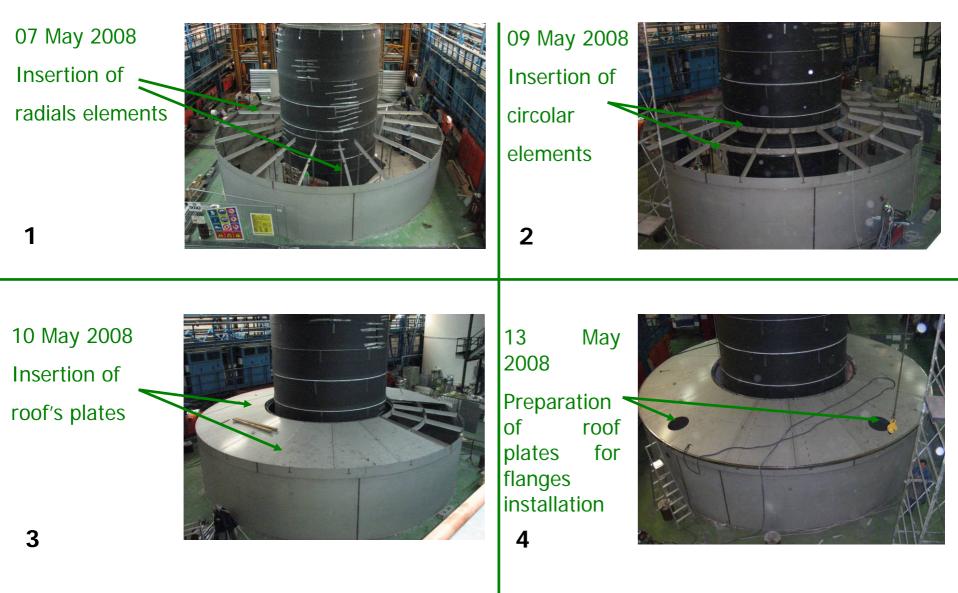
# Assembly of WT shell: 1st

After assembly of the first ring the roof frame structure has been assembled and roof plates welded

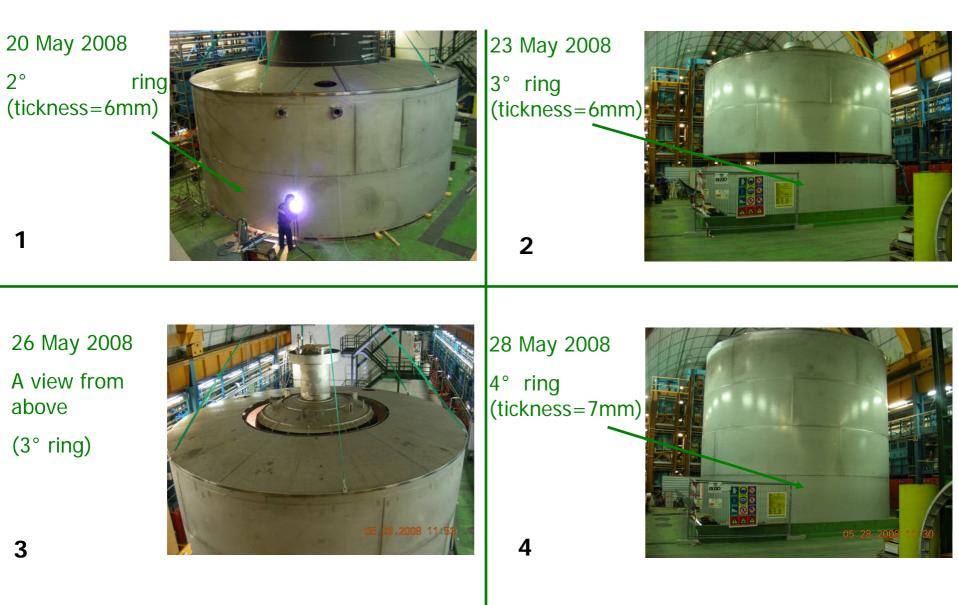
## Assembly of WT shell: 2nd

After the roof, the water tank has been lifted with the crane and three more rings were assembled.

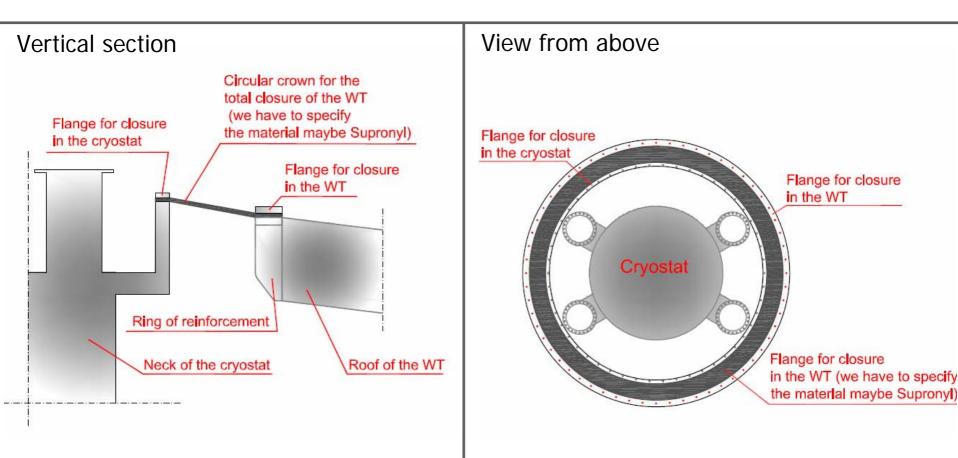
- For the closure of the WT we'll use two flanges: one on the reinforcment's ring of the WT and the second one on to the top of the cryostat.
- Between the two flanges we use a circolar corona of material that ensure air and Rn tightness (maybe the Supronyl).
