The Connecting Matrix:

Transmission line design is ugly:
too many connections, too many
components!

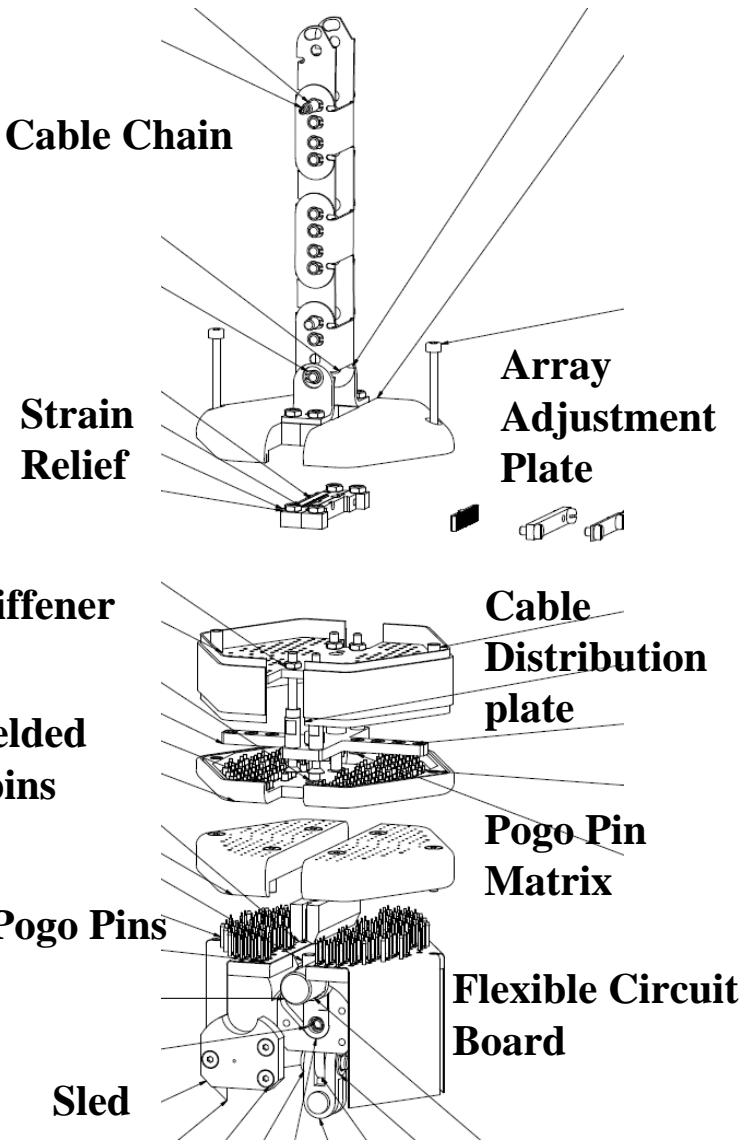
Cable chain with copper pin matrix is installed inside the lock. For Maintenance of this part the lock needs to be opened.

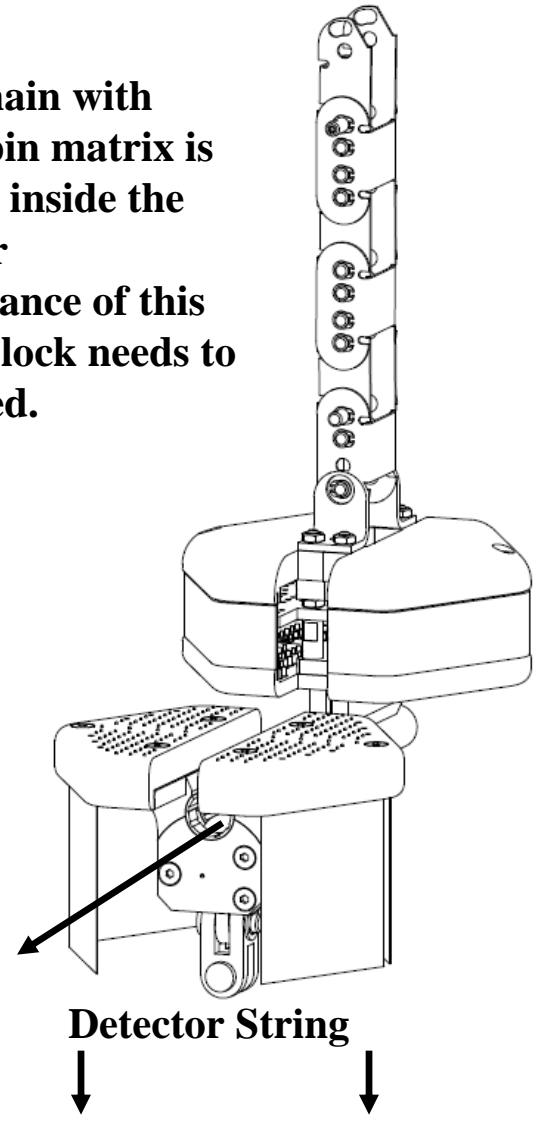
String on Pogo Pin matrix can be removed from lock

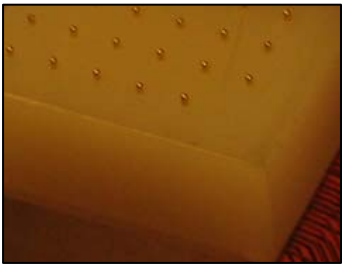
Cables laser
welded to
copper pins

Contact surface of
Copper pins Ni Au
plated

Pogo pin matrix

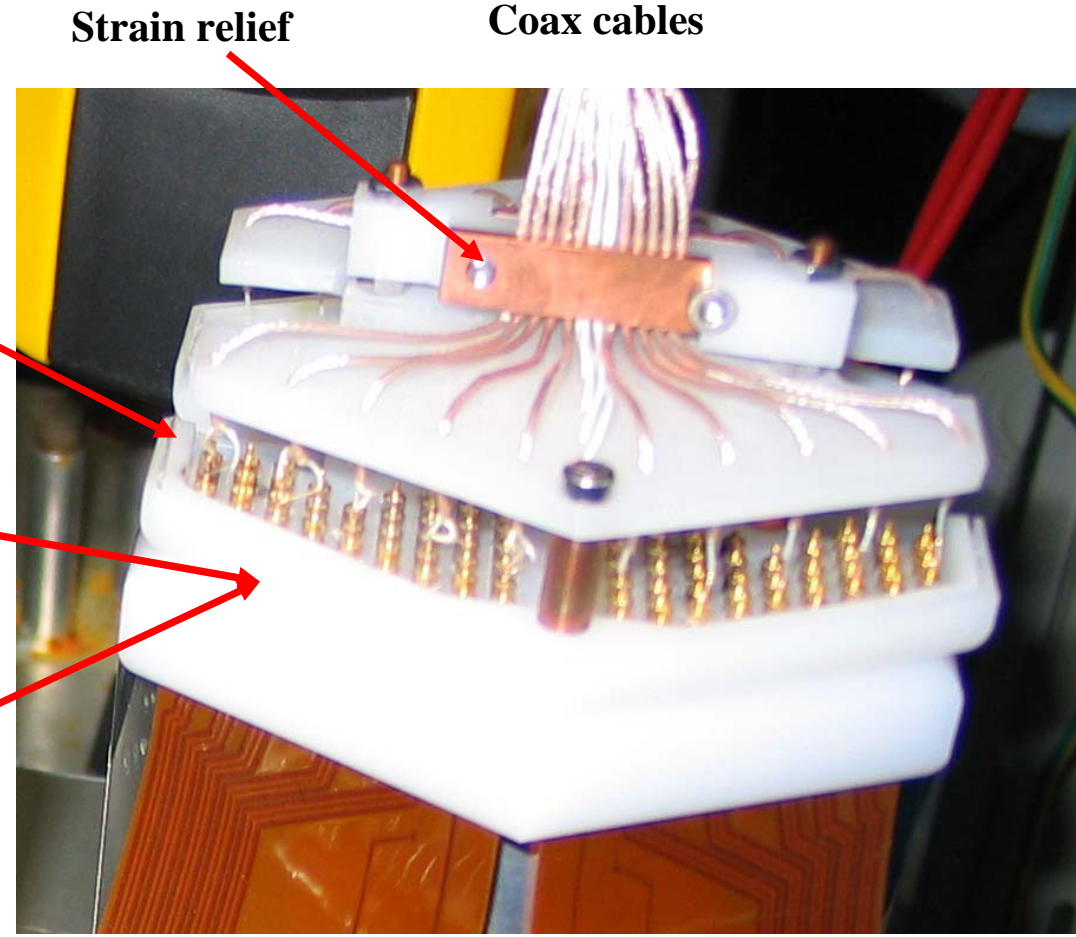
Strain relief

Coax cables

Kapton flat cable

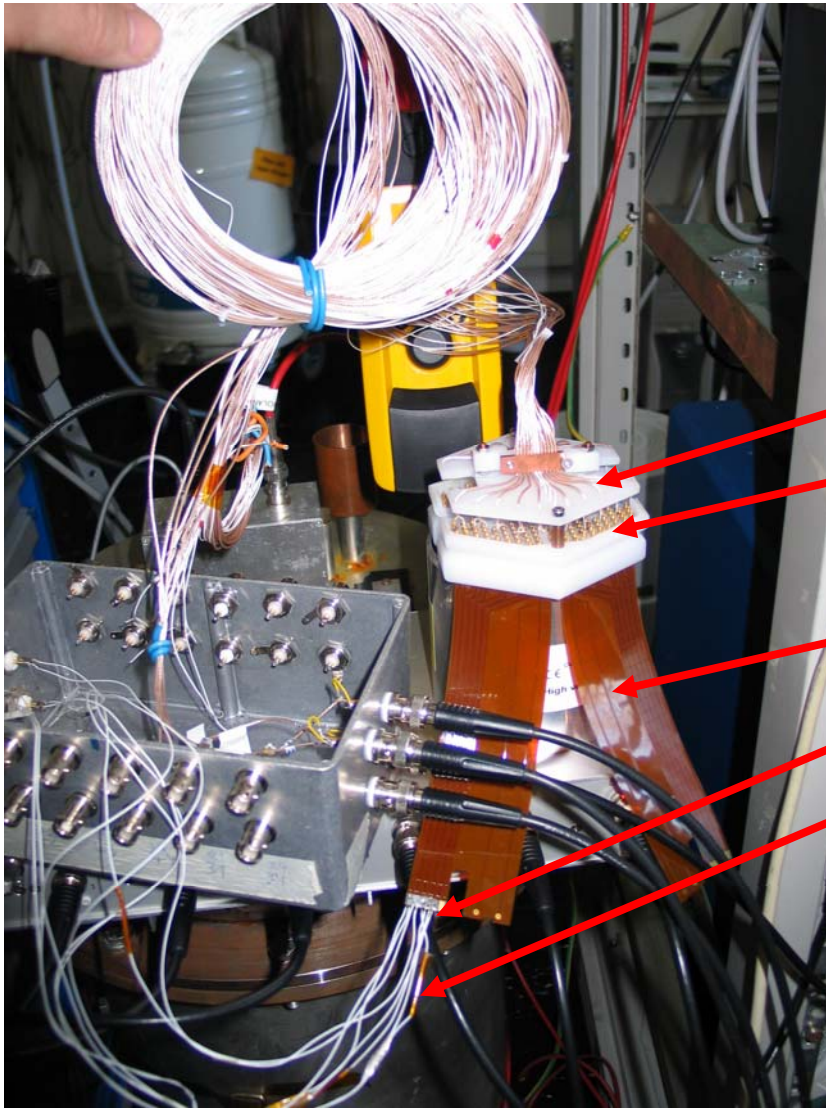
Coax cables

Copper Pin

Pogo Pins inside Plastic (screened)

Kapton flat cable

Cables laser welded to FPC

Cables towards FE

Copper on kapton not screened → Trying to replace with PEN FPC

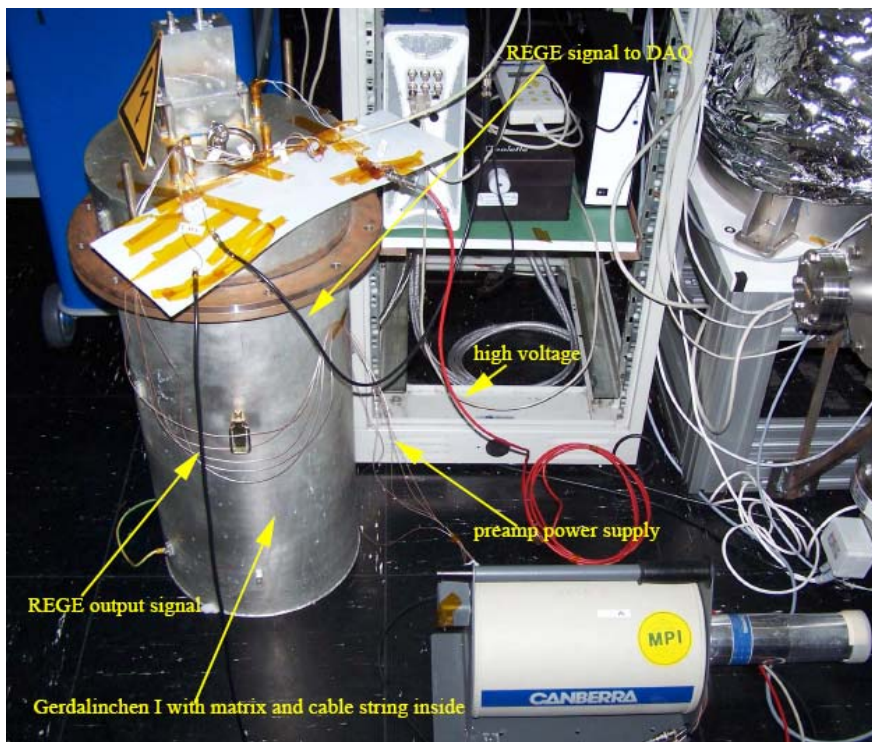
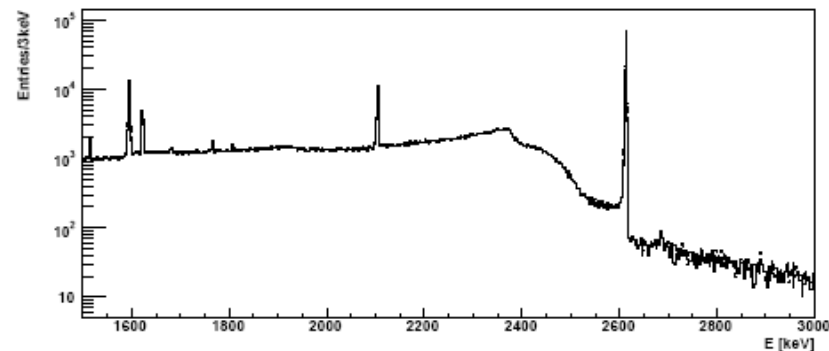
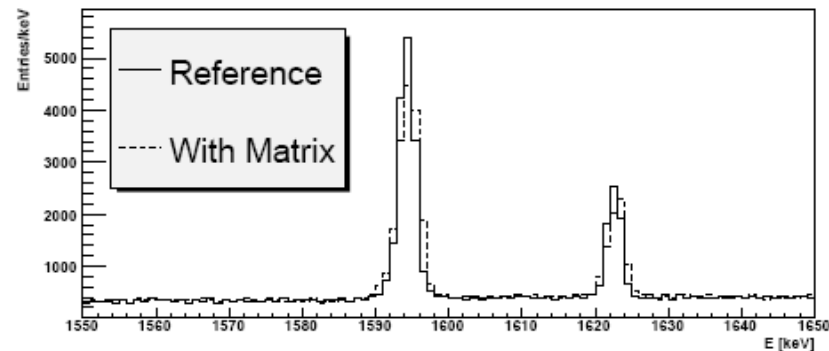
Signal, HV and preamp power supply have been fed through the full cable chain!

GSTR-08-013, GSTR-08-019

FWHM [keV]; REGE 2			
peak [keV]	reference I	with matrix II	preamp III
1173.0 (Co)	2.140 ± 0.037	1.976 ± 0.030	2.208 ± 0.041
1332.0 (Co)	2.175 ± 0.035	2.135 ± 0.032	2.267 ± 0.045
1460.0 (bg)	2.220 ± 0.061	2.016 ± 0.016	-
2614.0 (bg)	2.630 ± 0.152	2.820 ± 0.038	-

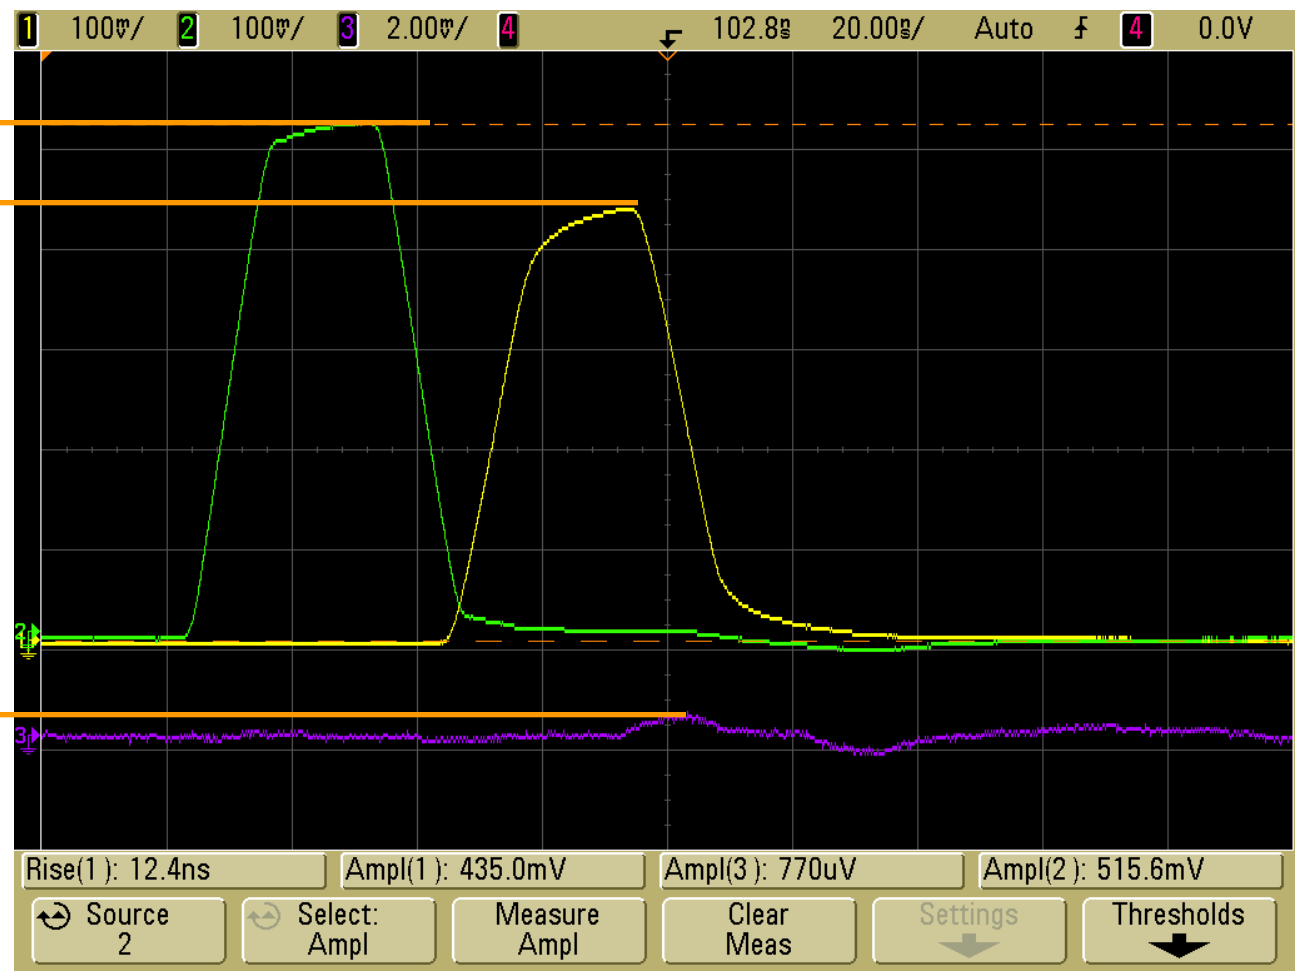
Signal Transmission:

Test Pulse
 Rise time: 10ns
 Flat: 20ns
 Fall time: 10ns
 Amplitude: 516 mV

Transmitted Signal:
 Rise time: 12.4ns
 Amplitude: 435 mV

Cross-talk Signal:
 Amplitude: 0.77 mV
 1.8‰ → ok

Timing Information: Rise time increase (10%-90%) by 2ns → ok
